Flood Damage Reduction Segment / System Inspection Report

Name of Segment / System: Souris River - Minot - Right Bank

Corps of Engineers Inspector: Joseph Hemmer Inspection Start Date: 10/30/2019

**Flood Damage Reduction Segment / System
Inspection Report
Souris River - Minot - Right Bank (MINR)**

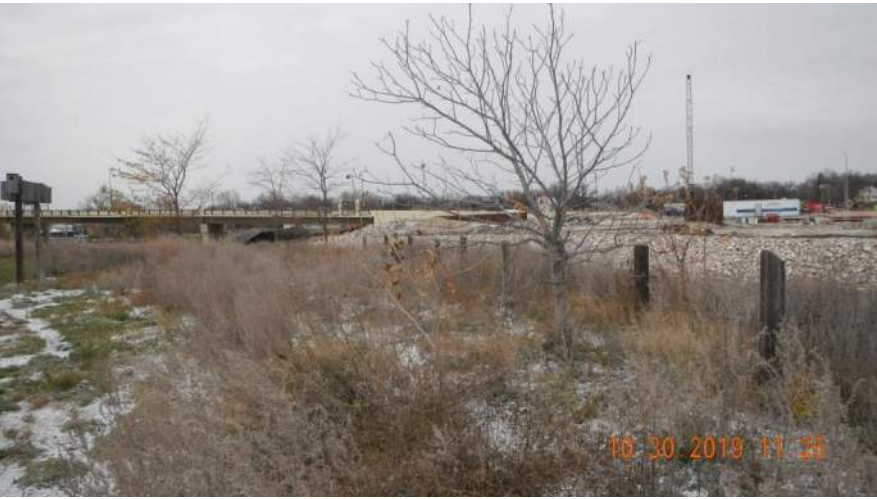
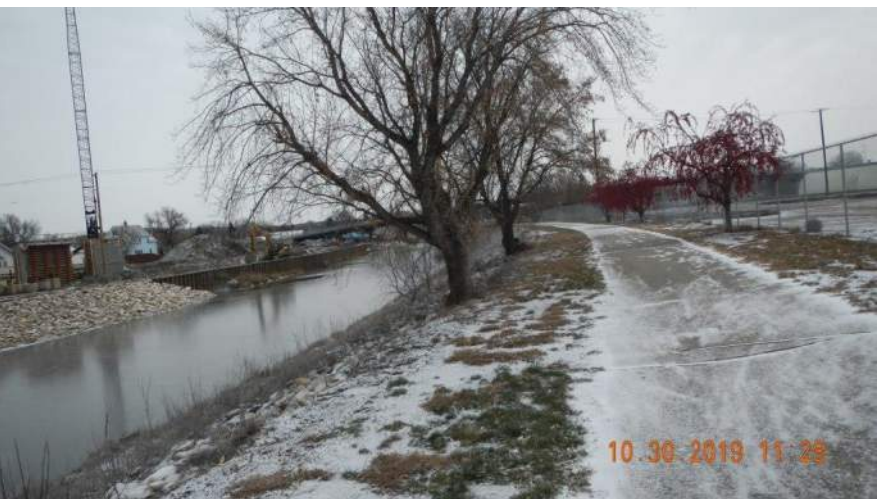
<p>Inspect ID: MINR_2019_a_0066 Title: USACE_CEMVP_MINR_2019_a_0066_1.jpg Rated Item: 1. Unwanted Vegetation Growth Caption: Rating: Unacceptable; Remarks: Trees along the top of the channel bank within the easement area; Action: Verify channel easement; Remove unwanted vegetation up to the channe easement. Remove root ball, backfill, compact in lifts, and reseed with grass. Ensure environmental compliance with all appropriate agencies prior to removal; Station_1: 717+00; Station_2: 740+00</p>

<p>Inspect ID: MINR_2019_a_0066 Title: USACE_CEMVP_MINR_2019_a_0066_2.jpg Rated Item: 1. Unwanted Vegetation Growth Caption: Rating: Unacceptable; Remarks: Trees along the top of the channel bank within the easement area; Action: Verify channel easement; Remove unwanted vegetation up to the channe easement. Remove root ball, backfill, compact in lifts, and reseed with grass. Ensure environmental compliance with all appropriate agencies prior to removal; Station_1: 717+00; Station_2: 740+00</p>

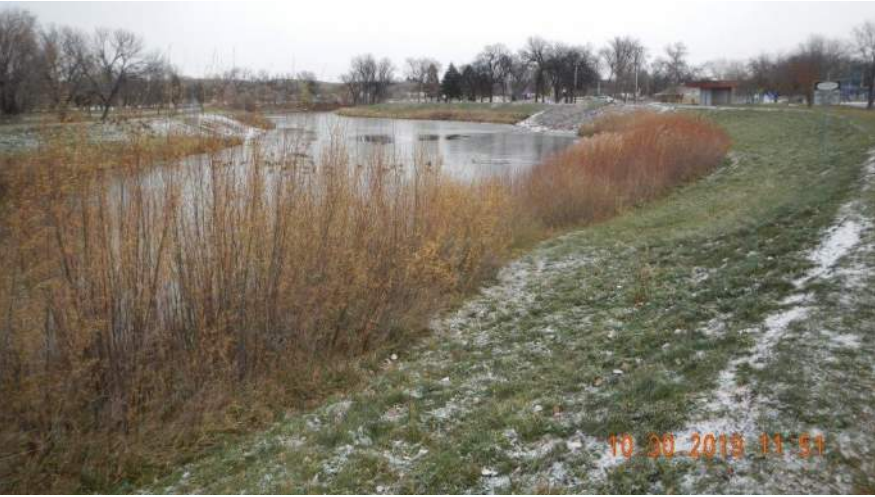
<p>A photograph showing a levee embankment with a grassy slope and a body of water. The vegetation is overgrown, and the water is calm. A timestamp in the bottom right corner reads "10 30 2019 11:51".</p>	<p>Inspect ID: MINR_2019_a_0077 Title: USACE_CEMVP_MINR_2019_a_0077_1.jpg Rated Item: 1. Unwanted Vegetation Growth Caption: Rating: Minimally Acceptable; Remarks: Overgrown vegetation growing at riverside toe of levee prevents inspection to water's edge; Action: Mow grass on a routine basis and maintain in compliance with operation and maintenance manual (A=0-6", M=6"-12", U=12+"); Station_1: 693+89; Station_2: 697+65</p>

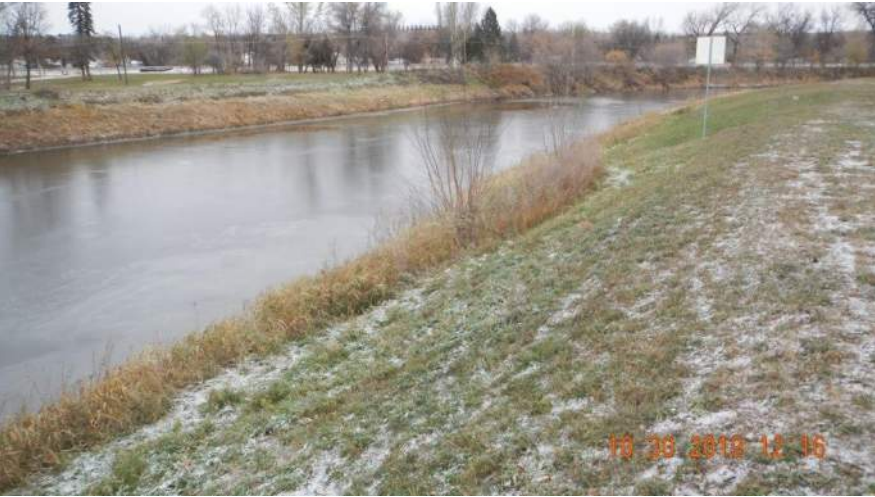
<p>A photograph showing a levee embankment with a grassy slope and a body of water. Several trees are visible in the background, and the water is calm. A timestamp in the bottom right corner reads "10 30 2019 11:36".</p>	<p>Inspect ID: MINR_2019_a_0088 Title: USACE_CEMVP_MINR_2019_a_0088_1.jpg Rated Item: 1. Unwanted Vegetation Growth Caption: Rating: Unacceptable; Remarks: Multiple trees with trunks greater than 2 inches in diameter appear to be within the levee alignment and within the vegetation free zone; Action: Remove unwanted vegetation from vegetation-free zone, up to levee easement. Remove root ball, backfill, compact in lifts, and reseed grass. Ensure environmental compliance with appropriate agencies prior to removal; Station_1: 647+00; Station_2: 692+17</p>

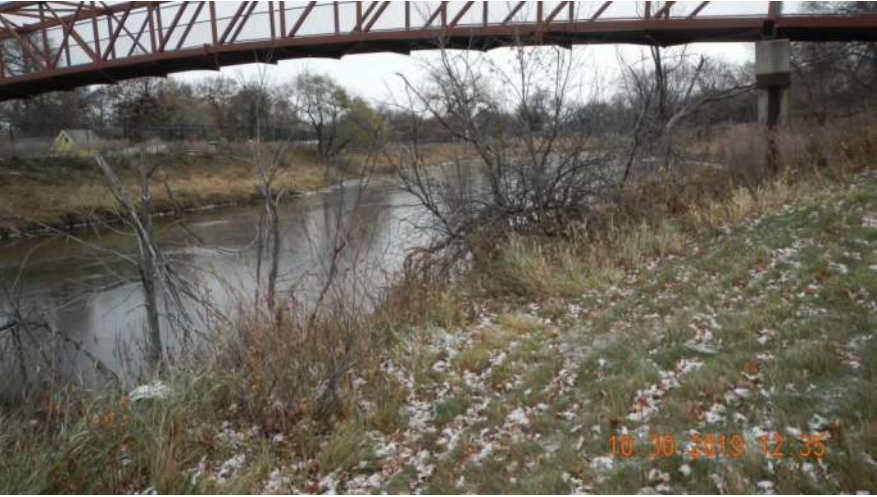
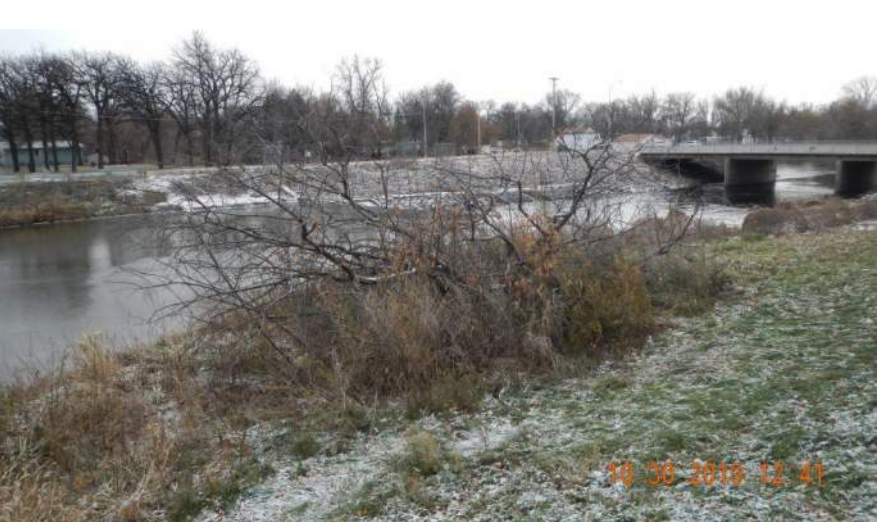
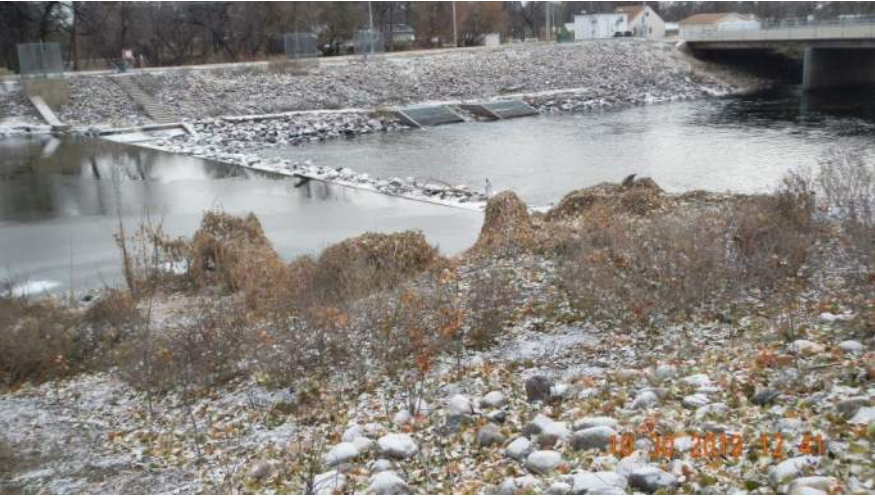
<p>Inspect ID: MINR_2019_a_0088 Title: USACE_CEMVP_MINR_2019_a_0088_6.jpg Rated Item: 1. Unwanted Vegetation Growth Caption: Rating: Unacceptable; Remarks: Multiple trees with trunks greater than 2 inches in diameter appear to be within the levee alignment and within the vegetation free zone; Action: Remove unwanted vegetation from vegetation-free zone, up to levee easement. Remove root ball, backfill, compact in lifts, and reseed grass. Ensure environmental compliance with appropriate agencies prior to removal; Station_1: 647+00; Station_2: 692+17</p>

<p>Inspect ID: MINR_2019_a_0088 Title: USACE_CEMVP_MINR_2019_a_0088_7.jpg Rated Item: 1. Unwanted Vegetation Growth Caption: Rating: Unacceptable; Remarks: Multiple trees with trunks greater than 2 inches in diameter appear to be within the levee alignment and within the vegetation free zone; Action: Remove unwanted vegetation from vegetation-free zone, up to levee easement. Remove root ball, backfill, compact in lifts, and reseed grass. Ensure environmental compliance with appropriate agencies prior to removal; Station_1: 647+00; Station_2: 692+17</p>

<p>Inspect ID: MINR_2019_a_0088 Title: USACE_CEMVP_MINR_2019_a_0088_8.jpg Rated Item: 1. Unwanted Vegetation Growth Caption: Rating: Unacceptable; Remarks: Multiple trees with trunks greater than 2 inches in diameter appear to be within the levee alignment and within the vegetation free zone; Action: Remove unwanted vegetation from vegetation-free zone, up to levee easement. Remove root ball, backfill, compact in lifts, and reseed grass. Ensure environmental compliance with appropriate agencies prior to removal; Station_1: 647+00; Station_2: 692+17</p>

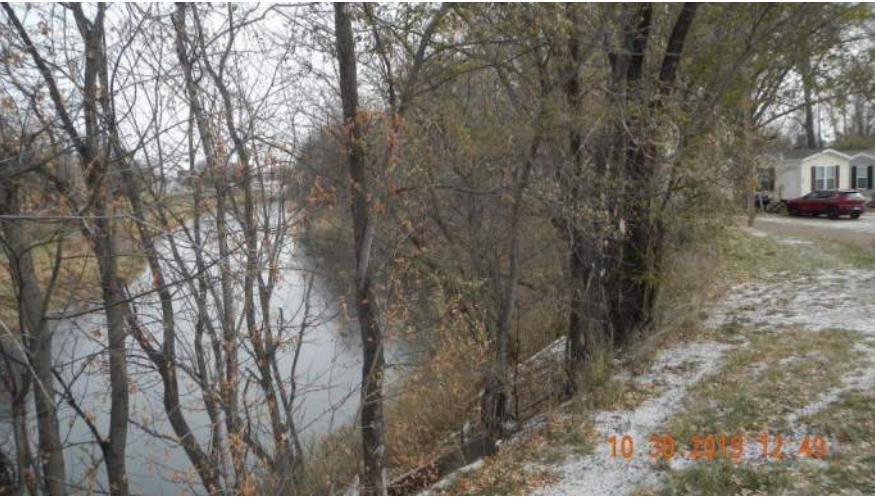
<p>Inspect ID: MINR_2019_a_0101 Title: USACE_CEMVP_MINR_2019_a_0101_1.jpg Rated Item: 1. Unwanted Vegetation Growth Caption: Rating: Unacceptable; Remarks: Trees (> 2 inches in diameter) with long vegetation are located along the levee alignment; Action: Remove unwanted vegetation from vegetation-free zone, up to levee easement. Remove root ball, backfill, compact in lifts, and reseed grass. Ensure environmental compliance with appropriate agencies prior to removal; Station_1: 632+74; Station_2: 644+54</p>

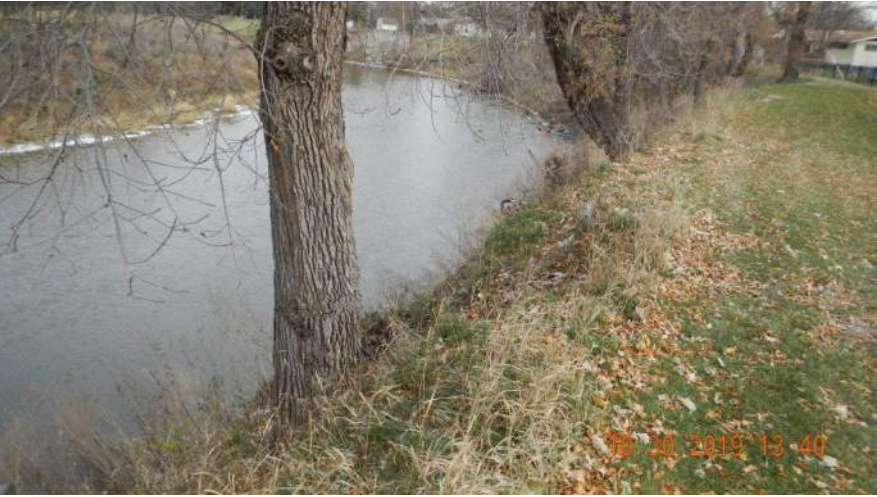
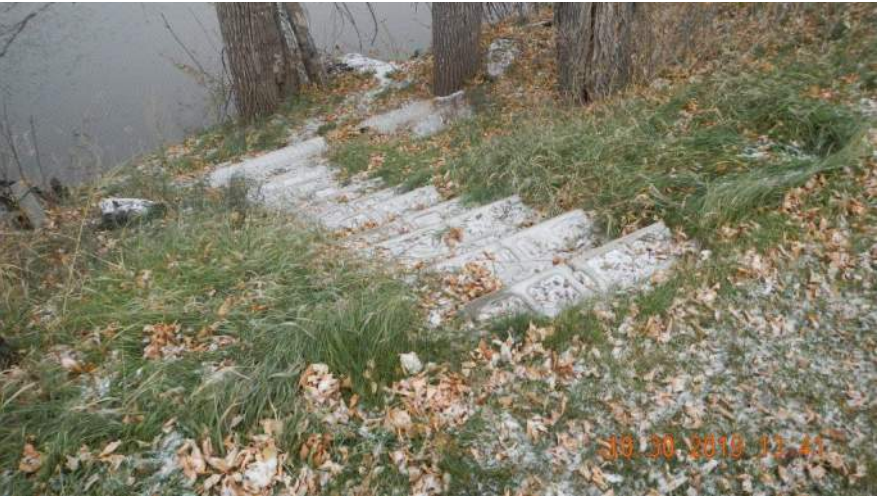
<p>A photograph showing a grassy levee embankment next to a body of water. A large tree trunk is visible in the foreground on the left. The water is calm and reflects the sky. The grass is green with some fallen leaves. A timestamp '39 30 2019 13:40' is visible in the bottom right corner of the photo.</p>	<p>Inspect ID: MINR_2019_a_0124 Title: USACE_CEMVP_MINR_2019_a_0124_4.jpg Rated Item: 1. Unwanted Vegetation Growth Caption: Rating: Unacceptable; Remarks: Trees (> 2 in diameter) and long vegetation located along the levee alignment and channel bank slope; Action: Remove unwanted vegetation from vegetation-free zone, up to levee easement. Remove root ball, backfill, compact in lifts, and reseed grass. Ensure environmental compliance with appropriate agencies prior to removal; Station_1: 572+72; Station_2: 588+37</p>

<p>A photograph showing a grassy levee embankment next to a body of water. A large tree trunk is visible in the foreground on the left. The water is calm and reflects the sky. The grass is green with some fallen leaves. A timestamp '39 30 2019 13:41' is visible in the bottom right corner of the photo.</p>	<p>Inspect ID: MINR_2019_a_0124 Title: USACE_CEMVP_MINR_2019_a_0124_5.jpg Rated Item: 1. Unwanted Vegetation Growth Caption: Rating: Unacceptable; Remarks: Trees (> 2 in diameter) and long vegetation located along the levee alignment and channel bank slope; Action: Remove unwanted vegetation from vegetation-free zone, up to levee easement. Remove root ball, backfill, compact in lifts, and reseed grass. Ensure environmental compliance with appropriate agencies prior to removal; Station_1: 572+72; Station_2: 588+37</p>

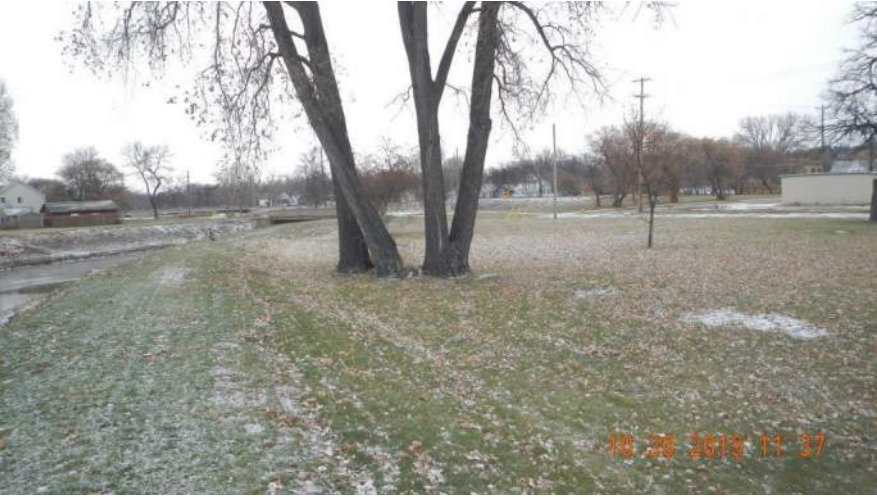
<p>A wide-angle photograph of a levee embankment. In the foreground, there is a grassy area with scattered dry leaves. Two large, mature trees with bare branches stand prominently. In the background, a residential area with houses and utility poles is visible under an overcast sky. A timestamp in orange text at the bottom right reads '10 30 2019 11 37'.</p>	<p>Inspect ID: MINR_2019_a_0150 Title: USACE_CEMVP_MINR_2019_a_0150_1.jpg Rated Item: 1. Unwanted Vegetation Growth Caption: Rating: Unacceptable; Remarks: Trees (> 2 inches in diameter) along the levee landside toe that appear to be within the vegetation free zone; Action: Remove unwanted vegetation from vegetation free zone, up to levee easement. Remove root ball, backfill, compact in lifts, and reseed grass. Ensure environmental compliance with appropriate agencies prior to removal; Station_1: 707+70; Station_2: 713+62</p>

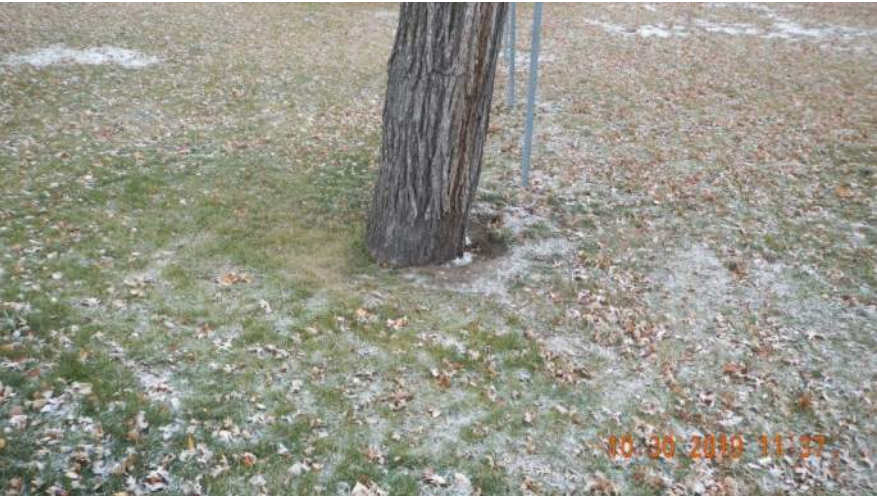
<p>A close-up photograph of a tree trunk on a levee embankment. The ground is covered with grass and dry leaves. A blue surveying tape or string is visible, extending from the tree trunk towards the right. A timestamp in orange text at the bottom right reads '10 30 2019 11 37'.</p>	<p>Inspect ID: MINR_2019_a_0150 Title: USACE_CEMVP_MINR_2019_a_0150_2.jpg Rated Item: 1. Unwanted Vegetation Growth Caption: Rating: Unacceptable; Remarks: Trees (> 2 inches in diameter) along the levee landside toe that appear to be within the vegetation free zone; Action: Remove unwanted vegetation from vegetation free zone, up to levee easement. Remove root ball, backfill, compact in lifts, and reseed grass. Ensure environmental compliance with appropriate agencies prior to removal; Station_1: 707+70; Station_2: 713+62</p>

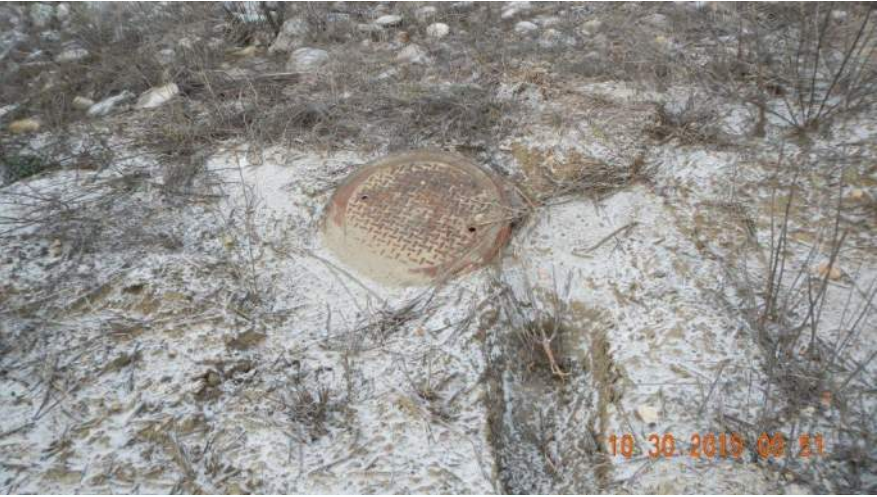
<p>Inspect ID: MINR_2019_a_0014 Title: USACE_CEMVP_MINR_2019_a_0014_1.jpg Rated Item: 3. Encroachments Caption: Rating: Unacceptable; Remarks: Sewer manhole located at levee crown. Sponsor indicated this portion of levee will be abandoned with new design; Action: Verify levee easement. Relocate encroachments/debris outside of levee easement. Verify approval was received from Corps to perform excavations; Station_1: 847+38</p>

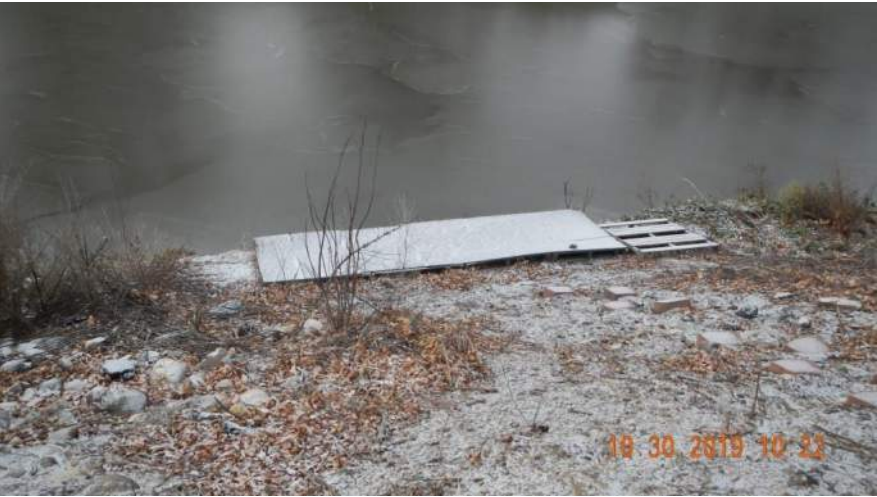
<p>Inspect ID: MINR_2019_a_0040 Title: USACE_CEMVP_MINR_2019_a_0040_1.jpg Rated Item: 3. Encroachments Caption: Rating: Unacceptable; Remarks: Boat dock driven into riverside levee slope. Steps and other residential debris on slope as well; Action: Verify levee easement. Relocate encroachments/debris outside of levee easement; Station_1: 819+61</p>

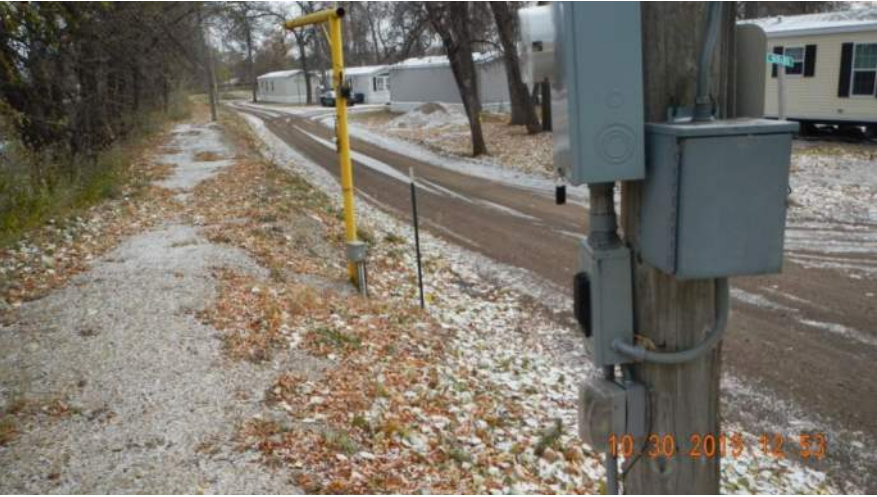
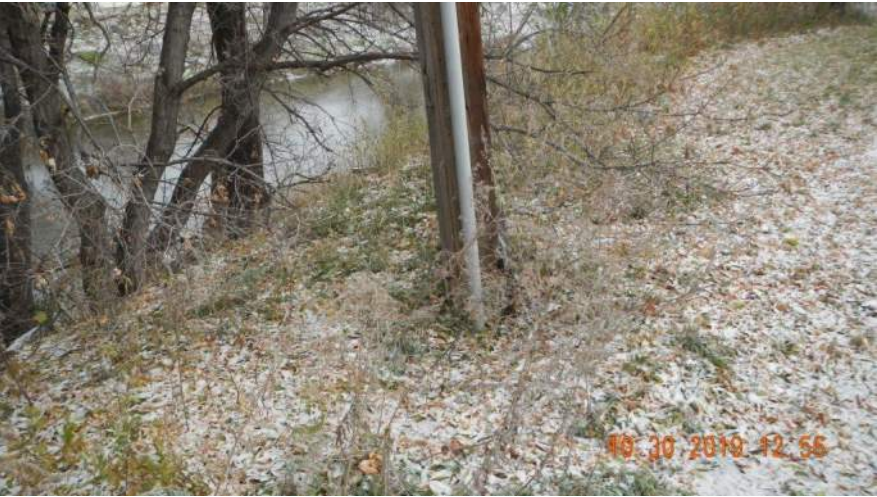
<p>Inspect ID: MINR_2019_a_0102 Title: USACE_CEMVP_MINR_2019_a_0102_2.jpg Rated Item: 3. Encroachments Caption: Rating: Unacceptable; Remarks: Multiple encroachment (light and power poles, fire hydrant, residential, fence and debris) along the levee alignment; Action: Verify levee easement. Relocate encroachments/debris outside of levee easement, unless approved by the Corps; Station_1: 625+70; Station_2: 643+37</p>

<p>Inspect ID: MINR_2019_a_0102 Title: USACE_CEMVP_MINR_2019_a_0102_3.jpg Rated Item: 3. Encroachments Caption: Rating: Unacceptable; Remarks: Multiple encroachment (light and power poles, fire hydrant, residential, fence and debris) along the levee alignment; Action: Verify levee easement. Relocate encroachments/debris outside of levee easement, unless approved by the Corps; Station_1: 625+70; Station_2: 643+37</p>

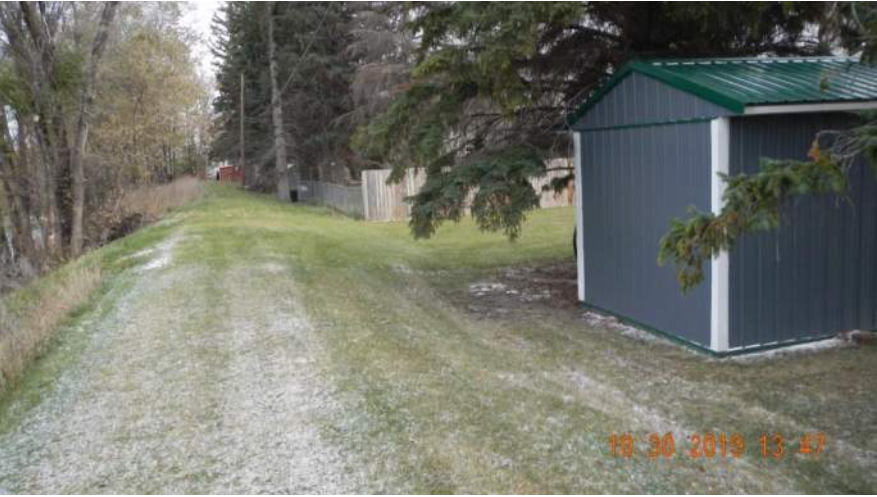
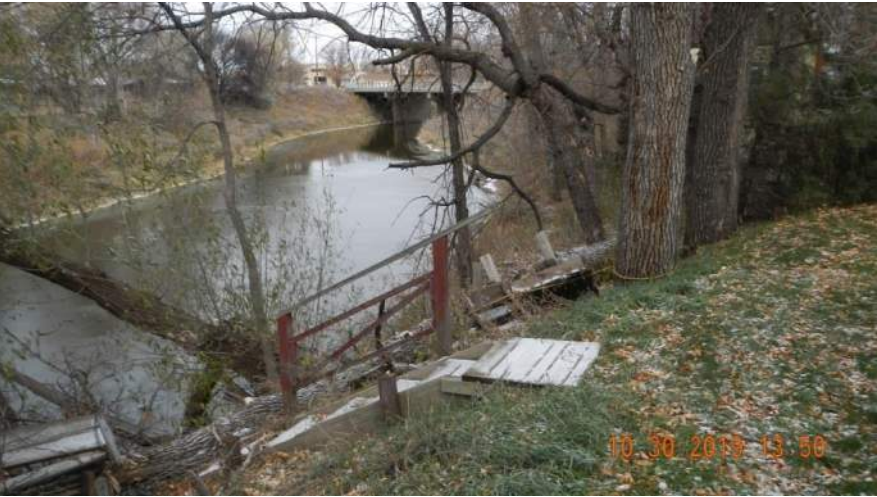
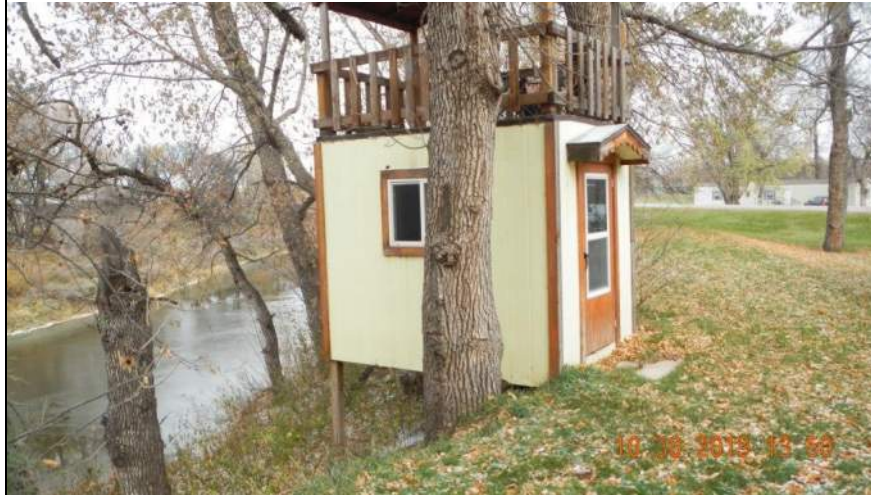
<p>Inspect ID: MINR_2019_a_0123 Title: USACE_CEMVP_MINR_2019_a_0123_10.jpg Rated Item: 3. Encroachments Caption: Rating: Unacceptable; Remarks: Multiple residential encroachments along levee slopes and crown. These include stairs, irrigation lines, pumps, power poles, children's playhouses, retaining walls, fences, and gardens; Action: Verify levee easement. Relocate encroachments outside of levee easement. Discourage home owners from modifying levee, unless approved by the Corps; Station_1: 572+99; Station_2: 589+25</p>

<p>Inspect ID: MINR_2019_a_0123 Title: USACE_CEMVP_MINR_2019_a_0123_11.jpg Rated Item: 3. Encroachments Caption: Rating: Unacceptable; Remarks: Multiple residential encroachments along levee slopes and crown. These include stairs, irrigation lines, pumps, power poles, children's playhouses, retaining walls, fences, and gardens; Action: Verify levee easement. Relocate encroachments outside of levee easement. Discourage home owners from modifying levee, unless approved by the Corps; Station_1: 572+99; Station_2: 589+25</p>

Inspect ID: MINR_2019_a_0123 **Title:** USACE_CEMVP_MINR_2019_a_0123_12.jpg **Rated Item:** 3. Encroachments
Caption: Rating: Unacceptable; Remarks: Multiple residential encroachments along levee slopes and crown. These include stairs, irrigation lines, pumps, power poles, children's playhouses, retaining walls, fences, and gardens; Action: Verify levee easement. Relocate encroachments outside of levee easement. Discourage home owners from modifying levee, unless approved by the Corps; Station_1: 572+99; Station_2: 589+25

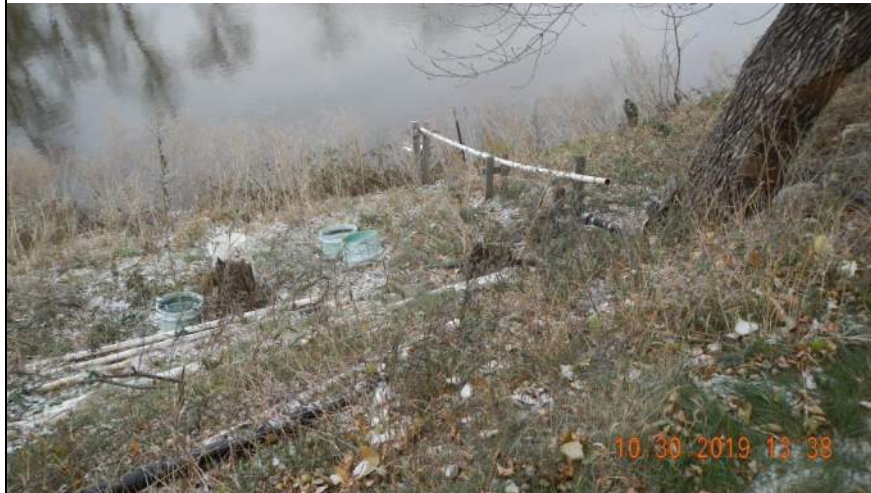
Inspect ID: MINR_2019_a_0125 **Title:** USACE_CEMVP_MINR_2019_a_0125_1.jpg
Rated Item: 3. Encroachments **Caption:** Rating: Unacceptable; Remarks: Two pipes drilled through levee approximately 4 feet below crown are covered in grass and tree stump debris by landowner. The 2018 Culvert Inspection indicates that the pipes have minor sags and no closure structures; Action: Verify levee easement. Determine origin of pipes and remove from levee easement, unless approved by Corps; Station_1: 587+80

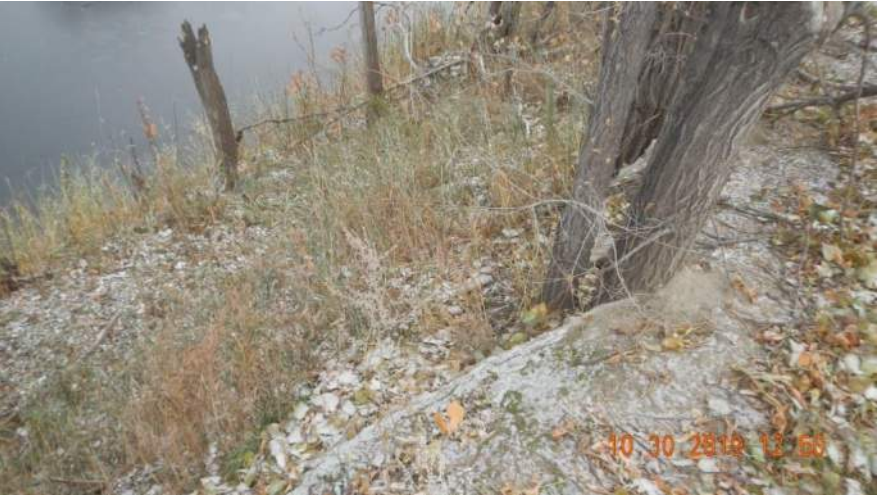
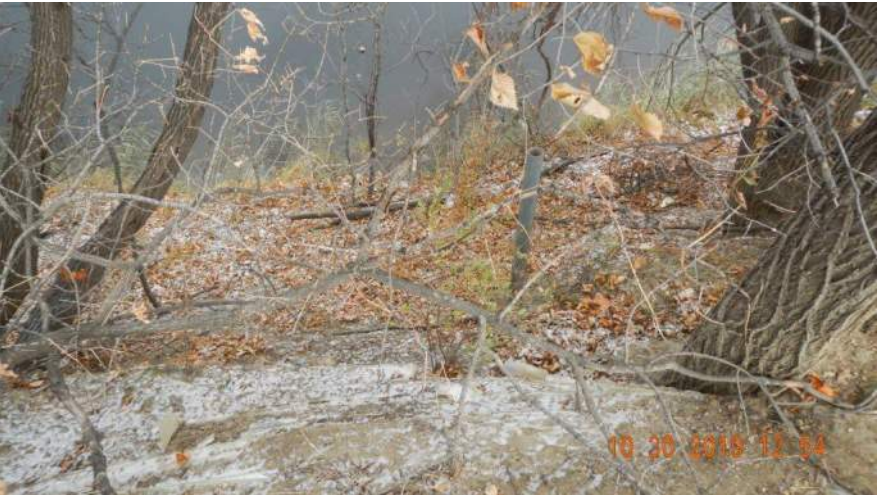
<p>10 30 2019 12 50</p>	<p>Inspect ID: MINR_2019_a_0152 Title: USACE_CEMVP_MINR_2019_a_0152_1.jpg Rated Item: 6. Erosion/ Bank Caving Caption: Rating: Unacceptable; Remarks: Erosion and steep channel bank along the riverside levee slope; Action: Evaluate steep bank and flatten slope. Backfill erosion to design grade, compact in lifts, and evaluate the need for erosion protection; Station_1: 633+96; Station_2: 643+69</p>

<p>10 30 2019 12 54</p>	<p>Inspect ID: MINR_2019_a_0152 Title: USACE_CEMVP_MINR_2019_a_0152_2.jpg Rated Item: 6. Erosion/ Bank Caving Caption: Rating: Unacceptable; Remarks: Erosion and steep channel bank along the riverside levee slope; Action: Evaluate steep bank and flatten slope. Backfill erosion to design grade, compact in lifts, and evaluate the need for erosion protection; Station_1: 633+96; Station_2: 643+69</p>

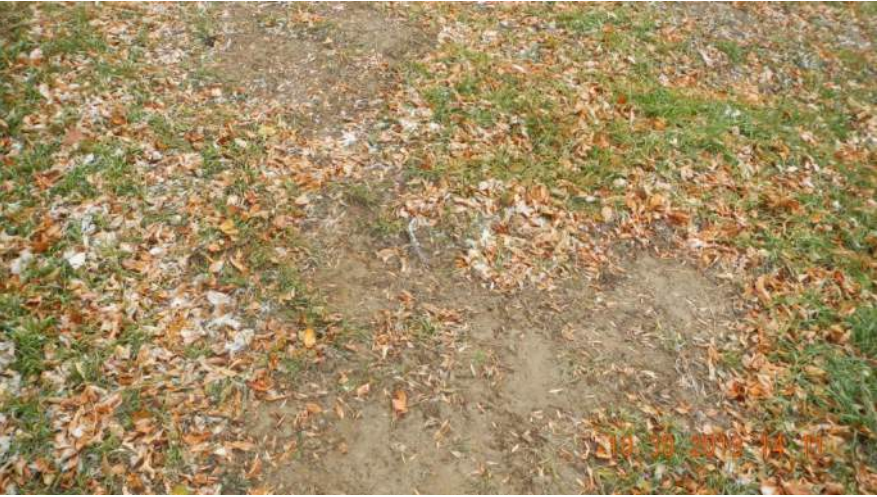
<p>Inspect ID: MINR_2019_a_0139 Title: USACE_CEMVP_MINR_2019_a_0139_1.jpg Rated Item: 8. Depressions/ Rutting Caption: Rating: Minimally Acceptable; Remarks: Depression and rutting on levee crown, ; Action: Backfill ruts/depression to the design grade, compact in lifts, and re-sod; Reevaluate levee crown surface; A resilient surface treatment is recommended for levee activities; Station_1: 560+00</p>

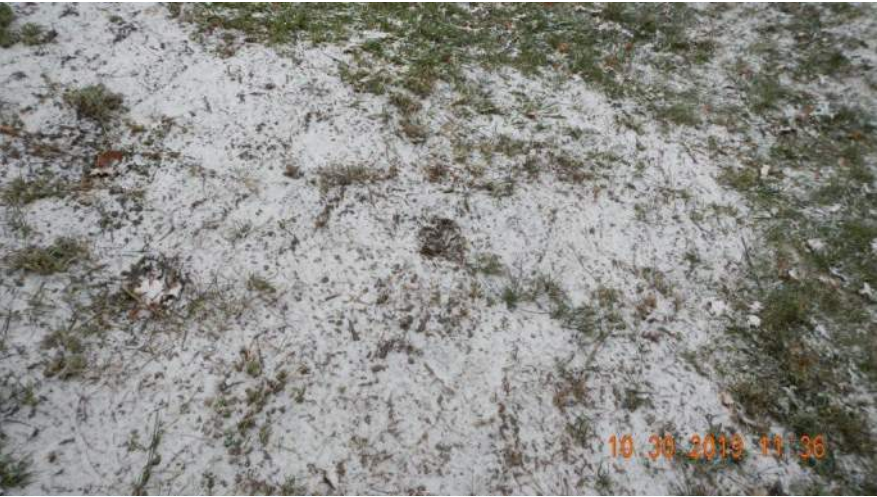
<p>Inspect ID: MINR_2019_a_0069 Title: USACE_CEMVP_MINR_2019_a_0069_1.jpg Rated Item: 10. Animal Control Caption: Rating: Minimally Acceptable; Remarks: Large animal burrow; Action: Excavate, inspect, backfill, compact in lifts, and reseed with grass; Improve animal burrow control program; Station_1: 714+07</p>

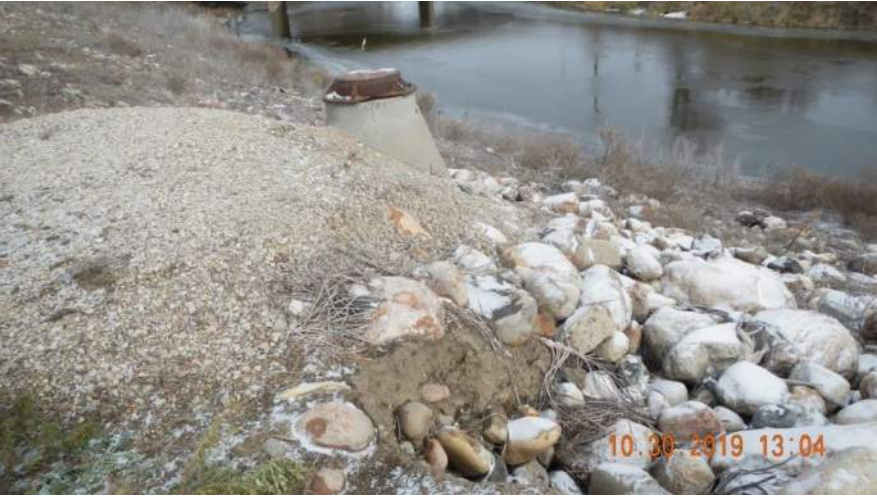
<p>Inspect ID: MINR_2019_a_0108 Title: USACE_CEMVP_MINR_2019_a_0108_1.jpg Rated Item: 12. Riprap Revetments & Bank Protection Caption: Rating: Unacceptable; Remarks: The existing riprap is scoured out, deteriorated, missing, and covered by organics and soil.; Action: Replace riprap with hard, durable rock of suitable size; Replace filter-blanket layer; Replace/Repair geotextile fabric under the stone riprap; Contact Corps for technical assistance when installing geotextile fabric; Remove all vegetation from riprap; Station_1: 624+00</p>

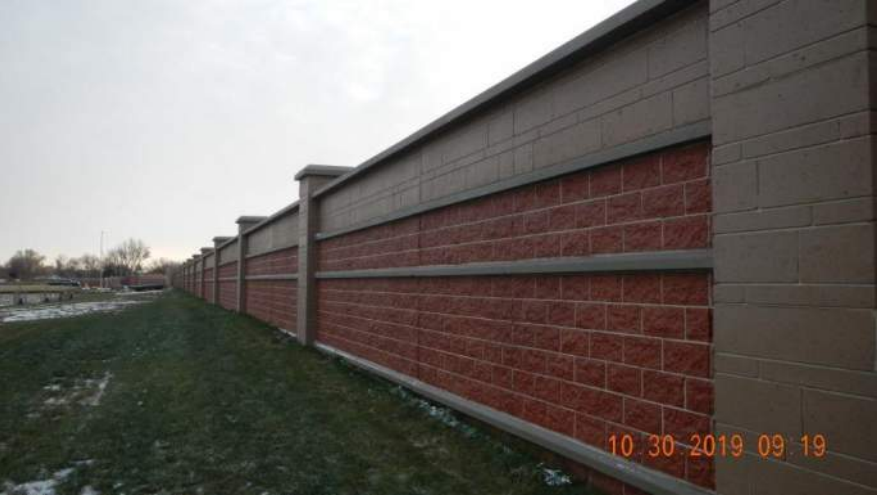
<p>Inspect ID: MINR_2019_a_0007 Title: USACE_CEMVP_MINR_2019_a_0007_1.jpg Rated Item: 3. Closure Structures (Stop Log Closures and Gates) (A or U only) Caption: Rating: Unacceptable; Remarks: As-built drawings have not been submitted to the Corps for the 408 Minot Water Treatment Plant Floodwall Project; Action: Submit updated as-built drawings; Station_1: 855+00</p>

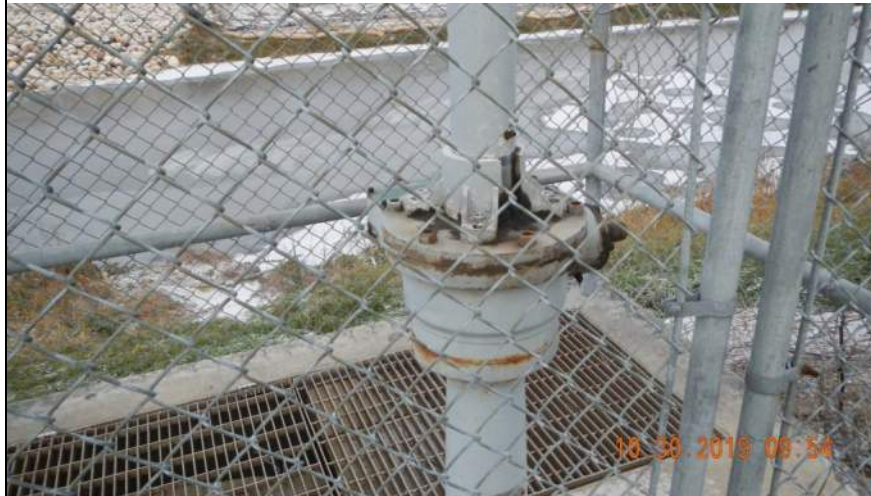
Inspect ID: MINR_2019_a_0023 **Title:** USACE_CEMVP_MINR_2019_a_0023_1.jpg
Rated Item: 13. Other Metallic Items **Caption:** Rating: Minimally Acceptable;
Remarks: Gate well lifter and indicator appear to be in good condition; however, gate lifting is performed by visually monitoring gate through the open well during lift. Sponsor indicated this portion of levee will be abandoned with new design; **Action:** Determine method of operation that does not require the gate operator to work over an open well (OSHA compliance); Station_1: 847+50

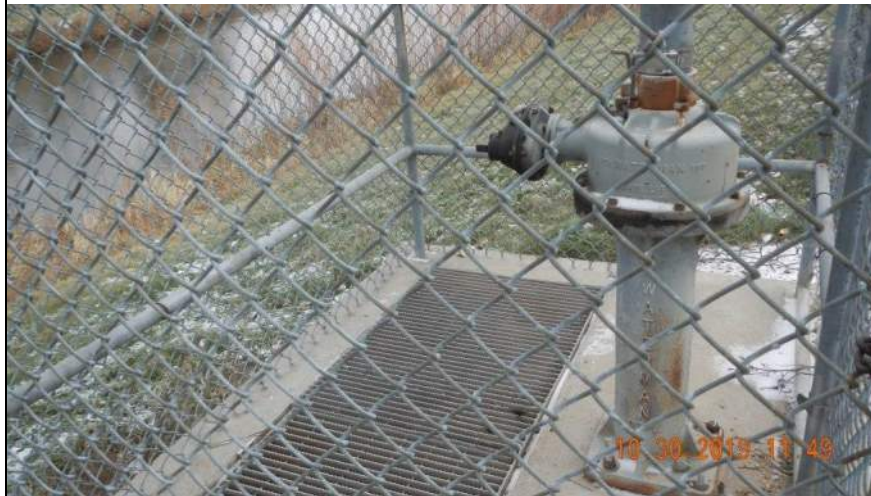
Inspect ID: MINR_2019_a_0074 **Title:** USACE_CEMVP_MINR_2019_a_0074_1.jpg
Rated Item: 13. Other Metallic Items **Caption:** Rating: Minimally Acceptable;
Remarks: Gate well crank appears to be in good condition; however, gate well height indicator has been replaced by opaque metal pole, requiring operator to look into well; **Action:** Determine method of operation that does not require the operator to work over an open well (OSHA compliance); Station_1: 697+93

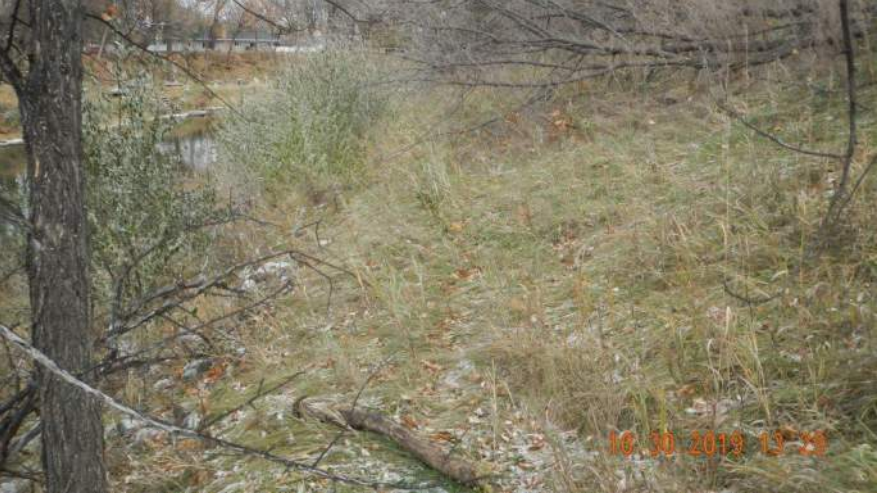
<p>Inspect ID: MINR_2019_a_0117 Title: USACE_CEMVP_MINR_2019_a_0117_1.jpg Rated Item: 4. Erosion Caption: Rating: Unacceptable; Remarks: Significant erosion of channel bank. NOTE: Vegetation makes erosion difficult to see in photographs; Action: Backfill erosion to the design grade, compact in lifts, and reseed with grass or provide rock bank protection. Reevaluate drainage and erosion protection; Station_1: 620+00</p>

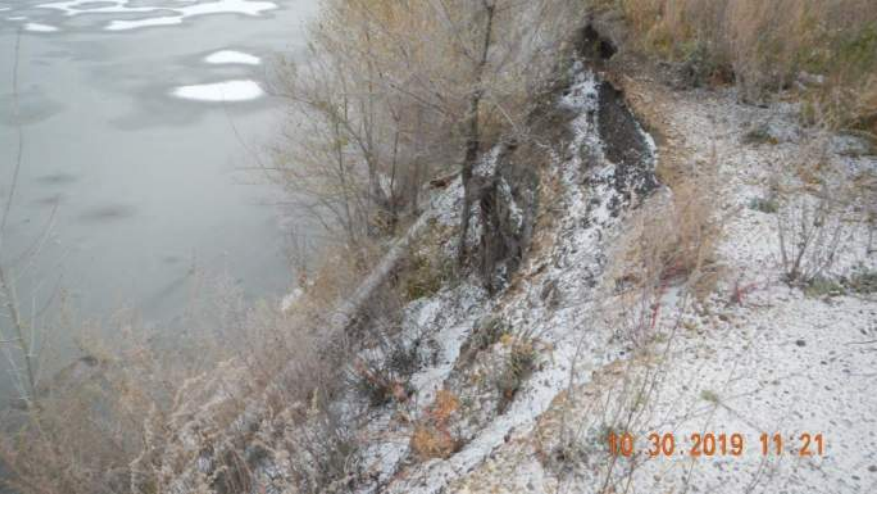
<p>Inspect ID: MINR_2019_a_0148 Title: USACE_CEMVP_MINR_2019_a_0148_1.jpg Rated Item: 4. Erosion Caption: Rating: Unacceptable; Remarks: The channel has erosion greater than a 1 foot horizontal deviation from design grade or cross section. Exposed pipe and the walking path is breaking off into the river; Action: Conduct engineering evaluation to determine best method of repair. Complete remedial action to ensure slope stability and protection; Station_1: 742+50; Station_2: 746+50</p>
