Flood Damage Reduction Segment / System Inspection Report

Name of Segment / System: Souris River-Burlington to Minot - Brooks

Public Sponsor(s): Souris River Joint Water Resources Board

Corps of Engineers Inspector: Luke Schmidt and Joe Hemmer Inspection Start Date: 10/29/2019

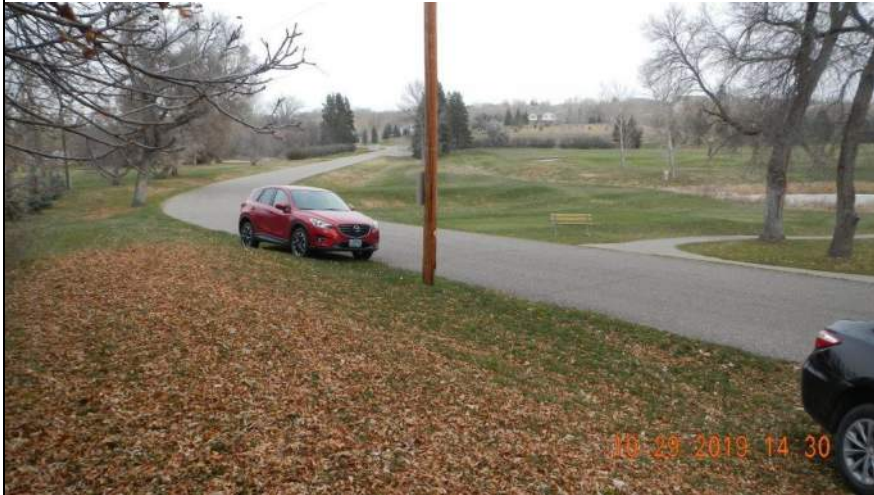
Inspect ID: BMBA_2019_a_0001 **Title:** USACE_CEMVP_BMBA_2019_a_0001_1.jpg **Rated Item:** 3. Encroachments
Caption: Rating: Unacceptable; Remarks: Power Pole on levee easment; Action: Verify levee easement. Relocate encroachments outside of levee easement; Station_1: 01+60

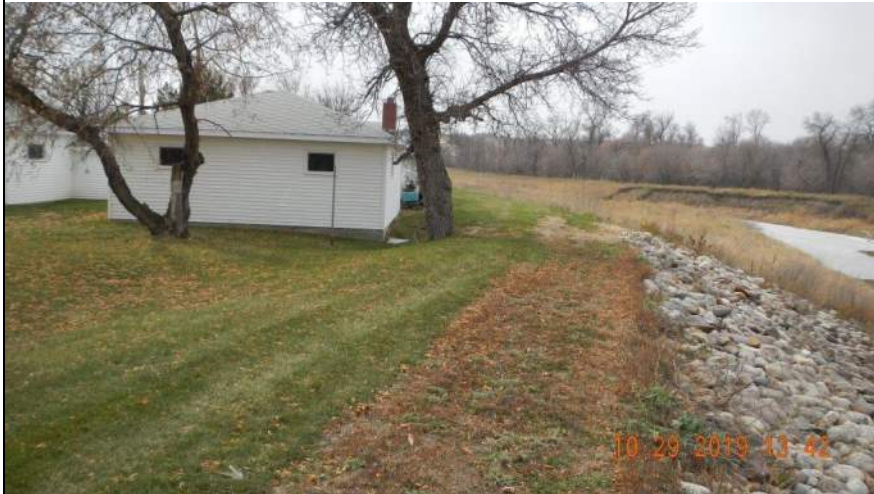
Inspect ID: BMBA_2019_a_0002 **Title:** USACE_CEMVP_BMBA_2019_a_0002_1.jpg **Rated Item:** 3. Encroachments
Caption: Rating: Unacceptable; Remarks: Tree, home, and storage shed at landward toe of levee; Action: Verify levee easement. Relocate encroachments outside of levee easement, unless approved by Corps; Station_1: 45+00

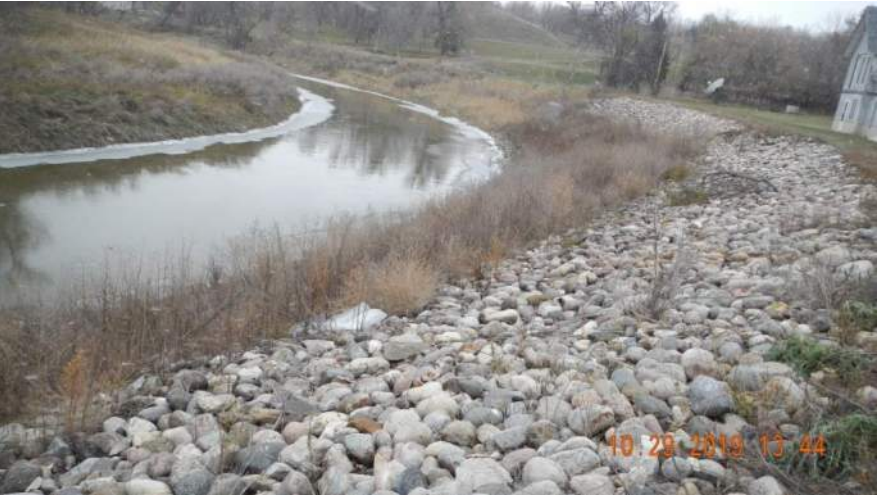
<p>Inspect ID: BMBA_2019_a_0044 Title: USACE_CEMVP_BMBA_2019_a_0044_1.jpg Rated Item: 12. Riprap Revetments & Bank Protection Caption: Rating: Minimally Acceptable; Remarks: Weeds and other woody vegetation within all riprapped areas; the local sponsor has attempted spraying, but spraying has been patchy and ineffective; Action: Remove all woody vegetation from riprap and spray grasses. Ensure environmental compliance with all appropriate agencies prior to removal; Station_1: 43+00; Station_2: 46+50</p>

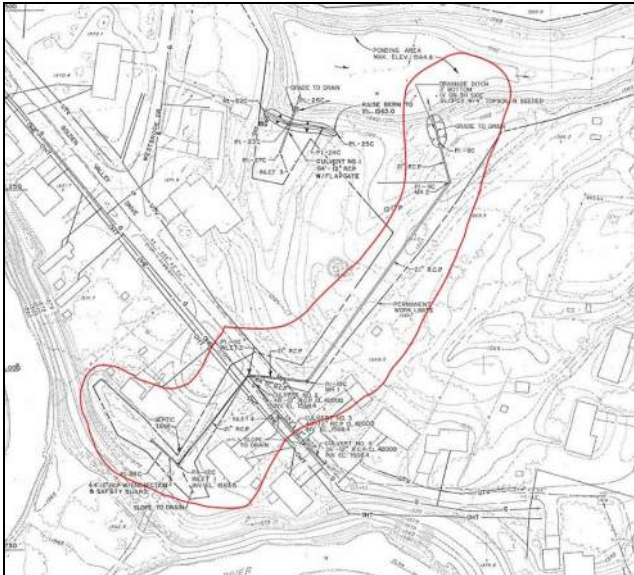
Inspect ID: BMBA_2019_a_0050 **Title:** USACE_CEMVP_BMBA_2019_a_0050_1.jpg **Rated Item:** 9. Culverts/ Discharge Pipes **Caption:** Rating: Minimally Acceptable; Remarks: Although Houston Engineering has performed some inspections of interior drainage culverts in 2017, these interior drainage culverts do not appear on Houston Engineering's printout; Action: Perform video or visual inspections of the project culverts every five years and provide USACE with documentation indicating inspection results. Ensure all culverts within project are inspected; Station_1: NA; Station_2: NA

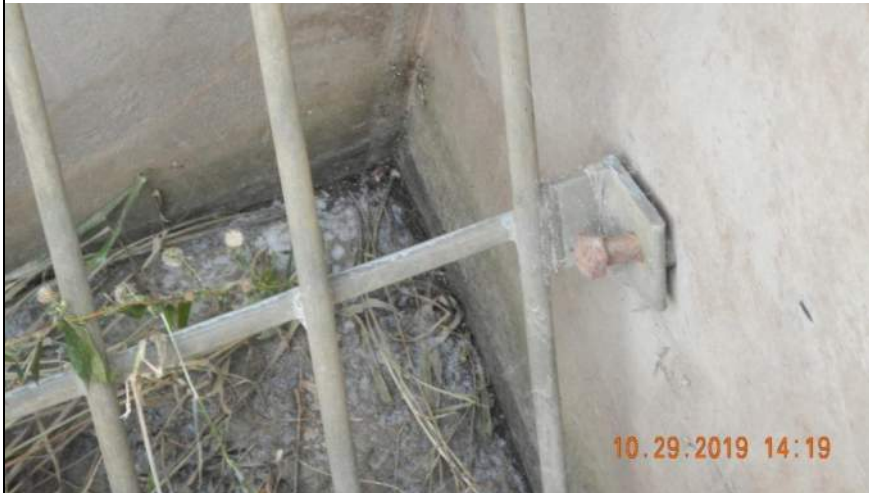
13. Other Metallic Items	M	A	All metal parts are protected from corrosion damage and show no rust, damage, or deterioration that would cause a safety concern.	BMBA_2019_a_0029: Station_1 7+50: There is a loose bolt that connects the trash guard to the drop structure at the outlet of the culvert from the pump station. Bolt not pictured: Tighten loose bolt to secure trash guard (M)
		M	Corrosion seen on metallic parts appears to be maintainable.	
		U	Metallic parts are severely corroded and require replacement to prevent failure, equipment damage, or safety issues.	
		N/A	There are no other significant metallic items.

Inspect ID: BMBA_2019_a_0029 **Title:** USACE_CEMVP_BMBA_2019_a_0029_1.jpg **Rated Item:** 13. Other Metallic Items **Caption:** Rating: Minimally Acceptable; Remarks: There is a loose bolt that connects the trash guard to the drop structure at the outlet of the culvert from the pump station. Bolt not pictured; Action: Tighten loose bolt to secure trash guard; Station_1: 7+50
