## Flood Damage Reduction Segment / System Inspection Report

Name of Segment / System: Souris River - Minot - Left Bank

Inspection Start Date: 10/30/2019

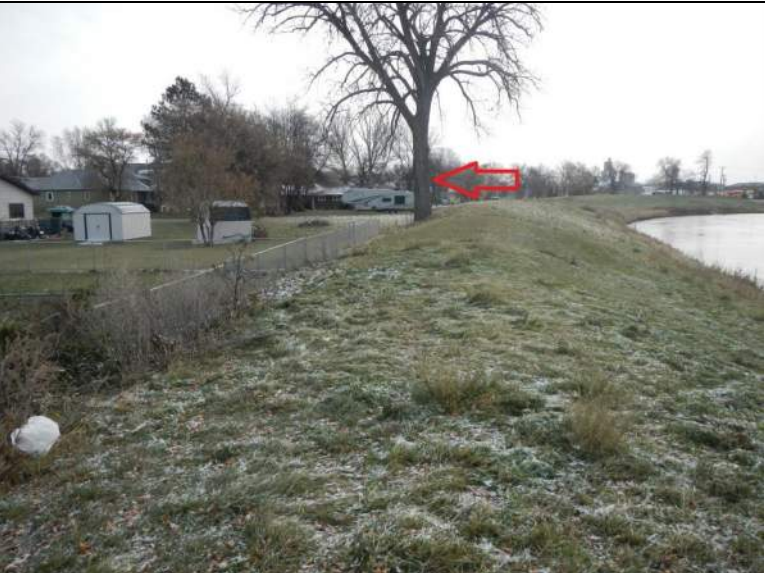
<p><b>Inspect ID:</b> MINL_2019_a_0034 <b>Title:</b> USACE_CEMVP_MINL_2019_a_0034_1.jpg <b>Rated Item:</b> 1. Unwanted Vegetation Growth <b>Caption:</b> Rating: Unacceptable; Remarks: Large tree on the levee landside slope ; Action: Remove large tree from vegetation-free zone, up to the levee easement. Remove root ball, backfill, compact in lifts, and reseed with grass. Ensure environmental compliance with all appropriate agencies prior to removal; Station_1: 765+00; ; ; ; ;</p>

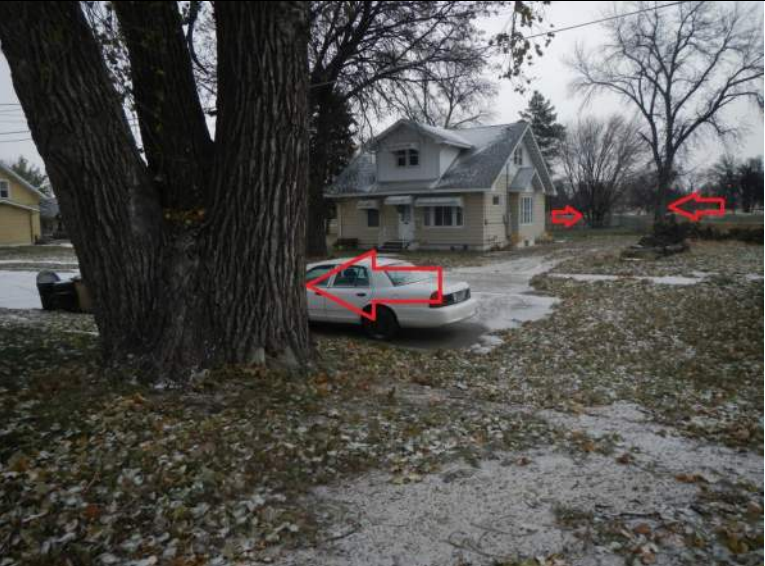
<p><b>Inspect ID:</b> MINL_2019_a_0051 <b>Title:</b> USACE_CEMVP_MINL_2019_a_0051_1.jpg <b>Rated Item:</b> 1. Unwanted Vegetation Growth <b>Caption:</b> Rating: Unacceptable; Remarks: Large tree within the vegetation-free zone; Action: Remove large tree from vegetation-free zone, up to the levee easement. Remove root ball, backfill, compact in lifts, and reseed with grass. Ensure environmental compliance with all appropriate agencies prior to removal; Station_1: 697+50</p>

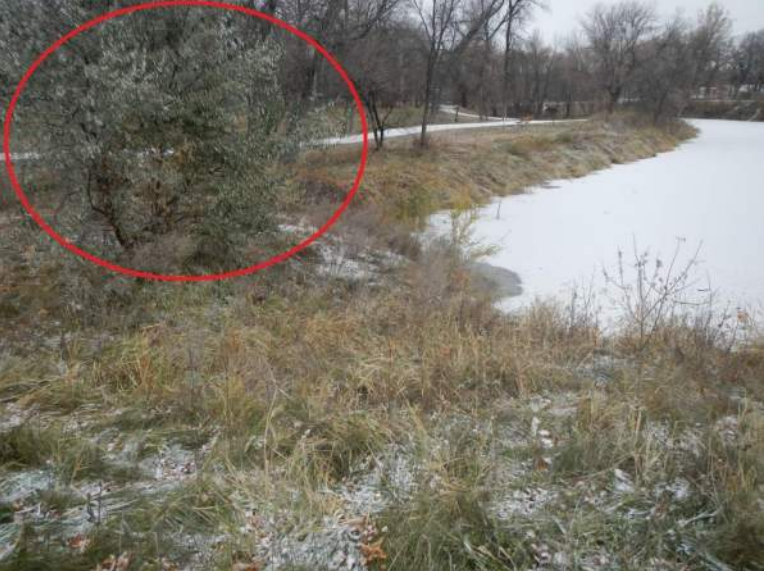
<p><b>Inspect ID:</b> MINL_2019_a_0066 <b>Title:</b> USACE_CEMVP_MINL_2019_a_0066_1.jpg <b>Rated Item:</b> 1. Unwanted Vegetation Growth <b>Caption:</b> Rating: Unacceptable; Remarks: Trees within the vegetation free zone; Action: Remove unwanted vegetation from vegetation free zone, up to levee easement. Remove root ball, backfill, compact in lifts, and reseed grass. Ensure environmental compliance with appropriate agencies prior to removal; Station_1: 662+14L</p>

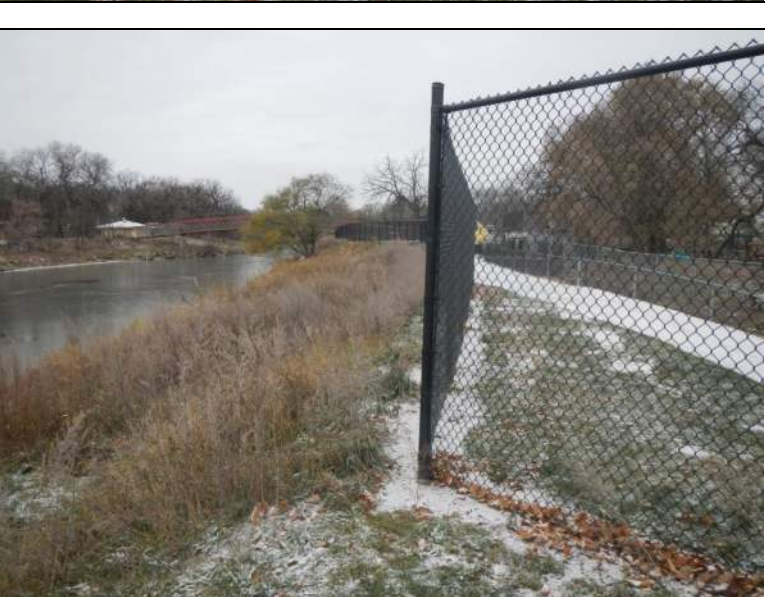
<p><b>Inspect ID:</b> MINL_2019_a_0067 <b>Title:</b> USACE_CEMVP_MINL_2019_a_0067_1.jpg <b>Rated Item:</b> 1. Unwanted Vegetation Growth <b>Caption:</b> Rating: Unacceptable; Remarks: Zoo fence and overgrown vegetation on levee riverside slope; Action: Remove unwanted vegetation from vegetation-free zone, up to the levee easement; Ensure environmental compliance with all appropriate agencies prior to removal; Relocate encroachments/debris outside of levee easement, unless approved by Corps; ; Station_1: 07+27; ; ;</p>

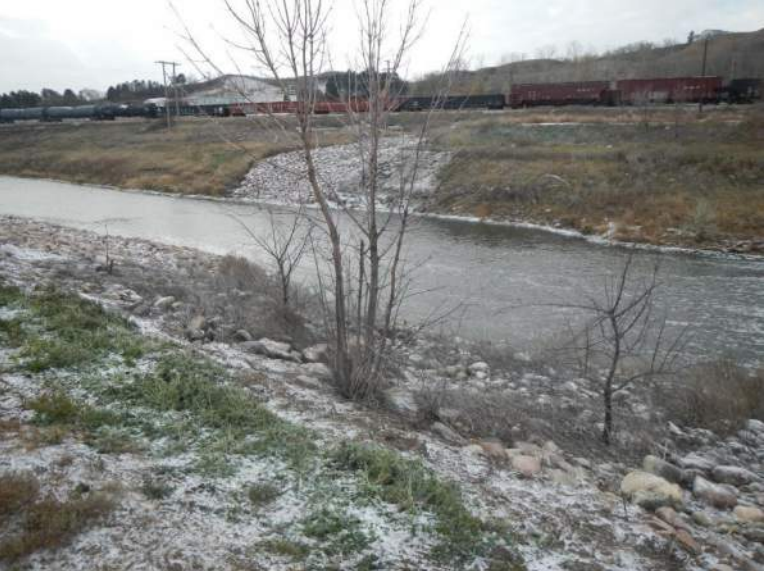
<p><b>Inspect ID:</b> MINL_2019_a_0086 <b>Title:</b> USACE_CEMVP_MINL_2019_a_0086_1.jpg <b>Rated Item:</b> 1. Unwanted Vegetation Growth <b>Caption:</b> Rating: Unacceptable; Remarks: Large trees growing within the riverside levee slope; Action: Remove large trees from vegetation-free zone, up to the levee easement. Remove root ball and backfill with riprap. Ensure environmental compliance with all appropriate agencies prior to removal; Station_1: 609+54</p>

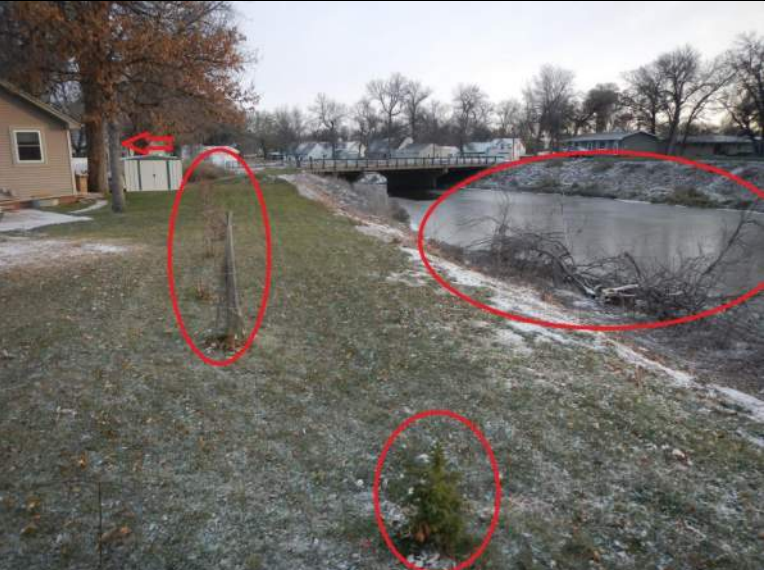
Rated Item	Rating	Rating Guidelines	Location/Remarks/Recommendations
			<p>MINL_2019_a_0096: Station_1 813+77L: Station_2 828+60L: Large trees (greater than 2in) and overgrown vegetation within the levee prism and slopes and toes: Remove large trees and unwanted vegetation from the Vegetaion-free zone, up to the levee easement. Remove root ball, backfill, compact in lifts, and reseed with grass. Ensure environmental compliance with all appropriate agencies prior to removal (U)</p> <p>MINL_2019_a_0099: Station_1 804+31L: Station_2 812+24L: Trees located along the toe of the levee within the vegetation-free zone (VFZ): Remove trees from vegetation-free zone, up to the levee easement. Remove root ball, backfill, compact in lifts, and reseed with grass. Ensure environmental compliance with all appropriate agencies prior to removal (U)</p> <p>MINL_2019_a_0101: Station_1 791+07L: Station_2 794+21L: Large trees located on the riverside slope of the levee embankment: Remove large tree from vegetation-free zone, up to the levee easement. Remove root ball, backfill, compact in lifts, and reseed with grass. Ensure environmental compliance with all appropriate agencies prior to removal (U)</p> <p>MINL_2019_a_0112: Station_1 710+53L: Station_2 707+80L: Large trees and overgrown vegetation along the landside toe of the levee embankment: Remove unwanted vegetation from vegetation free zone up to the easement. Remove root ball, backfill, compact in lifts and reseed (U)</p> <p>MINL_2019_a_0114: Station_1 NPS: Station_2 NPS: Large trees along the levee emabankment and vegetation-free zone: Remove large trees from vegetation-free zone, up to the levee easement. Remove root ball, backfill, compact in lifts, and reseed with grass. Ensure environmental compliance with all appropriate agencies prior to removal (U)</p> <p>MINL_2019_a_0116: Station_1 681+87L: Station_2 686+53L: Trees and overgrown vegetation along the channel bank and levee riverside slope: Remove unwanted vegetation from vegetation-free zone, up to the levee easement. Remove root ball, backfill, compact in lifts, and reseed with grass. Ensure environmental compliance with all appropriate agencies prior to removal (U)</p> <p>MINL_2019_a_0118: Station_1 670+97L: Station_2 676+63L: Trees and overgrown vegetation growth located along the riverside levee slope. The backside of the levee has</p>

<p><b>Inspect ID:</b> MINL_2019_a_0096 <b>Title:</b> USACE_CEMVP_MINL_2019_a_0096_1.jpg <b>Rated Item:</b> 1. Unwanted Vegetation Growth <b>Caption:</b> Rating: Unacceptable; Remarks: Large trees (greater than 2in) and overgrown vegetation within the levee prism and slopes and toes; Action: Remove large trees and unwanted vegetation from the Vegetaion-free zone, up to the levee easement. Remove root ball, backfill, compact in lifts, and reseed with grass. Ensure environmental compliance with all appropriate agencies prior to removal; Station_1: 813+77L; Station_2: 828+60L</p>

Rated Item	Rating	Rating Guidelines		Location/Remarks/Recommendations
				<p>been widen by the sponsor: Remove unwanted vegetation from vegetation free zone, up to the levee easement; Remove root ball, backfill, compact in lifts, and reseed with grass; Ensure environmental compliance with all appropriate agencies prior to removal (U)</p> <p>MINL_2019_a_0119: Station_1 673+61L: Station_2 677+12L: Trees and overgrown vegetation growth located along the landside levee slope. The backside of the levee has been widen by the sponsor: Remove unwanted vegetation from vegetation-free zone, up to the levee easement; Remove root ball, backfill, compact in lifts, and reseed with grass; Ensure environmental compliance with all appropriate agencies prior to removal (U)</p> <p>MINL_2019_a_0120: Station_1 667+73L: Station_2 669+74L: Trees and overgrown vegetation on the riverside slope of the levee embankment: Remove unwanted vegetation from vegetation-free zone, up to the levee easement; Remove root ball, backfill, compact in lifts, and reseed with grass; Ensure environmental compliance with all appropriate agencies prior to removal (M)</p> <p>MINL_2019_a_0122: Station_1 02+96L: Station_2 09+81L: Overgrown vegetation along the zoo fence: Remove unwanted vegetation from vegetation-free zone, up to the levee easement. Remove root ball, backfill, compact in lifts, and reseed with grass (U)</p> <p>MINL_2019_a_0125: Station_1 637+43L: Station_2 642+67L: Large trees located along the toe of the levee within the vegetation free zone: Remove unwanted vegetation from vegetation free zone, up to levee easement. Remove root ball, backfill, compact in lifts, and reseed grass. Ensure environmental compliance with appropriate agencies prior to removal (U)</p> <p>MINL_2019_a_0130: Station_1 570+86L: Station_2 593+26L: Trees (&gt; 2 inches in diameter) located on levee and within the Vegetation Free Zone: Remove unwanted vegetation from vegetation-free zone, up to the levee easement; Remove root ball, backfill, compact in lifts, and reseed with grass; Ensure environmental compliance with all appropriate agencies prior to removal (U)</p>

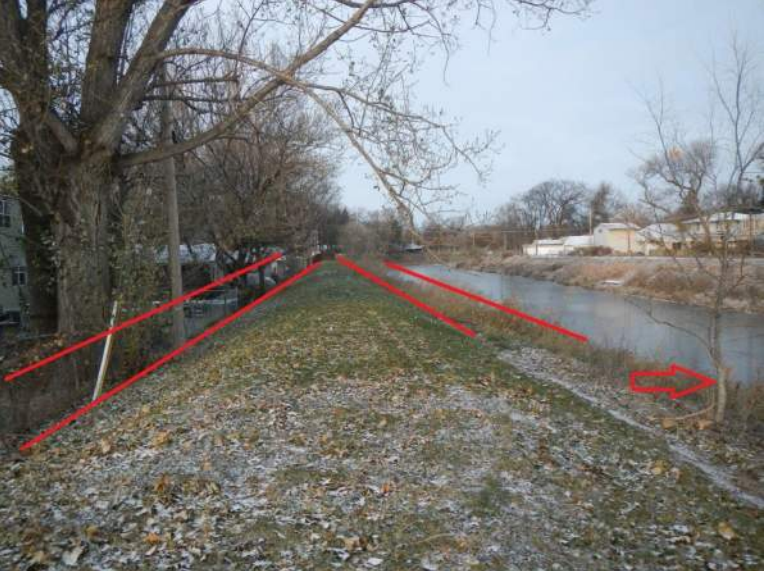
<p><b>Inspect ID:</b> MINL_2019_a_0096 <b>Title:</b> USACE_CEMVP_MINL_2019_a_0096_2.jpg <b>Rated Item:</b> 1. Unwanted Vegetation Growth <b>Caption:</b> Rating: Unacceptable; Remarks: Large trees (greater than 2in) and overgrown vegetation within the levee prism and slopes and toes; Action: Remove large trees and unwanted vegetation from the Vegetaion-free zone, up to the levee easement. Remove root ball, backfill, compact in lifts, and reseed with grass. Ensure environmental compliance with all appropriate agencies prior to removal; Station_1: 813+77L; Station_2: 828+60L</p>

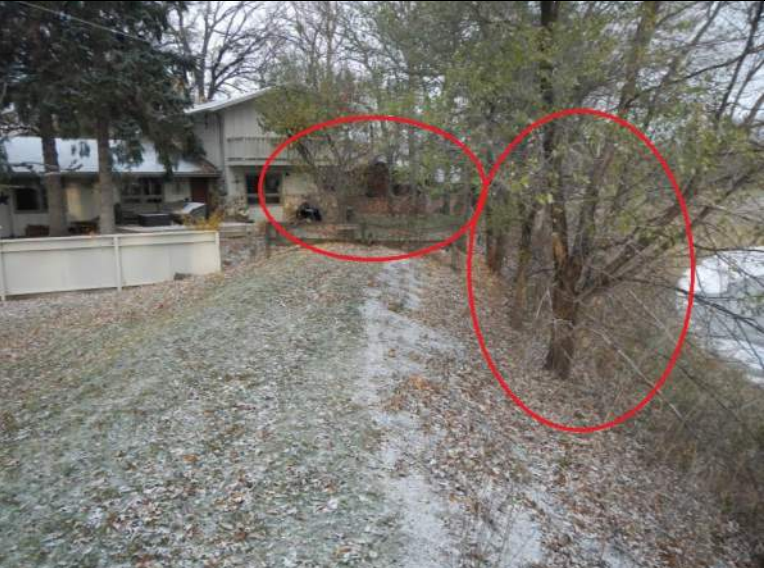
<p><b>Inspect ID:</b> MINL_2019_a_0096 <b>Title:</b> USACE_CEMVP_MINL_2019_a_0096_3.jpg <b>Rated Item:</b> 1. Unwanted Vegetation Growth <b>Caption:</b> Rating: Unacceptable; Remarks: Large trees (greater than 2in) and overgrown vegetation within the levee prism and slopes and toes; Action: Remove large trees and unwanted vegetation from the Vegetaion-free zone, up to the levee easement. Remove root ball, backfill, compact in lifts, and reseed with grass. Ensure environmental compliance with all appropriate agencies prior to removal; Station_1: 813+77L; Station_2: 828+60L</p>

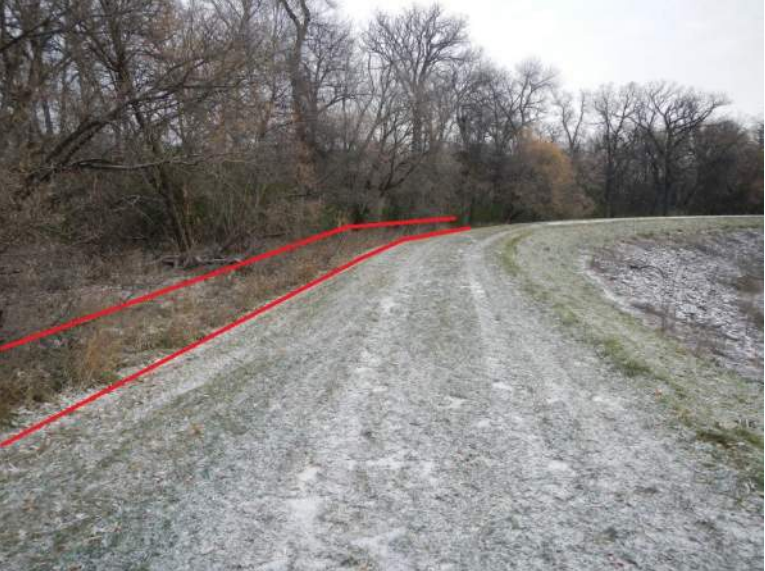
<p><b>Inspect ID:</b> MINL_2019_a_0099 <b>Title:</b> USACE_CEMVP_MINL_2019_a_0099_1.jpg <b>Rated Item:</b> 1. Unwanted Vegetation Growth <b>Caption:</b> Rating: Unacceptable; Remarks: Trees located along the toe of the levee within the vegetation-free zone (VFZ); Action: Remove trees from vegetation-free zone, up to the levee easement. Remove root ball, backfill, compact in lifts, and reseed with grass. Ensure environmental compliance with all appropriate agencies prior to removal; Station_1: 804+31L; Station_2: 812+24L</p>

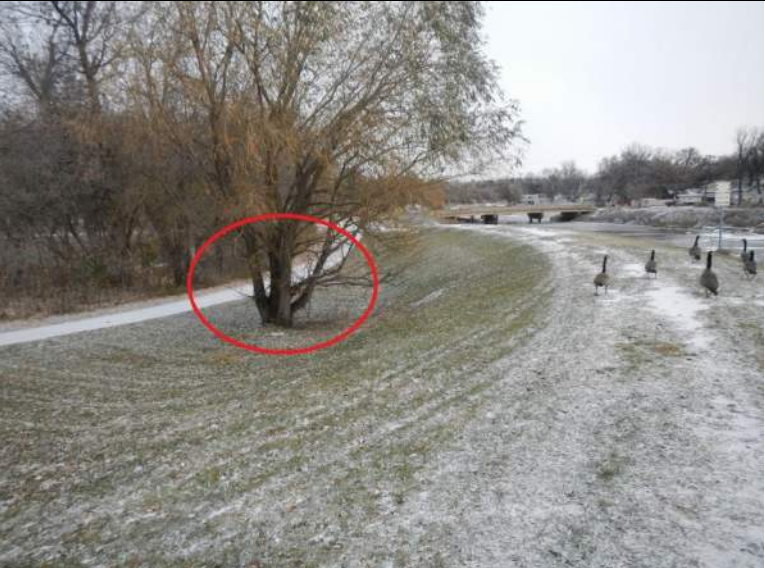
<p><b>Inspect ID:</b> MINL_2019_a_0099 <b>Title:</b> USACE_CEMVP_MINL_2019_a_0099_2.jpg <b>Rated Item:</b> 1. Unwanted Vegetation Growth <b>Caption:</b> Rating: Unacceptable; Remarks: Trees located along the toe of the levee within the vegetation-free zone (VFZ); Action: Remove trees from vegetation-free zone, up to the levee easement. Remove root ball, backfill, compact in lifts, and reseed with grass. Ensure environmental compliance with all appropriate agencies prior to removal; Station_1: 804+31L; Station_2: 812+24L</p>

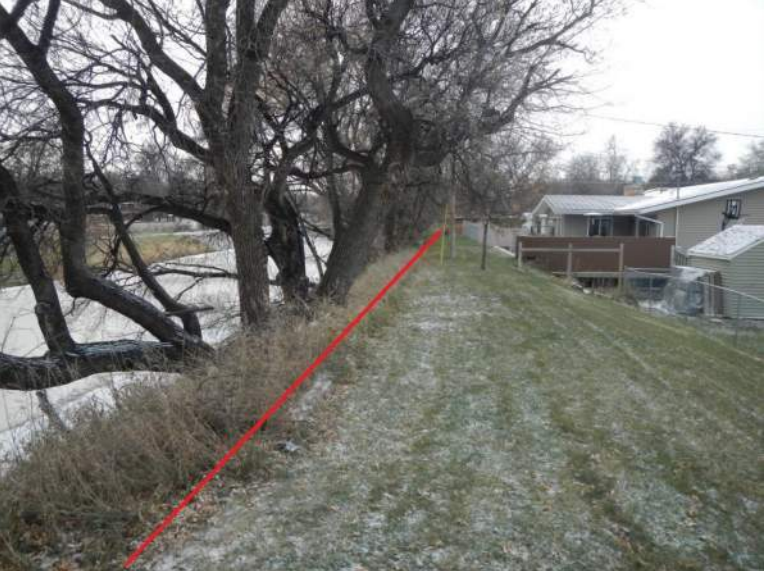
<p><b>Inspect ID:</b> MINL_2019_a_0101 <b>Title:</b> USACE_CEMVP_MINL_2019_a_0101_1.jpg <b>Rated Item:</b> 1. Unwanted Vegetation Growth <b>Caption:</b> Rating: Unacceptable; Remarks: Large trees located on the riverside slope of the levee embankment; Action: Remove large tree from vegetation-free zone, up to the levee easement. Remove root ball, backfill, compact in lifts, and reseed with grass. Ensure environmental compliance with all appropriate agencies prior to removal; Station_1: 791+07L; Station_2: 794+21L</p>

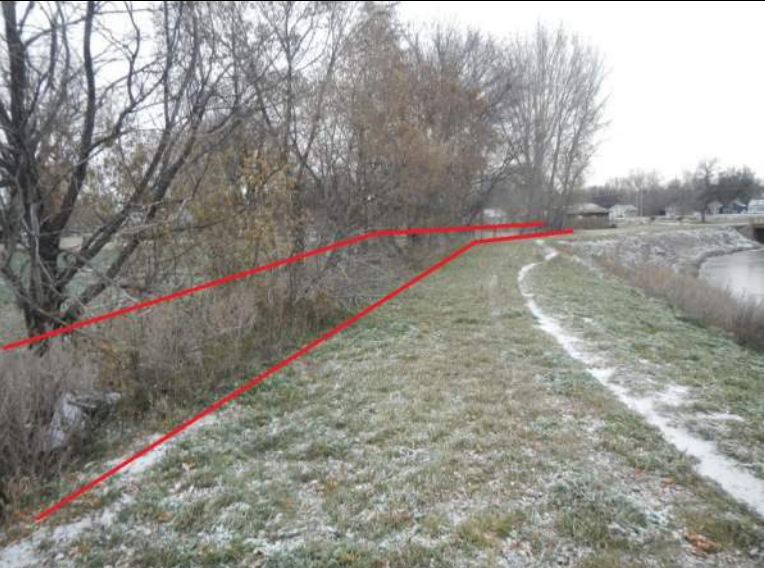
<p><b>Inspect ID:</b> MINL_2019_a_0112 <b>Title:</b> USACE_CEMVP_MINL_2019_a_0112_1.jpg <b>Rated Item:</b> 1. Unwanted Vegetation Growth <b>Caption:</b> Rating: Unacceptable; Remarks: Large trees and overgrown vegetation along the landside toe of the levee embankment; Action: Remove unwanted vegetation from vegetation free zone up to the easement. Remove root ball, backfill, compact in lifts and reseed; Station_1: 710+53L; Station_2: 707+80L</p>

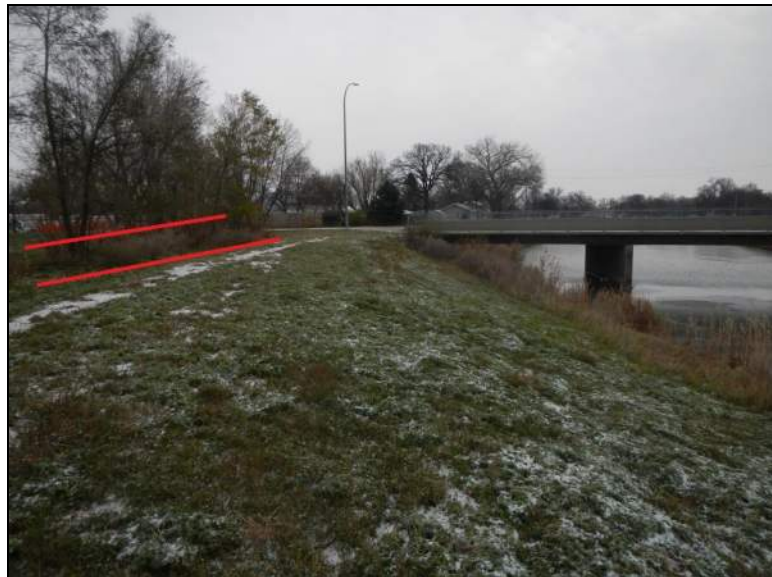
<p><b>Inspect ID:</b> MINL_2019_a_0114 <b>Title:</b> USACE_CEMVP_MINL_2019_a_0114_1.jpg <b>Rated Item:</b> 1. Unwanted Vegetation Growth <b>Caption:</b> Rating: Unacceptable; Remarks: Large trees along the levee embankment and vegetation-free zone; Action: Remove large trees from vegetation-free zone, up to the levee easement. Remove root ball, backfill, compact in lifts, and reseed with grass. Ensure environmental compliance with all appropriate agencies prior to removal; Station_1: NPS; Station_2: NPS</p>

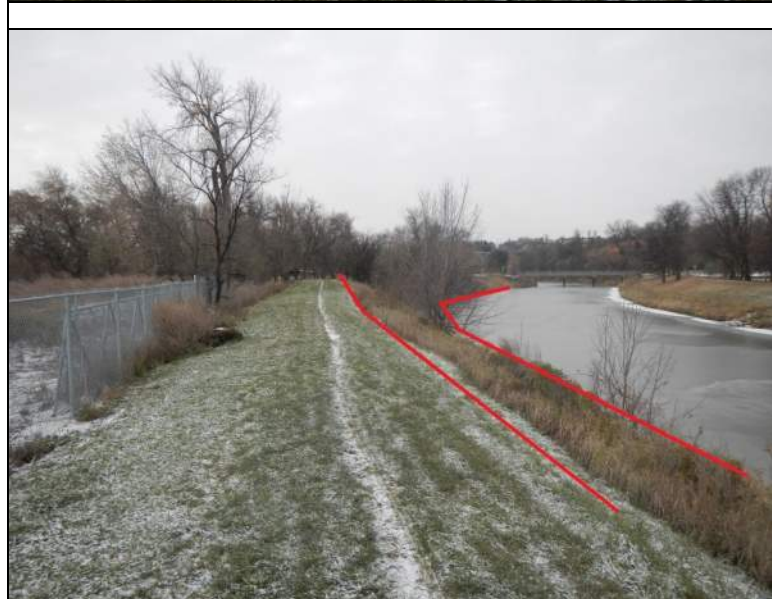
<p><b>Inspect ID:</b> MINL_2019_a_0118 <b>Title:</b> USACE_CEMVP_MINL_2019_a_0118_1.jpg <b>Rated Item:</b> 1. Unwanted Vegetation Growth <b>Caption:</b> Rating: Unacceptable; Remarks: Trees and overgrown vegetation growth located along the riverside levee slope. The backside of the levee has been widened by the sponsor; Action: Remove unwanted vegetation from vegetation free zone, up to the levee easement; Remove root ball, backfill, compact in lifts, and reseed with grass; Ensure environmental compliance with all appropriate agencies prior to removal; Station_1: 670+97L; Station_2: 676+63L; Remove root ball, backfill, compact in lifts, and reseed with grass; Ensure environmental compliance with all appropriate agencies prior to removal; ;</p>

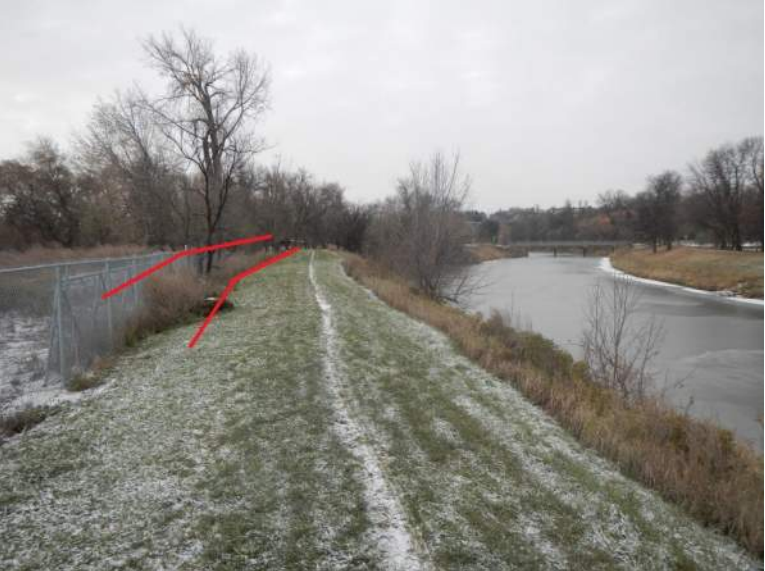
<p><b>Inspect ID:</b> MINL_2019_a_0119 <b>Title:</b> USACE_CEMVP_MINL_2019_a_0119_1.jpg <b>Rated Item:</b> 1. Unwanted Vegetation Growth <b>Caption:</b> Rating: Unacceptable; Remarks: Trees and overgrown vegetation growth located along the landside levee slope. The backside of the levee has been widened by the sponsor; Action: Remove unwanted vegetation from vegetation-free zone, up to the levee easement; Remove root ball, backfill, compact in lifts, and reseed with grass; Ensure environmental compliance with all appropriate agencies prior to removal; Station_1: 673+61L; Station_2: 677+12L</p>

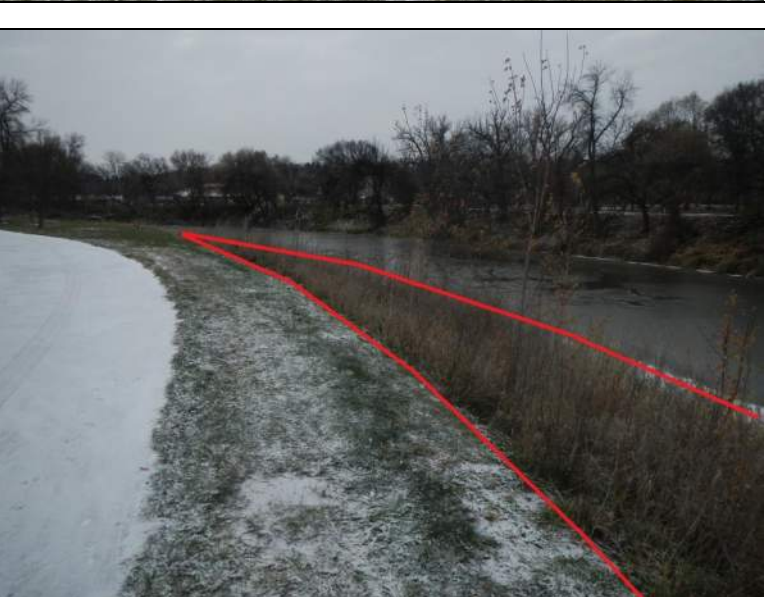
<p><b>Inspect ID:</b> MINL_2019_a_0120 <b>Title:</b> USACE_CEMVP_MINL_2019_a_0120_1.jpg <b>Rated Item:</b> 1. Unwanted Vegetation Growth <b>Caption:</b> Rating: Minimally Acceptable; Remarks: Trees and overgrown vegetation on the riverside slope of the levee embankment; Action: Remove unwanted vegetation from vegetation-free zone, up to the levee easement; Remove root ball, backfill, compact in lifts, and reseed with grass; Ensure environmental compliance with all appropriate agencies prior to removal; Station_1: 667+73L; Station_2: 669+74L</p>

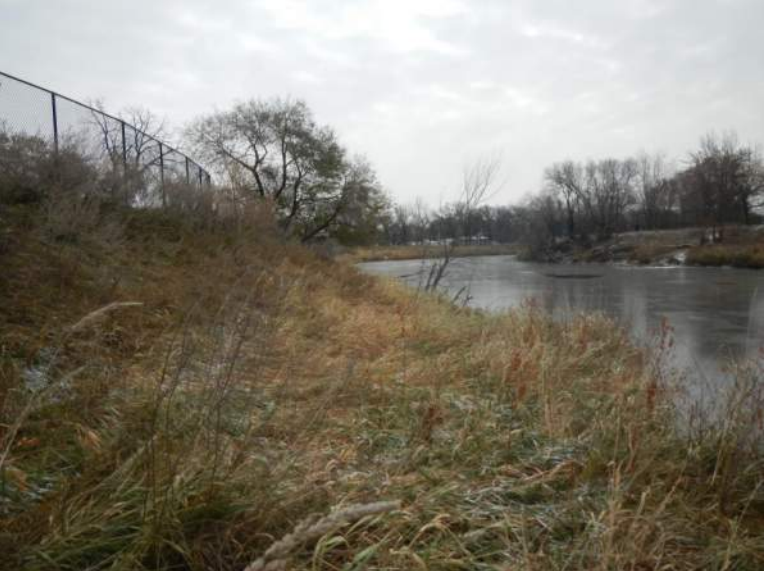
<p><b>Inspect ID:</b> MINL_2019_a_0122 <b>Title:</b> USACE_CEMVP_MINL_2019_a_0122_1.jpg <b>Rated Item:</b> 1. Unwanted Vegetation Growth <b>Caption:</b> Rating: Unacceptable; Remarks: Overgrown vegetation along the zoo fence; Action: Remove unwanted vegetation from vegetation-free zone, up to the levee easement. Remove root ball, backfill, compact in lifts, and reseed with grass; Station_1: 02+96L; Station_2: 09+81L</p>

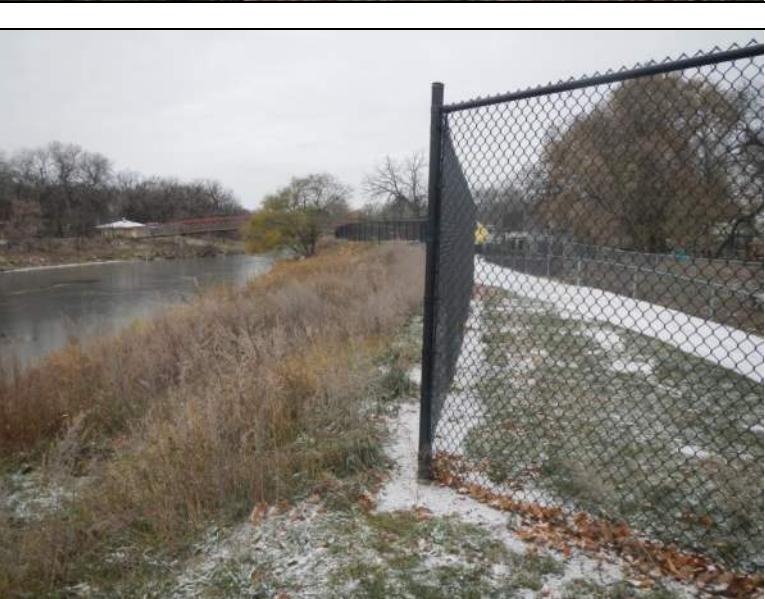
<p><b>Inspect ID:</b> MINL_2019_a_0122 <b>Title:</b> USACE_CEMVP_MINL_2019_a_0122_2.jpg <b>Rated Item:</b> 1. Unwanted Vegetation Growth <b>Caption:</b> Rating: Unacceptable; Remarks: Overgrown vegetation along the zoo fence; Action: Remove unwanted vegetation from vegetation-free zone, up to the levee easement. Remove root ball, backfill, compact in lifts, and reseed with grass; Station_1: 02+96L; Station_2: 09+81L</p>

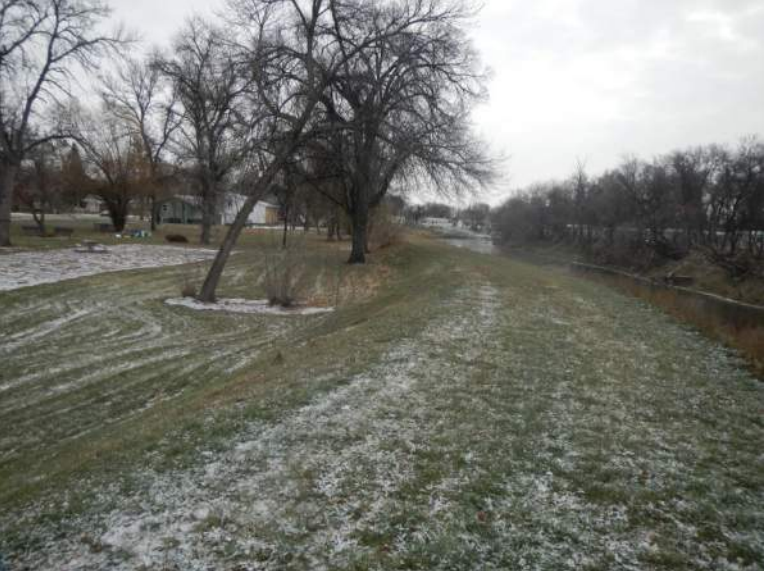
<p><b>Inspect ID:</b> MINL_2019_a_0125 <b>Title:</b> USACE_CEMVP_MINL_2019_a_0125_1.jpg <b>Rated Item:</b> 1. Unwanted Vegetation Growth <b>Caption:</b> Rating: Unacceptable; Remarks: Large trees located along the toe of the levee within the vegetation free zone; Action: Remove unwanted vegetation from vegetation free zone, up to levee easement. Remove root ball, backfill, compact in lifts, and reseed grass. Ensure environmental compliance with appropriate agencies prior to removal; Station_1: 637+43L; Station_2: 642+67L</p>

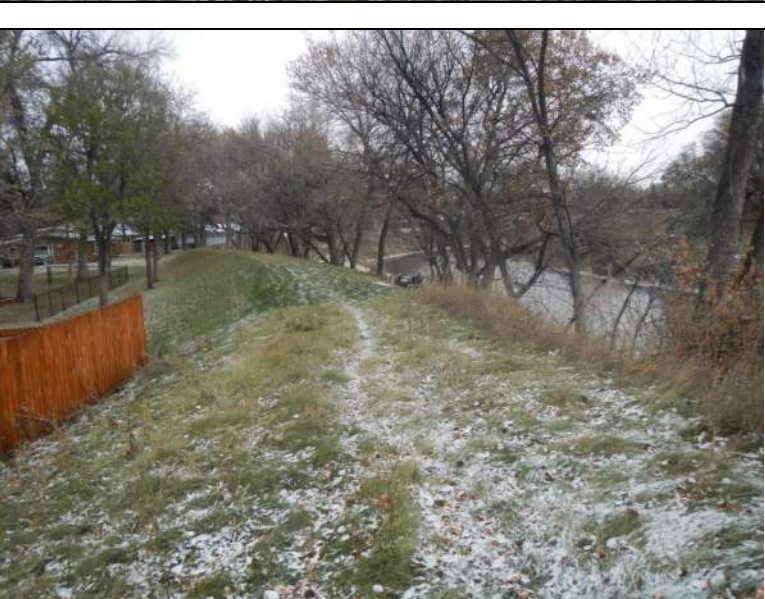
<p><b>Inspect ID:</b> MINL_2019_a_0130 <b>Title:</b> USACE_CEMVP_MINL_2019_a_0130_1.jpg <b>Rated Item:</b> 1. Unwanted Vegetation Growth <b>Caption:</b> Rating: Unacceptable; Remarks: Trees (&gt; 2 inches in diameter) located on levee and within the Vegetation Free Zone; Action: Remove unwanted vegetation from vegetation-free zone, up to the levee easement; Remove root ball, backfill, compact in lifts, and reseed with grass; Ensure environmental compliance with all appropriate agencies prior to removal; Station_1: 570+86L; Station_2: 593+26L</p>

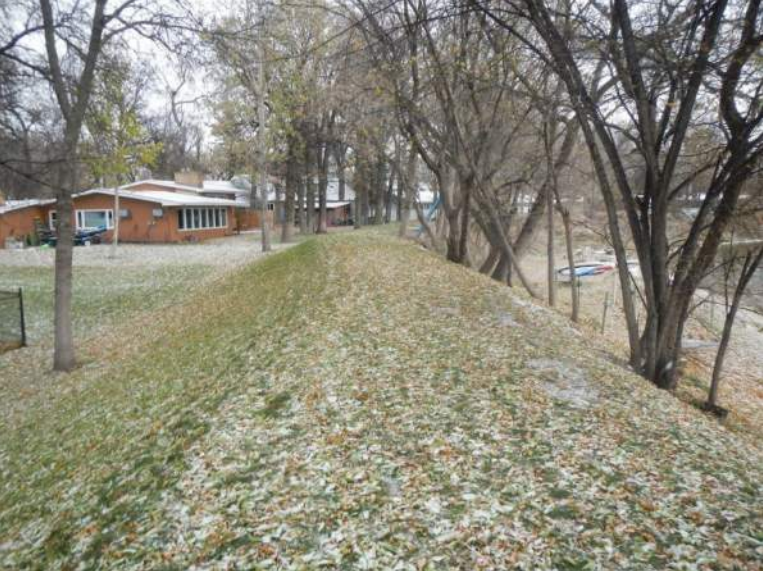
<p><b>Inspect ID:</b> MINL_2019_a_0130 <b>Title:</b> USACE_CEMVP_MINL_2019_a_0130_2.jpg <b>Rated Item:</b> 1. Unwanted Vegetation Growth <b>Caption:</b> Rating: Unacceptable; Remarks: Trees (&gt; 2 inches in diameter) located on levee and within the Vegetation Free Zone; Action: Remove unwanted vegetation from vegetation-free zone, up to the levee easement; Remove root ball, backfill, compact in lifts, and reseed with grass; Ensure environmental compliance with all appropriate agencies prior to removal; Station_1: 570+86L; Station_2: 593+26L</p>
 	<p><b>Inspect ID:</b> MINL_2019_a_0130 <b>Title:</b> USACE_CEMVP_MINL_2019_a_0130_3.jpg <b>Rated Item:</b> 1. Unwanted Vegetation Growth <b>Caption:</b> Rating: Unacceptable; Remarks: Trees (&gt; 2 inches in diameter) located on levee and within the Vegetation Free Zone; Action: Remove unwanted vegetation from vegetation-free zone, up to the levee easement; Remove root ball, backfill, compact in lifts, and reseed with grass; Ensure environmental compliance with all appropriate agencies prior to removal; Station_1: 570+86L; Station_2: 593+26L</p>

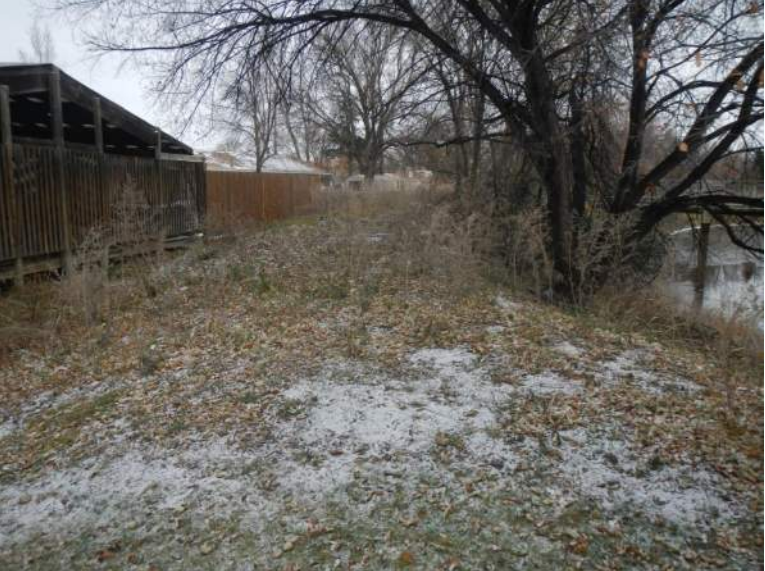
<p><b>Inspect ID:</b> MINL_2019_a_0130 <b>Title:</b> USACE_CEMVP_MINL_2019_a_0130_4.jpg <b>Rated Item:</b> 1. Unwanted Vegetation Growth <b>Caption:</b> Rating: Unacceptable; Remarks: Trees (&gt; 2 inches in diameter) located on levee and within the Vegetation Free Zone; Action: Remove unwanted vegetation from vegetation-free zone, up to the levee easement; Remove root ball, backfill, compact in lifts, and reseed with grass; Ensure environmental compliance with all appropriate agencies prior to removal; Station_1: 570+86L; Station_2: 593+26L</p>

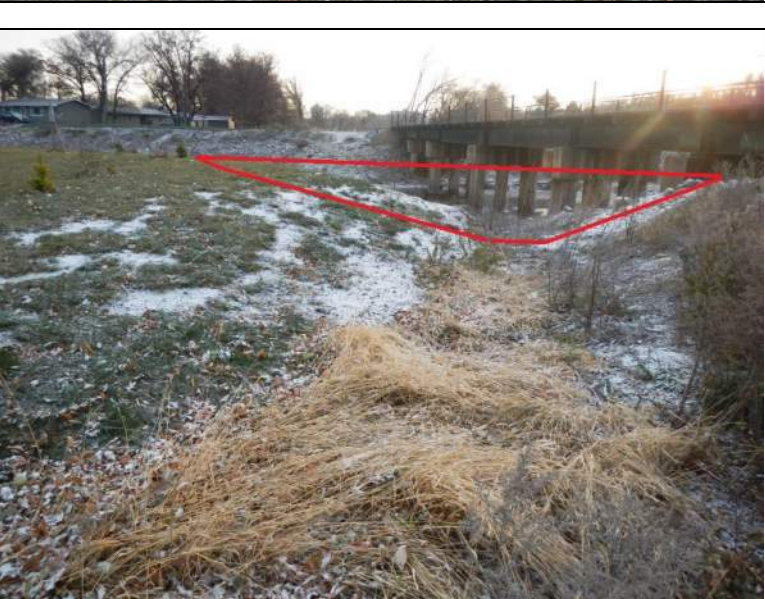
<p><b>Inspect ID:</b> MINL_2019_a_0001 <b>Title:</b> USACE_CEMVP_MINL_2019_a_0001_1.jpg <b>Rated Item:</b> 3. Encroachments <b>Caption:</b> Rating: Unacceptable; Remarks: A drainage ditch was cut through the levee prism; Action: Fill and compact the cut area with appropriate material to design elevation, and reseed with grass; Station_1: 828+60</p>

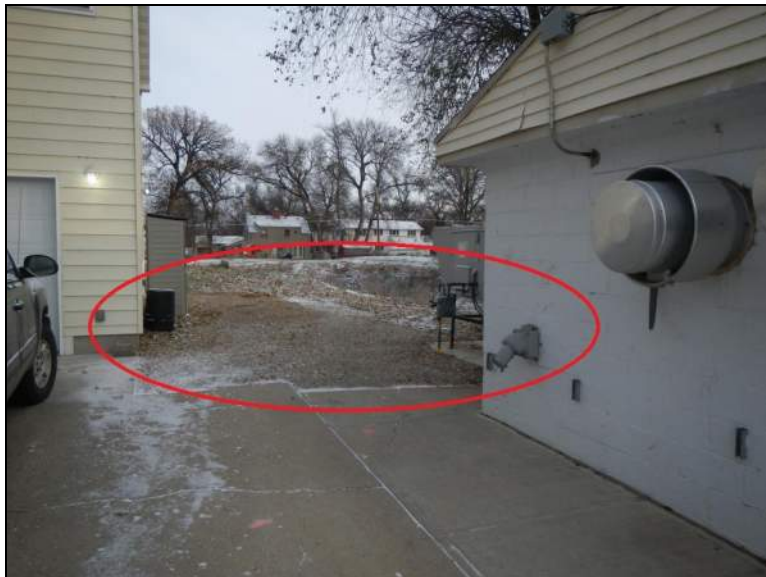
**Inspect ID:** MINL\_2019\_a\_0004 **Title:** USACE\_CEMVP\_MINL\_2019\_a\_0004\_1.jpg  
**Rated Item:** 3. Encroachments **Caption:** Rating: Unacceptable; Remarks: Low spot in levee crown and new garage next to levee; Action: Verify levee easement; Relocate encroachments/debris outside of levee easement, unless approved by Corps; Raise levee to design grade, compact in lifts, and reseed with grass; Station\_1: 822+82L

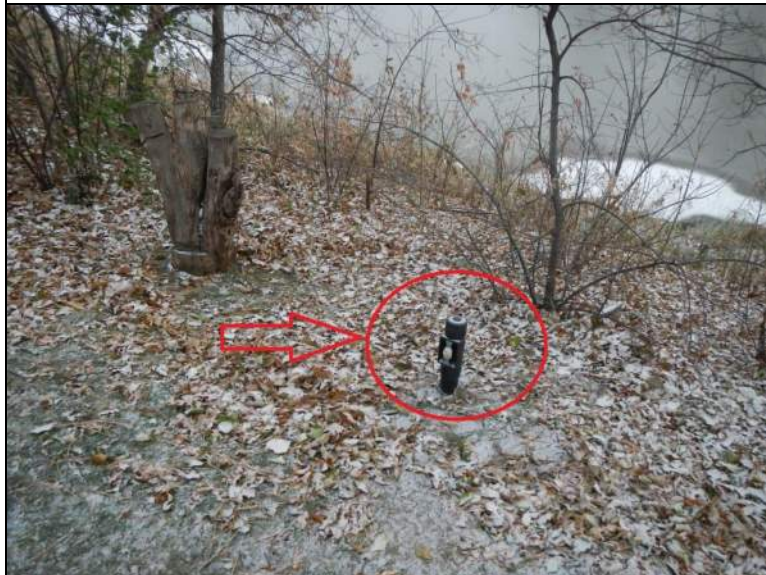
**Inspect ID:** MINL\_2019\_a\_0009 **Title:** USACE\_CEMVP\_MINL\_2019\_a\_0009\_1.jpg  
**Rated Item:** 3. Encroachments **Caption:** Rating: Unacceptable; Remarks: Sump pump hose through levee; Action: Verify levee easement; Relocate encroachments/debris outside of levee easement, unless approved by Corps; Station\_1: 815+33L

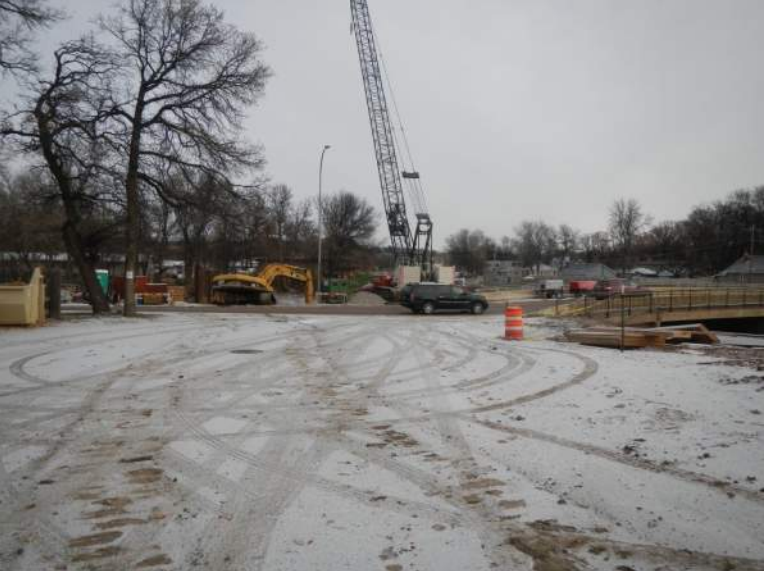
<p><b>Inspect ID:</b> MINL_2019_a_0015 <b>Title:</b> USACE_CEMVP_MINL_2019_a_0015_1.jpg <b>Rated Item:</b> 3. Encroachments <b>Caption:</b> Rating: Acceptable; Remarks: Private property sign on levee crown and riverside slope. Additionally, material to construct a fence is located at the toe of the levee. This has been reviewed and approved by the Corps to construct a fence across the levee; Action: No Action Required - Currently under construction and the fence will be removable and the city has keys to access the gate; Station_1: 797+09L</p>

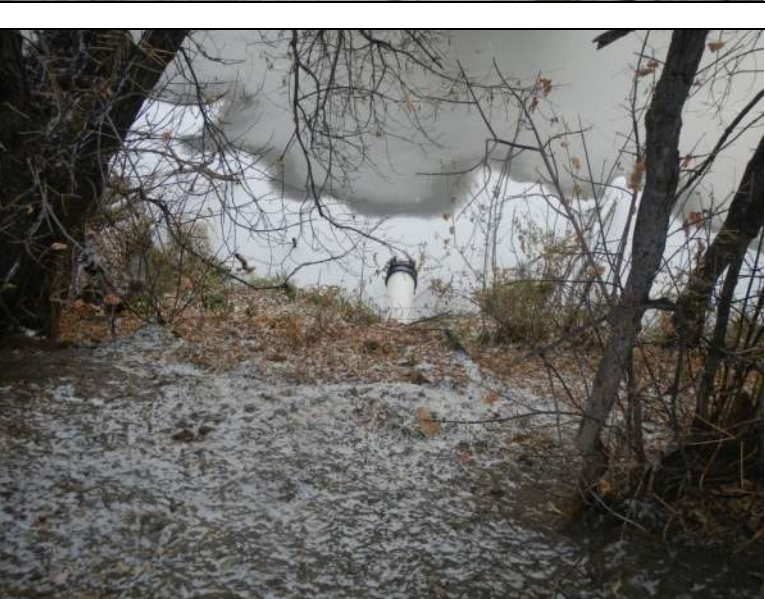
<p><b>Inspect ID:</b> MINL_2019_a_0019 <b>Title:</b> USACE_CEMVP_MINL_2019_a_0019_1.jpg <b>Rated Item:</b> 3. Encroachments <b>Caption:</b> Rating: Unacceptable; Remarks: Interior drainage pipe through the levee embankment. Not shown on as-built drawings. The 2018 Pipe Inspection Report indicates some slight deformity in the plastic pipe; Action: The pipe does not contain any means for closure during a flood event. Verify the pipe is part of the federal project or has been approved by the Corps. The pipe is scheduled to be cleaned and have backflow prevention installed as part of the SWIF; Station_1: 792+36L</p>

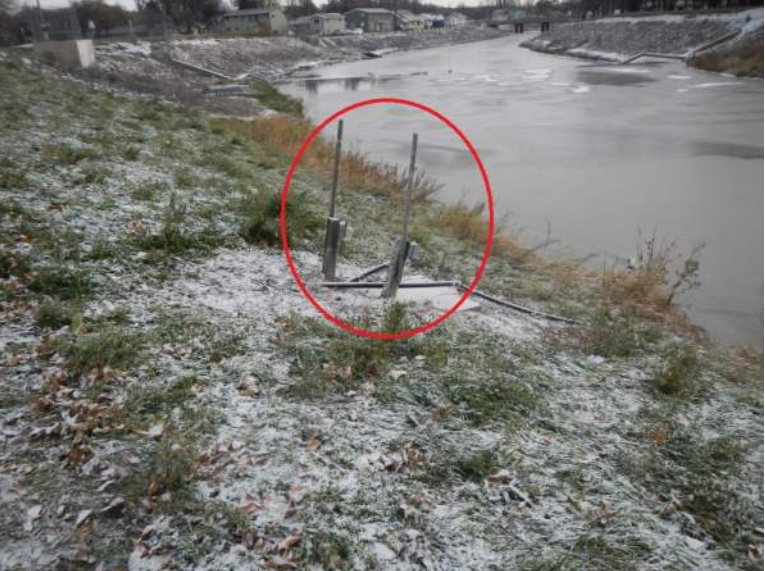
<p><b>Inspect ID:</b> MINL_2019_a_0020 <b>Title:</b> USACE_CEMVP_MINL_2019_a_0020_1.jpg <b>Rated Item:</b> 3. Encroachments <b>Caption:</b> Rating: Unacceptable; Remarks: Irrigation pumps and lines through levee; Action: Verify levee easement; Relocate encroachments outside of levee easement;; Station_1: 789+90L</p>
 	<p><b>Inspect ID:</b> MINL_2019_a_0030 <b>Title:</b> USACE_CEMVP_MINL_2019_a_0030_1.jpg <b>Rated Item:</b> 3. Encroachments <b>Caption:</b> Rating: Unacceptable; Remarks: Power poles in levee crown; Action: Verify levee easement; Relocate encroachments/debris outside of levee easement, unless approved by Corps; Station_1: 777+31L</p>

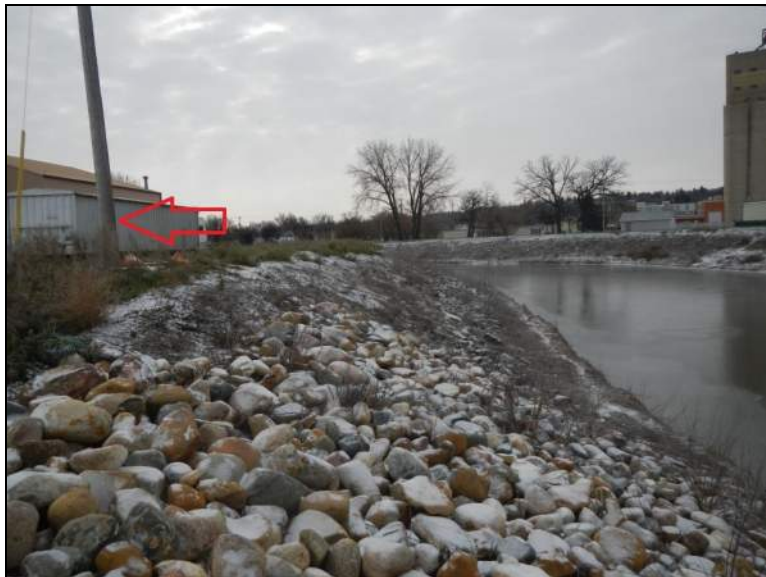
Rated Item	Rating	Rating Guidelines	Location/Remarks/Recommendations
			<p>encroachments/debris outside of levee easement, unless approved by Corps (U)</p> <p>MINL_2019_a_0044: Station_1 714+18: Power pole on levee, Vegetation in riprap: Verify levee easement, relocate encroachments outside of levee easement, unless approved by Corps, Remove unwanted vegetation from vegetation-free zone, Ensure environmental compliance with all appropriate agencies prior to removal (U)</p> <p>MINL_2019_a_0052: Station_1 697+50: Guard rail and power pole on levee: Verify levee easement; Relocate encroachments outside of levee easement (U)</p> <p>MINL_2019_a_0056: Station_1 686+53: A utility pole is located in the levee prism: Verify levee easement. Relocate utility pole outside of levee easement, unless approved by Corps (U)</p> <p>MINL_2019_a_0061: Station_1 675+42L: Sewer manhole on riverside levee slope: Verify levee easement; Relocate encroachments outside of levee easement (U)</p> <p>MINL_2019_a_0070: Station_1 648+32L: Power pole levee alignment: Verify levee easement; Relocate encroachments/debris outside of levee easement, unless approved by Corps (U)</p> <p>MINL_2019_a_0079: Station_1 633+41L: Power poles and guard rail on levee crown: Verify levee easement; Relocate encroachments outside of levee easement, unless approved by Corps (U)</p> <p>MINL_2019_a_0097: Station_1 813+77L: Station_2 828+60L: Residential encroachments, utility poles, fences, irrigation lines, etc. along the entire levee reach: Verify levee easement. Relocate encroachments outside of levee easement, unless approved by the Corps (U)</p> <p>MINL_2019_a_0100: Station_1 791+30L: Station_2 794+63L: Residential encroachments, structures, decks, irrigation line, and landscaping. Private property signs are posted on the levee: Verify levee easement. Relocate encroachments outside of levee easement, unless approved by Corps (U)</p> <p>MINL_2019_a_0107: Station_1 766+75L: Station_2 773+23L: Residential encroachments, structures, vehicles, power poles, and landscaping along the levee embankment: Verify levee easement. Relocate encroachments outside of levee embankment, unless approved by the Corps (U)</p> <p>MINL_2019_a_0110: Station_1 717+33L: Station_2</p>

**Inspect ID:** MINL\_2019\_a\_0044 **Title:** USACE\_CEMVP\_MINL\_2019\_a\_0044\_1.jpg  
**Rated Item:** 3. Encroachments **Caption:** Rating: Unacceptable; Remarks: Power pole on levee, Vegetation in riprap; Action: Verify levee easement, relocate encroachments outside of levee easement, unless approved by Corps, Remove unwanted vegetation from vegetation-free zone, Ensure environmental compliance with all appropriate agencies prior to removal; Station\_1: 714+18

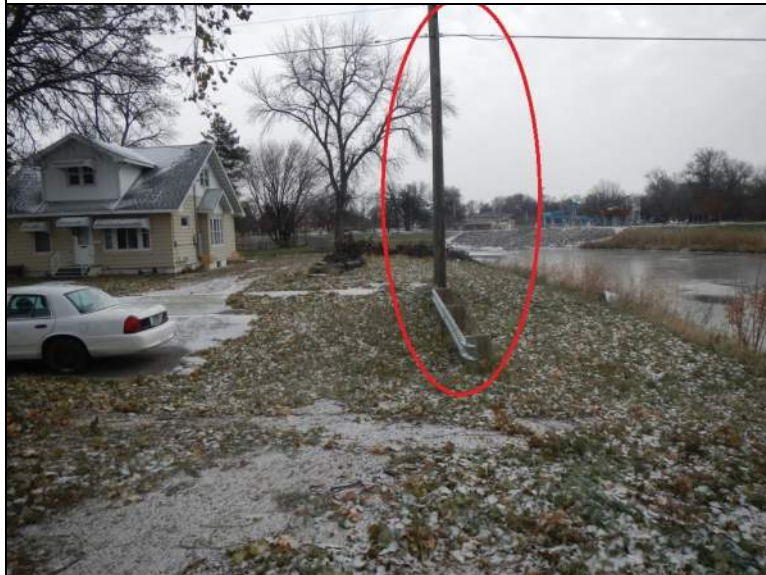
**Inspect ID:** MINL\_2019\_a\_0052 **Title:** USACE\_CEMVP\_MINL\_2019\_a\_0052\_1.jpg  
**Rated Item:** 3. Encroachments **Caption:** Rating: Unacceptable; Remarks: Guard rail and power pole on levee; Action: Verify levee easement; Relocate encroachments outside of levee easement; Station\_1: 697+50

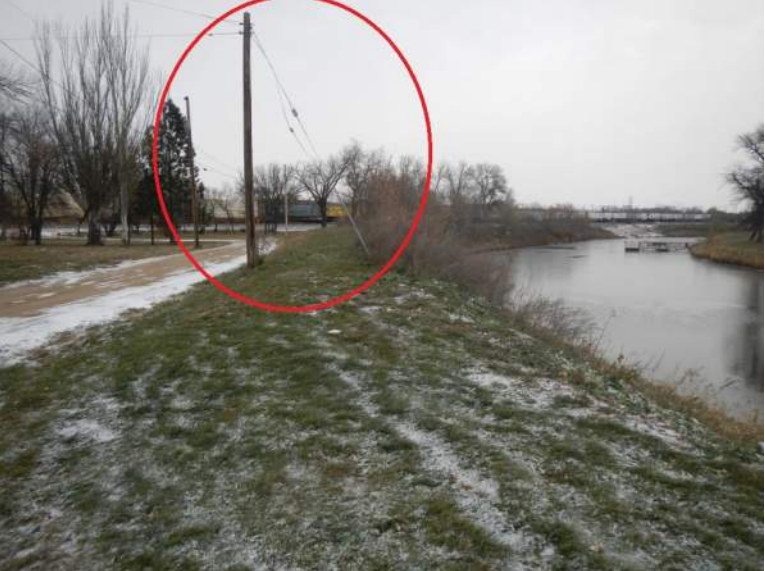
A photograph showing a grassy levee embankment next to a body of water. A utility pole is visible on the left side of the embankment, and it is circled in red. The background shows some trees and a distant bridge.	<p><b>Inspect ID:</b> MINL_2019_a_0056 <b>Title:</b> USACE_CEMVP_MINL_2019_a_0056_1.jpg <b>Rated Item:</b> 3. Encroachments <b>Caption:</b> Rating: Unacceptable; Remarks: A utility pole is located in the levee prism; Action: Verify levee easement. Relocate utility pole outside of levee easement, unless approved by Corps; Station_1: 686+53</p>

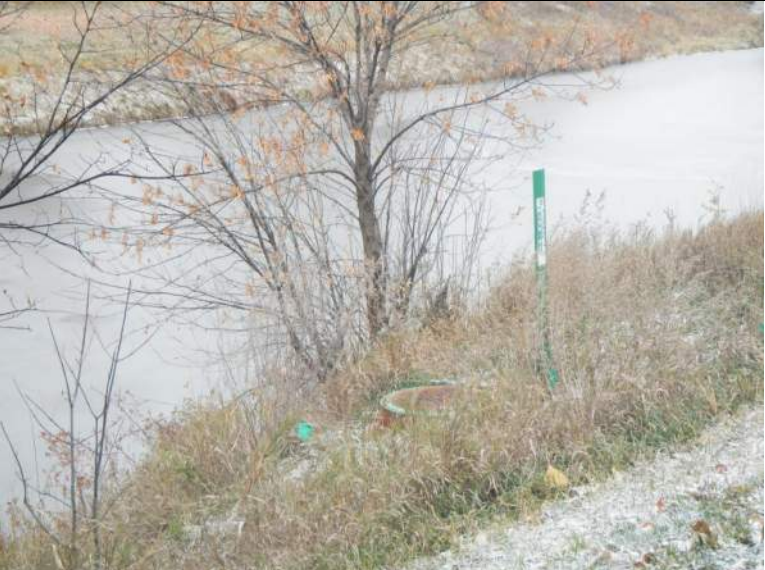
A photograph showing a levee embankment with a sewer manhole visible. The manhole is covered with a green lid and is surrounded by grass and some trees. The background shows a body of water and some trees.	<p><b>Inspect ID:</b> MINL_2019_a_0061 <b>Title:</b> USACE_CEMVP_MINL_2019_a_0061_1.jpg <b>Rated Item:</b> 3. Encroachments <b>Caption:</b> Rating: Unacceptable; Remarks: Sewer manhole on riverside levee slope; Action: Verify levee easement; Relocate encroachments outside of levee easement; Station_1: 675+42L</p>

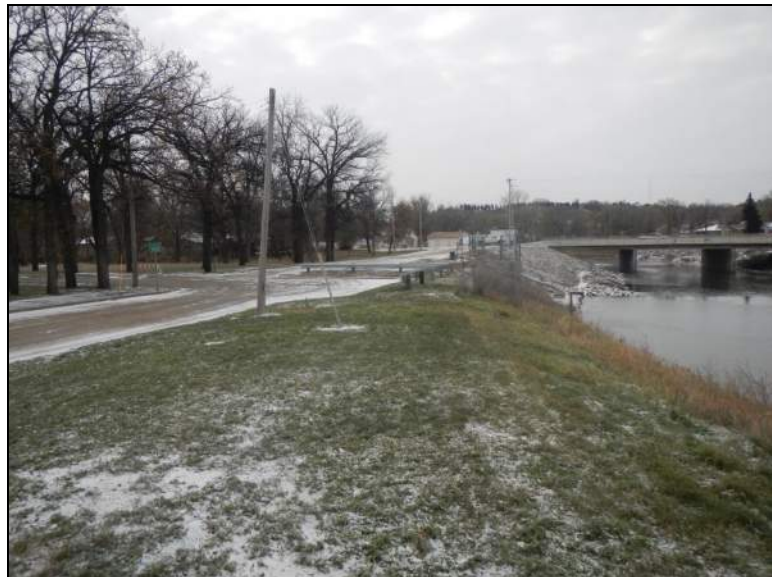
<p><b>Inspect ID:</b> MINL_2019_a_0070 <b>Title:</b> USACE_CEMVP_MINL_2019_a_0070_1.jpg <b>Rated Item:</b> 3. Encroachments <b>Caption:</b> Rating: Unacceptable; Remarks: Power pole levee alignment; Action: Verify levee easement; Relocate encroachments/debris outside of levee easement, unless approved by Corps; Station_1: 648+32L</p>

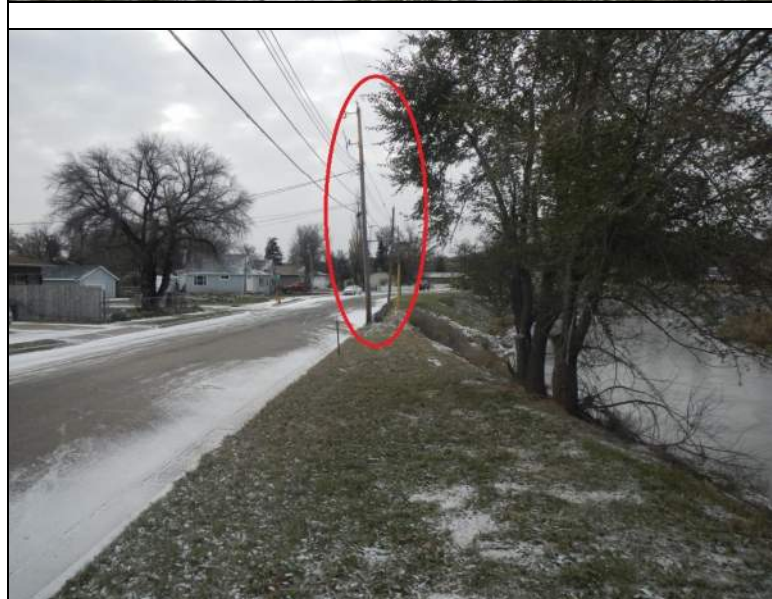
<p><b>Inspect ID:</b> MINL_2019_a_0079 <b>Title:</b> USACE_CEMVP_MINL_2019_a_0079_1.jpg <b>Rated Item:</b> 3. Encroachments <b>Caption:</b> Rating: Unacceptable; Remarks: Power poles and guard rail on levee crown; Action: Verify levee easement; Relocate encroachments outside of levee easement, unless approved by Corps; Station_1: 633+41L</p>

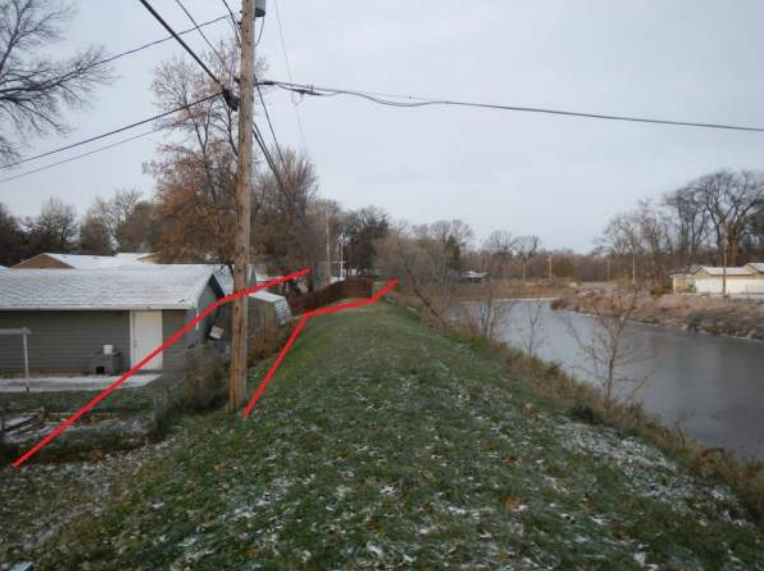
<p><b>Inspect ID:</b> MINL_2019_a_0097 <b>Title:</b> USACE_CEMVP_MINL_2019_a_0097_1.jpg <b>Rated Item:</b> 3. Encroachments <b>Caption:</b> Rating: Unacceptable; Remarks: Residential encroachments, utility poles, fences, irrigation lines, etc. along the entire levee reach; Action: Verify levee easement. Relocate encroachments outside of levee easement, unless approved by the Corps; Station_1: 813+77L; Station_2: 828+60L</p>
