## Flood Damage Reduction Segment / System Inspection Report

Name of Segment / System: Souris River - Minot - Left Bank

Inspection Start Date: 10/30/2019

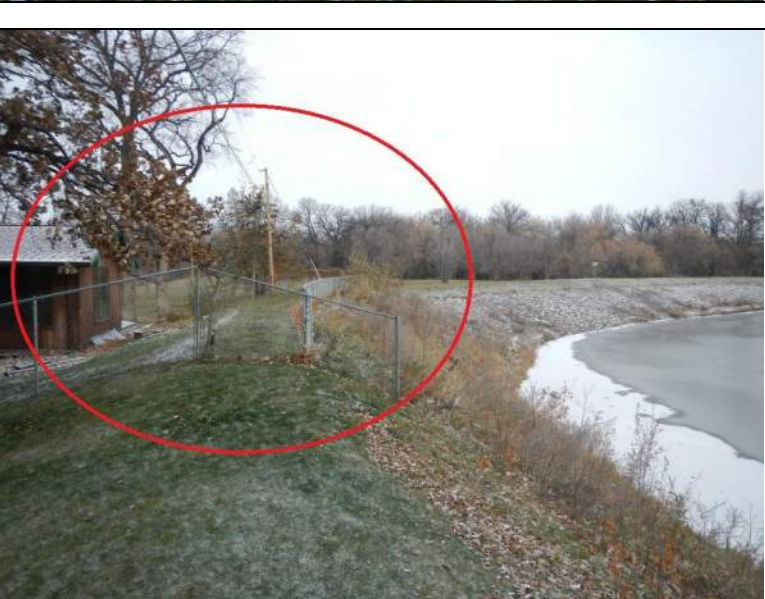
<p><b>Inspect ID:</b> MINL_2019_a_0097 <b>Title:</b> USACE_CEMVP_MINL_2019_a_0097_2.jpg <b>Rated Item:</b> 3. Encroachments <b>Caption:</b> Rating: Unacceptable; Remarks: Residential encroachments, utility poles, fences, irrigation lines, etc. along the entire levee reach; Action: Verify levee easement. Relocate encroachments outside of levee easement, unless approved by the Corps; Station_1: 813+77L; Station_2: 828+60L</p>

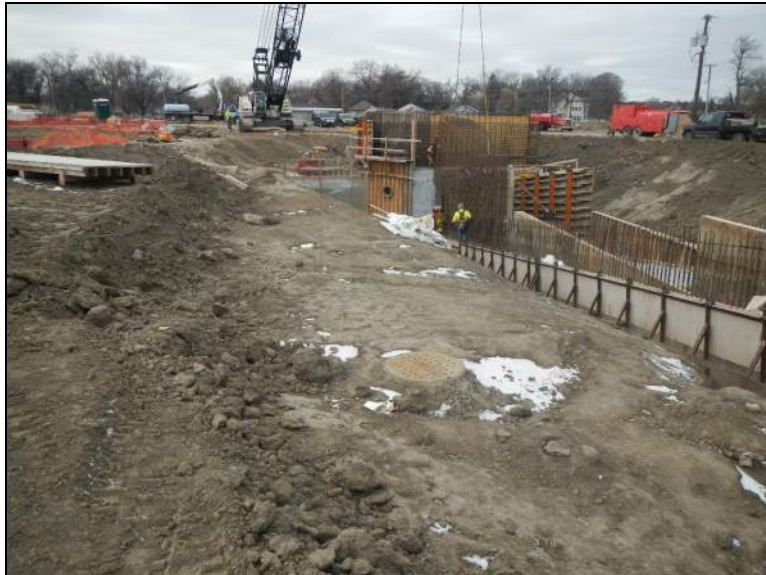
Rated Item	Rating	Rating Guidelines		Location/Remarks/Recommendations
				<p>759+15L: Area under construction for new levee and pump station construction. Approved as part of the 408 modification to the existing project: Construct project per the approved plans and specifications (A)</p> <p>MINL_2019_a_0117: Station_1 676+63L: Station_2 680+78L: A fence is located at the landside toe of the levee embankment: Verify levee easement. Relocate fence encroachment outside of levee easement, unless approved by Corps (U)</p> <p>MINL_2019_a_0121: Station_1 09+81L: Station_2 02+96L: Zoo fence located on top of the levee embankment. The fence has been approved by the Corps: NA (A)</p> <p>MINL_2019_a_0124: Station_1 643+92L: Station_2 647+52L: Multiple encroachments along the levee side toe: Verify levee easement. Relocate encroachment structures outside of levee easement, unless approved by Corps (U)</p> <p>MINL_2019_a_0128: Station_1 625+42: Power pole and utility box located within the alignment of levee: Verify levee easement; Relocate encroachments/debris outside of levee easement, unless approved by Corps (U)</p> <p>MINL_2019_a_0129: Station_1 570+64L: Station_2 592+84L: Numerous encroachments, including fences, landscaping materials, gardens, electric boxes, irrigation lines, and power poles: Verify levee easement. Relocate encroachments/debris outside of levee easement (U)</p> <p>MINL_2019_a_0132: Station_1 62+18L: Station_2 829+03L: Area under construction for new levee and pump station construction. approved as part of the 408 modification to the existing project: Construct project per the approved plans and specifications (A)</p>

**Inspect ID:** MINL\_2019\_a\_0110 **Title:** USACE\_CEMVP\_MINL\_2019\_a\_0110\_1.jpg  
**Rated Item:** 3. Encroachments **Caption:** Rating: Acceptable; Remarks: Area under construction for new levee and pump station construction. Approved as part of the 408 modification to the existing project; Action: Construct project per the approved plans and specifications; Station\_1: 717+33L; Station\_2: 759+15L

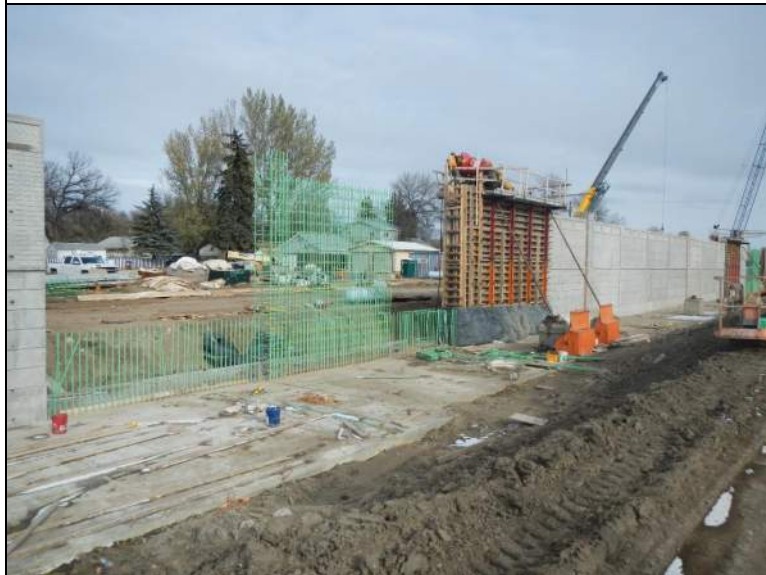
**Inspect ID:** MINL\_2019\_a\_0110 **Title:** USACE\_CEMVP\_MINL\_2019\_a\_0110\_2.jpg  
**Rated Item:** 3. Encroachments **Caption:** Rating: Acceptable; Remarks: Area under construction for new levee and pump station construction. Approved as part of the 408 modification to the existing project; Action: Construct project per the approved plans and specifications; Station\_1: 717+33L; Station\_2: 759+15L

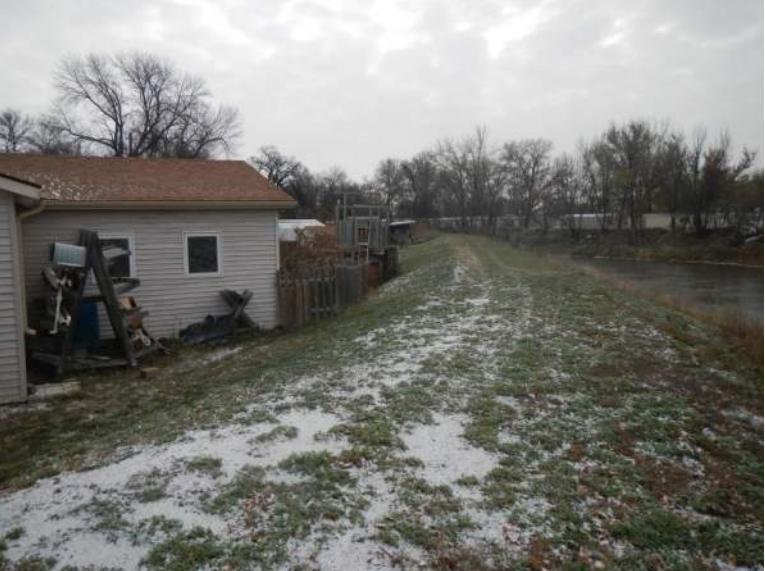
<p><b>Inspect ID:</b> MINL_2019_a_0124 <b>Title:</b> USACE_CEMVP_MINL_2019_a_0124_1.jpg <b>Rated Item:</b> 3. Encroachments <b>Caption:</b> Rating: Unacceptable; Remarks: Multiple encroachments along the levee side toe; Action: Verify levee easement. Relocate encroachment structures outside of levee easement, unless approved by Corps; Station_1: 643+92L; Station_2: 647+52L</p>

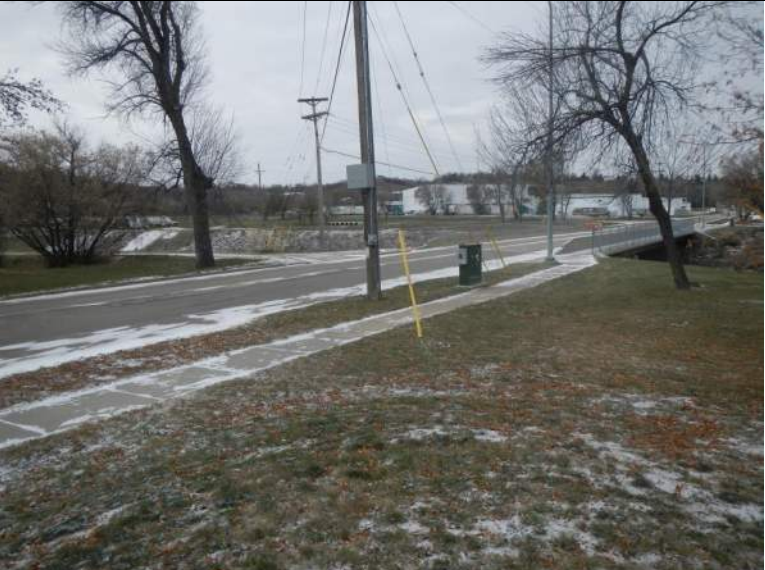
<p><b>Inspect ID:</b> MINL_2019_a_0128 <b>Title:</b> USACE_CEMVP_MINL_2019_a_0128_1.jpg <b>Rated Item:</b> 3. Encroachments <b>Caption:</b> Rating: Unacceptable; Remarks: Power pole and utility box located within the alignment of levee ; Action: Verify levee easement; Relocate encroachments/debris outside of levee easement, unless approved by Corps; Station_1: 625+42; ; ; ; ;</p>

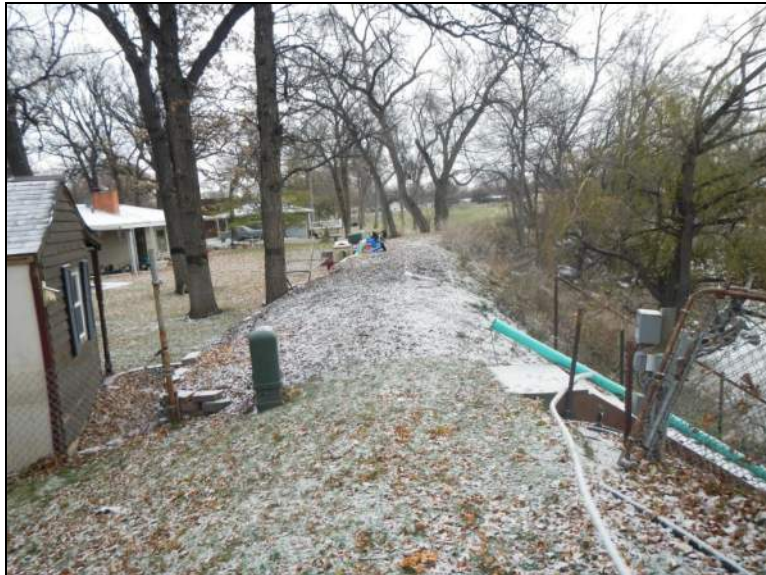
**Inspect ID:** MINL\_2019\_a\_0129 **Title:** USACE\_CEMVP\_MINL\_2019\_a\_0129\_3.jpg  
**Rated Item:** 3. Encroachments **Caption:** Rating: Unacceptable; Remarks: Numerous encroachments, including fences, landscaping materials, gardens, electric boxes, irrigation lines, and power poles; Action: Verify levee easement. Relocate encroachments/debris outside of levee easement; Station\_1: 570+64L; Station\_2: 592+84L

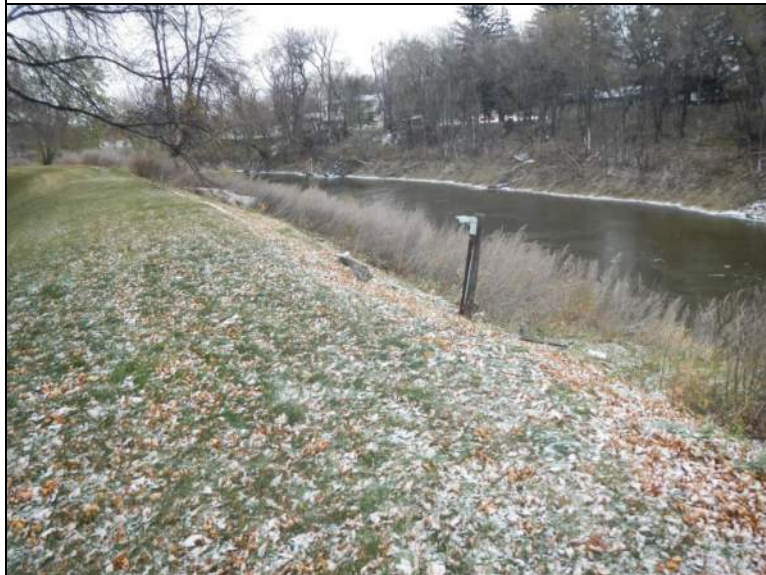
**Inspect ID:** MINL\_2019\_a\_0129 **Title:** USACE\_CEMVP\_MINL\_2019\_a\_0129\_4.jpg  
**Rated Item:** 3. Encroachments **Caption:** Rating: Unacceptable; Remarks: Numerous encroachments, including fences, landscaping materials, gardens, electric boxes, irrigation lines, and power poles; Action: Verify levee easement. Relocate encroachments/debris outside of levee easement; Station\_1: 570+64L; Station\_2: 592+84L

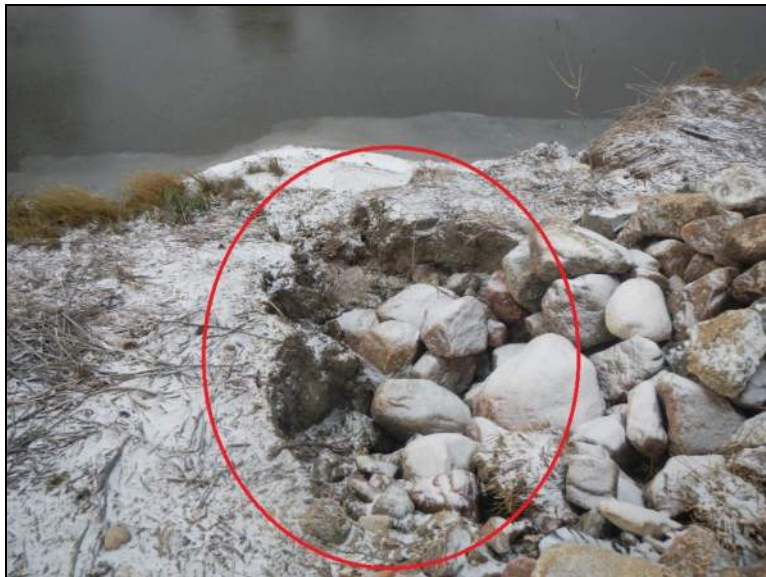
**Inspect ID:** MINL\_2019\_a\_0045 **Title:** USACE\_CEMVP\_MINL\_2019\_a\_0045\_1.jpg  
**Rated Item:** 6. Erosion/ Bank Caving **Caption:** Rating: Minimally Acceptable;  
Remarks: Erosion has occurred at the end of interior drainage culvert; Action: Extend erosion protection down to water surface to prevent further loss of material ; Station\_1: 711+83; ; ;

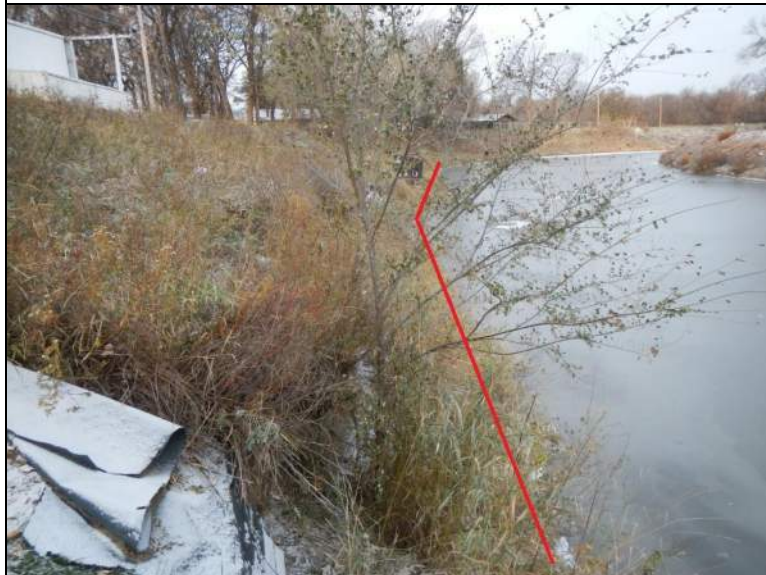
**Inspect ID:** MINL\_2019\_a\_0098 **Title:** USACE\_CEMVP\_MINL\_2019\_a\_0098\_1.jpg  
**Rated Item:** 6. Erosion/ Bank Caving **Caption:** Rating: Unacceptable; Remarks:  
Erosion and bank caving along the left channel bank and levee riverside slope and toe;  
Action: Backfill erosion to the design grade, compact in lifts, and evaluate if riprap is needed or reseed; Station\_1: 815+33L; Station\_2: 818.06L

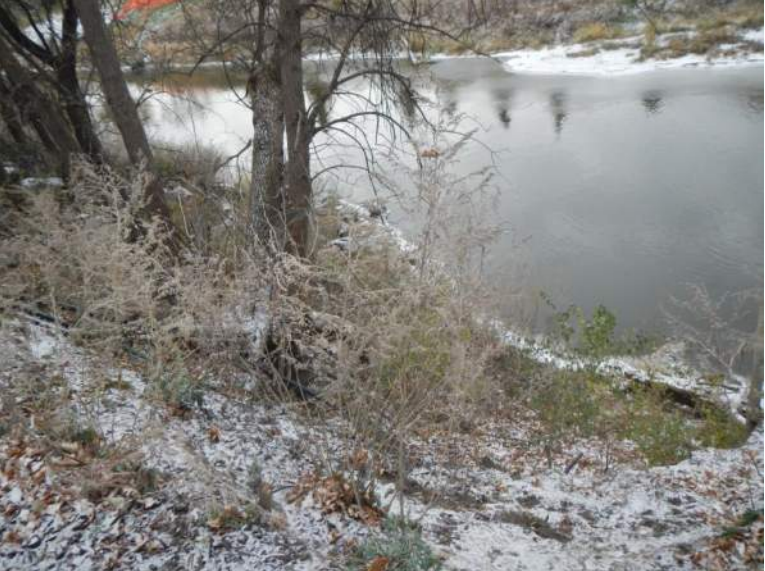
<p><b>Inspect ID:</b> MINL_2019_a_0131 <b>Title:</b> USACE_CEMVP_MINL_2019_a_0131_1.jpg <b>Rated Item:</b> 6. Erosion/ Bank Caving <b>Caption:</b> Rating: Minimally Acceptable; Remarks: Erosion and bank caving along the left channel bank and levee riverside slope and toe; Action: Backfill erosion to the design grade, compact in lifts, and reseed with grass; Station_1: 590+50</p>

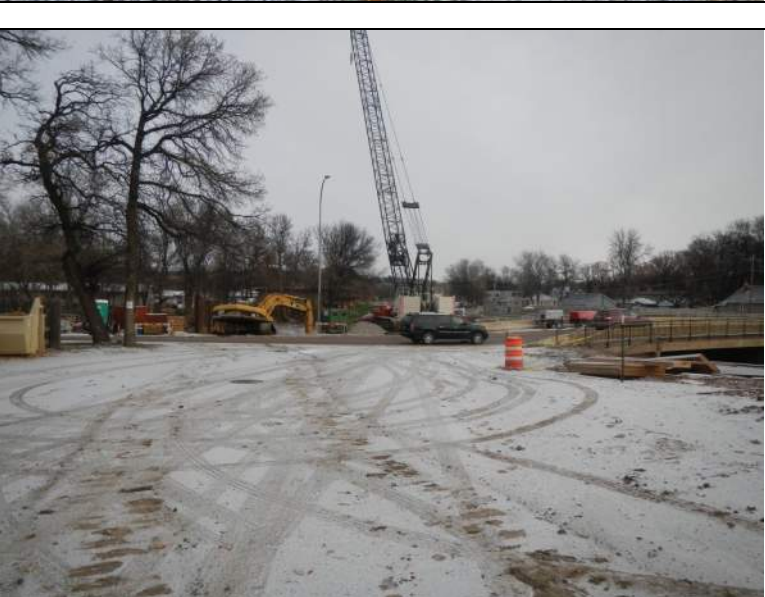
<p><b>Inspect ID:</b> MINL_2019_a_0014 <b>Title:</b> USACE_CEMVP_MINL_2019_a_0014_1.jpg <b>Rated Item:</b> 11. Culverts/ Discharge Pipes (This item includes both concrete and corrugated metal pipes.) <b>Caption:</b> Rating: Acceptable; Remarks: Project culvert being replaced. Approved under SWIF; Action: Send as-built drawings to the Corps ; Station_1: 797+38; ; ;</p>

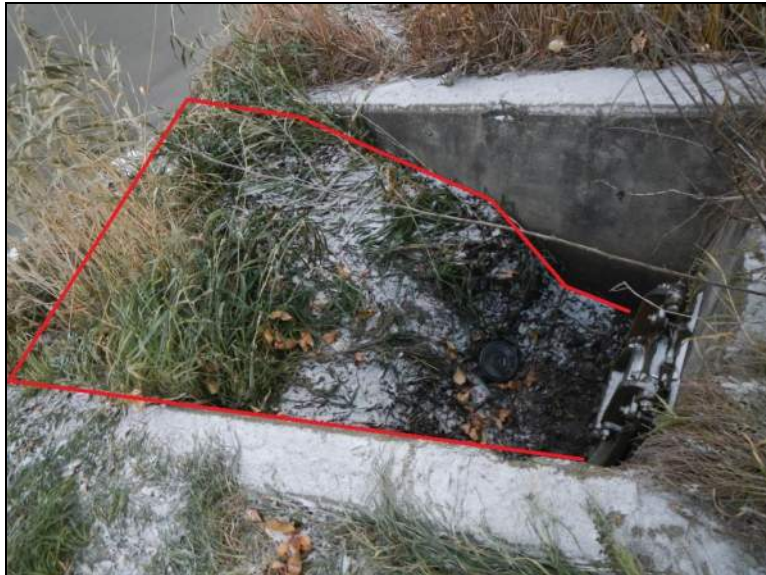
**Inspect ID:** MINL\_2019\_a\_0007 **Title:** USACE\_CEMVP\_MINL\_2019\_a\_0007\_1.jpg  
**Rated Item:** 1. Vegetation and Obstructions **Caption:** Rating: Minimally Acceptable;  
**Remarks:** Sediment and vegetation growth in discharge basin; **Action:** Remove vegetation and sedimentation from the drainage feature; **Station\_1:** 818+85L
