Flood Damage Reduction Segment / System Inspection Report

Name of Segment / System: Souris River-Burlington to Minot-TierrecitaVallejo

Public Sponsor(s): Souris River Joint Water Resources Board

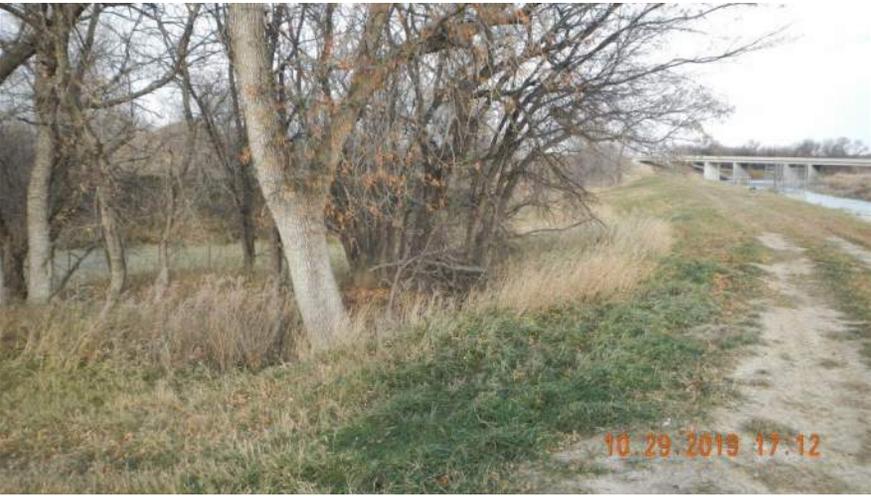
<p>Inspect ID: BMTV_2019_a_0014 Title: USACE_CEMVP_BMTV_2019_a_0014_1.jpg Rated Item: 1. Unwanted Vegetation Growth Caption: Rating: Unacceptable; Remarks: Unwanted Vegetation Growth. Trees (>2 inches in diameter) and long vegetation located on landside levee slope. ; Action: Remove unwanted vegetation from vegetation-free zone, up to the levee easement; Remove root ball, backfill, compact in lifts, and re-sod; Ensure environmental compliance with all appropriate agencies prior to removal; Station_1: -5+66; Station_2: 2+42</p>

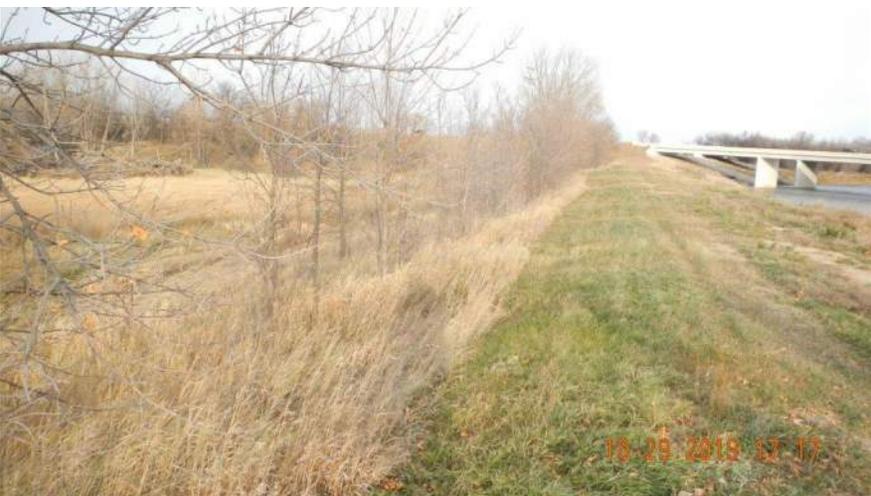
<p>Inspect ID: BMTV_2019_a_0014 Title: USACE_CEMVP_BMTV_2019_a_0014_2.jpg Rated Item: 1. Unwanted Vegetation Growth Caption: Rating: Unacceptable; Remarks: Unwanted Vegetation Growth. Trees (>2 inches in diameter) and long vegetation located on landside levee slope. ; Action: Remove unwanted vegetation from vegetation-free zone, up to the levee easement; Remove root ball, backfill, compact in lifts, and re-sod; Ensure environmental compliance with all appropriate agencies prior to removal; Station_1: -5+66; Station_2: 2+42</p>

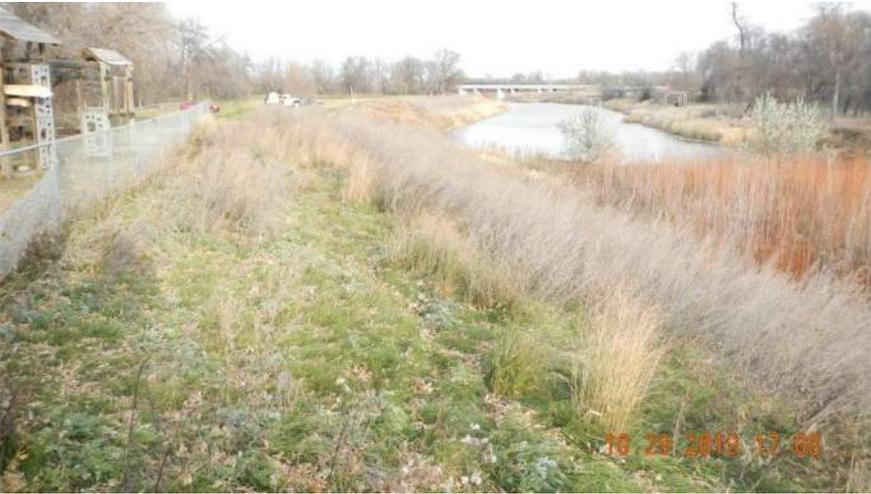
<p>Inspect ID: BMTV_2019_a_0023 Title: USACE_CEMVP_BMTV_2019_a_0023_1.jpg Rated Item: 1. Unwanted Vegetation Growth Caption: Rating: Unacceptable; Remarks: Overgrown grass, large dense tree cover, and brush cover the levee crown, slopes, toes, and vegetation-free zone; Action: Remove unwanted vegetation from vegetation-free zone, up to the levee easement. Remove root ball, backfill, compact in lifts, and reseed with grass. Ensure environmental compliance with all appropriate agencies prior to removal; Station_1: 7+67; Station_2: 9+84</p>

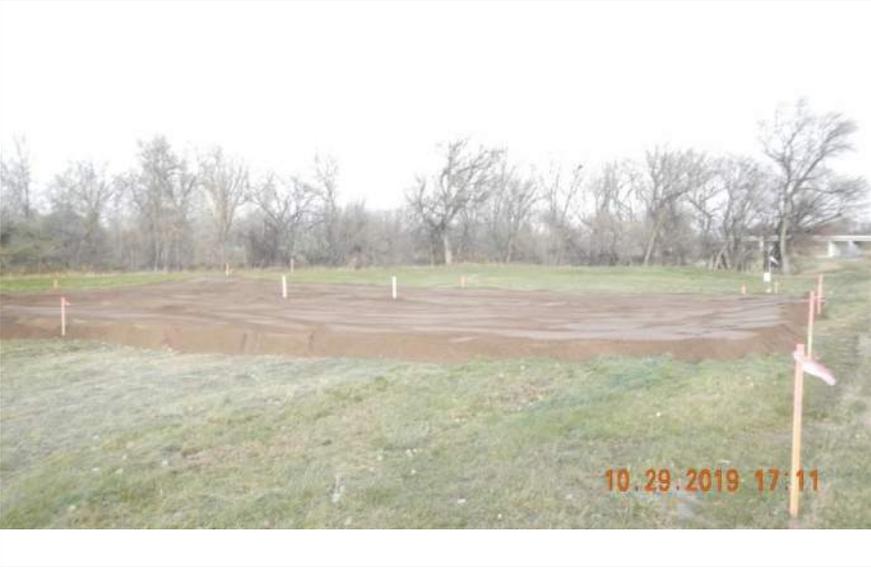
<p>Inspect ID: BMTV_2019_a_0007 Title: USACE_CEMVP_BMTV_2019_a_0007_1.jpg Rated Item: 3. Encroachments Caption: Rating: Acceptable; Remarks: Sand placed for a preload embankment; Action: Construction for new 408 Project; Station_1: 4+11</p>

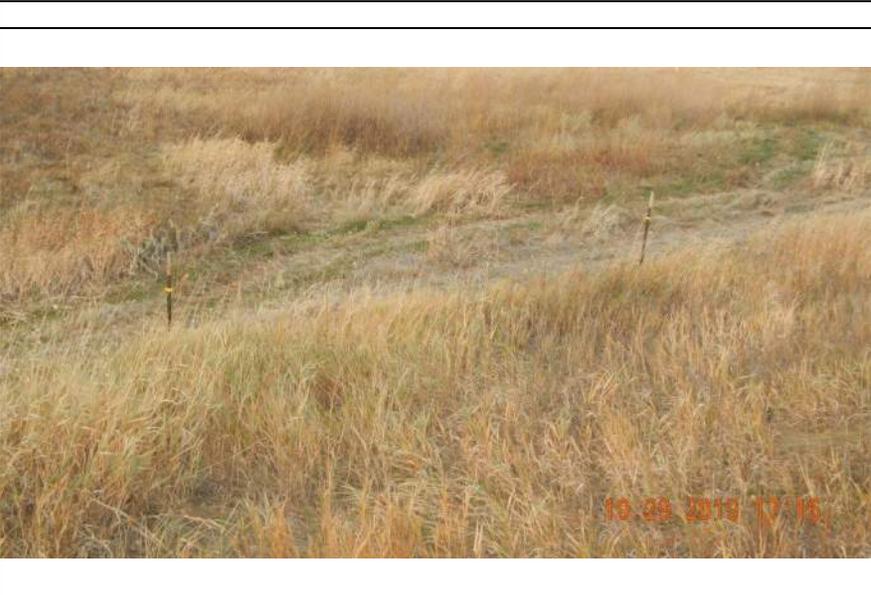
<p>Inspect ID: BMTV_2019_a_0013 Title: USACE_CEMVP_BMTV_2019_a_0013_1.jpg Rated Item: 3. Encroachments Caption: Rating: Minimally Acceptable; Remarks: Metal fence posts on the landside levee slope remain; wiring from the fence was removed; Action: Relocate fence posts outside of levee easement; Station_1: 0+00; Station_2: -03+98</p>

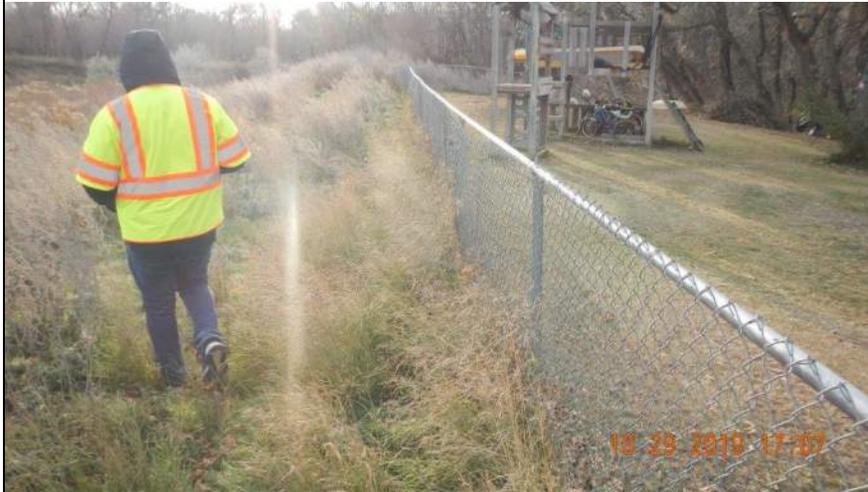
Inspect ID: BMTV_2019_a_0024 **Title:** USACE_CEMVP_BMTV_2019_a_0024_1.jpg **Rated Item:** 3. Encroachments
Caption: Rating: Unacceptable; Remarks: Miscellaneous residential encroachments including fencing and playground on the landside slope and toe; Action: Verify levee easement. Relocate encroachments outside of the levee easement unless approved by Corps; Station_1: 7+67; Station_2: 9+84

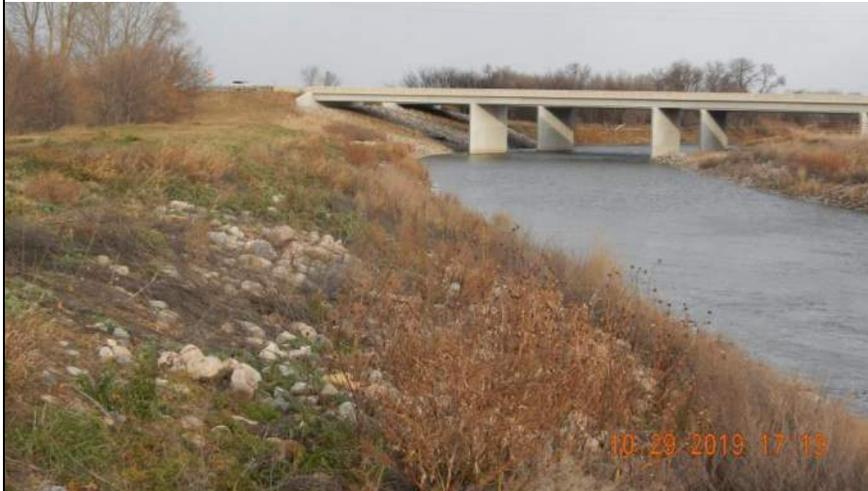
Inspect ID: BMTV_2019_a_0025 **Title:** USACE_CEMVP_BMTV_2019_a_0025_1.jpg **Rated Item:** 12. Riprap Revetments & Bank Protection
Caption: Rating: Unacceptable; Remarks: Riprap on riverward slope is overgrown with brush and saplings; Action: Remove all woody vegetation and spray or burn grasses; Station_1: -6+06; Station_2: 0+31

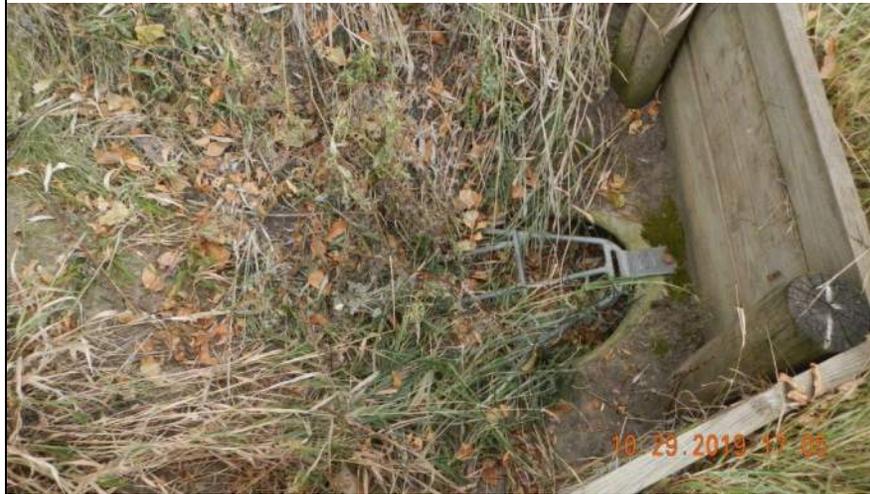
Inspect ID: BMTV_2019_a_0002 **Title:** USACE_CEMVP_BMTV_2019_a_0002_1.jpg **Rated Item:** 1. Vegetation and Obstructions **Caption:** Rating: Unacceptable; Remarks: Culvert opening is being obstructed by more than 10 percent from sedimentation and vegetation; Action: Remove sediment and vegetation from the drainage feature; Station_1: 7+50

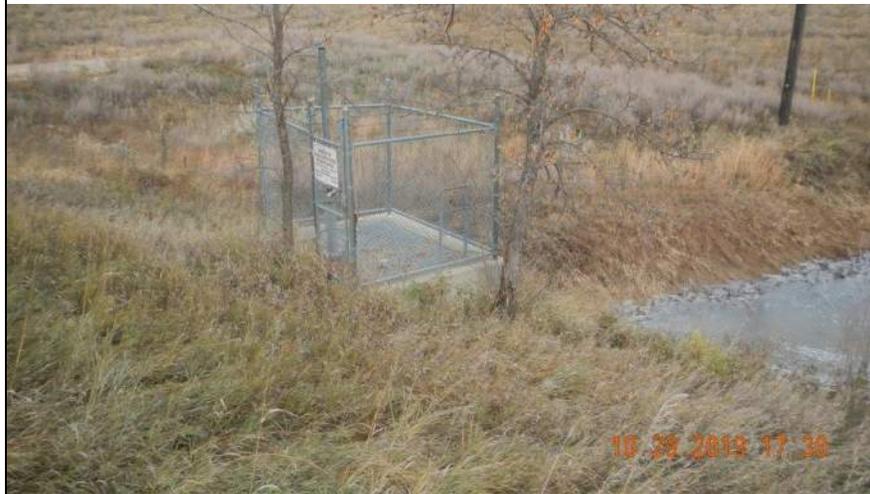
Inspect ID: BMTV_2019_a_0019 **Title:** USACE_CEMVP_BMTV_2019_a_0019_1.jpg **Rated Item:** 1. Vegetation and Obstructions **Caption:** Rating: Unacceptable; Remarks: Large trees and long vegetation growth surrounding the gatewell; Action: Remove unwanted vegetation; Backfill and compact in lifts; Station_1: -05+50

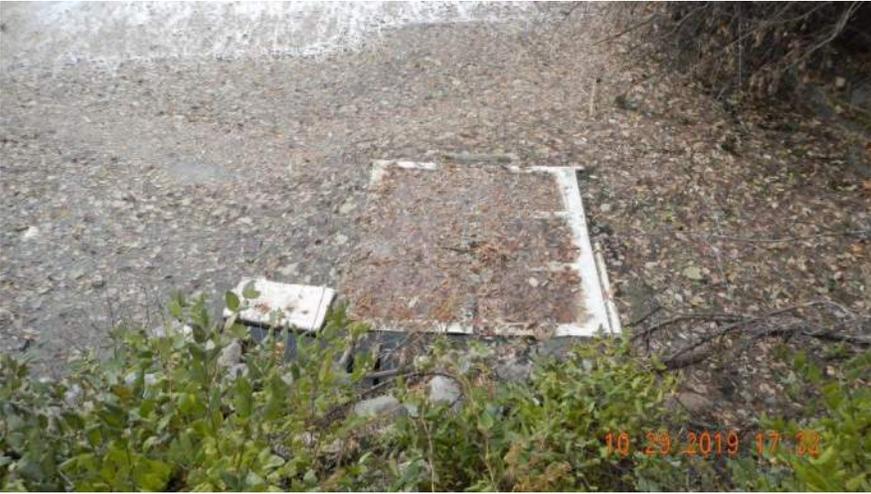
<p>Inspect ID: BMTV_2019_a_0021 Title: USACE_CEMVP_BMTV_2019_a_0021_1.jpg Rated Item: 1. Vegetation and Obstructions Caption: Rating: Unacceptable; Remarks: Large debris blocking inlet; Action: Remove debris from the drainage feature; Sponsor should discourage the public from placing debris within the drainage feature; Station_1: -5+00</p>

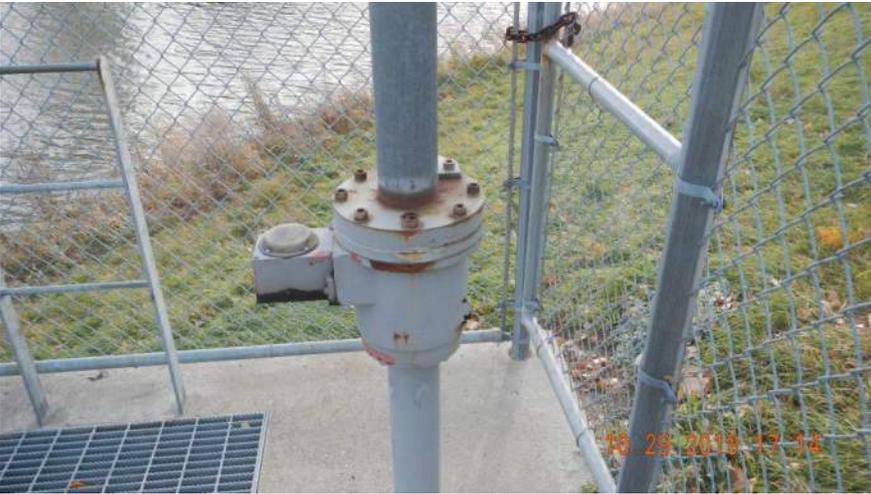
<p>Inspect ID: BMTV_2019_a_0011 Title: USACE_CEMVP_BMTV_2019_a_0011_1.jpg Rated Item: 10. Sluice/ Slide Gates Caption: Rating: Minimally Acceptable; Remarks: The position indicator cover for Gatewell No. 1 (Oxbow inlet) is weathered and prevents viewing the indicator; Action: Replace indicator cover; Station_1: 1+50</p>

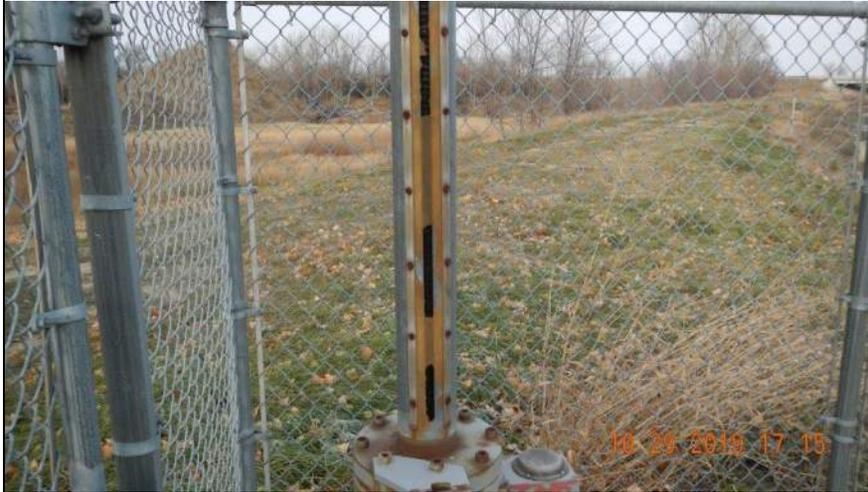
Inspect ID: BMTV_2019_a_0012 **Title:** USACE_CEMVP_BMTV_2019_a_0012_1.jpg **Rated Item:** 10. Sluice/ Slide Gates
Caption: Rating: Minimally Acceptable; Remarks: The plexiglass cover on the stem cover viewing window for Gatewell No. 1 (Oxbow inlet) is broken; Action: Replace viewing stem plexiglass or use PVC pipe to cover the stem preventing water from entering the gate lifter mechanism; Station_1: 1+50

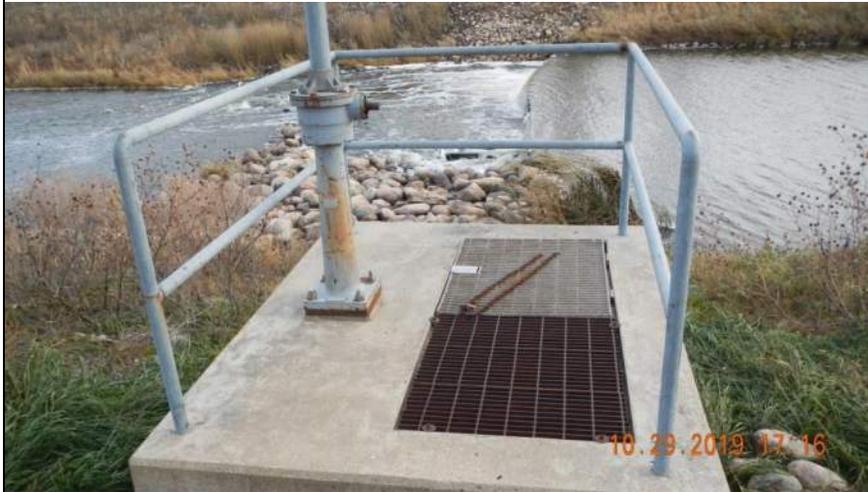
Inspect ID: BMTV_2019_a_0015 **Title:** USACE_CEMVP_BMTV_2019_a_0015_1.jpg **Rated Item:** 10. Sluice/ Slide Gates
Caption: Rating: Unacceptable; Remarks: Local sponsor is not maintaining bypass gatewell; Action: Bypass is to allow water downstream during low flow conditions. Maintain the gatewell in accordance with O&M Manual; Station_1: 0+50

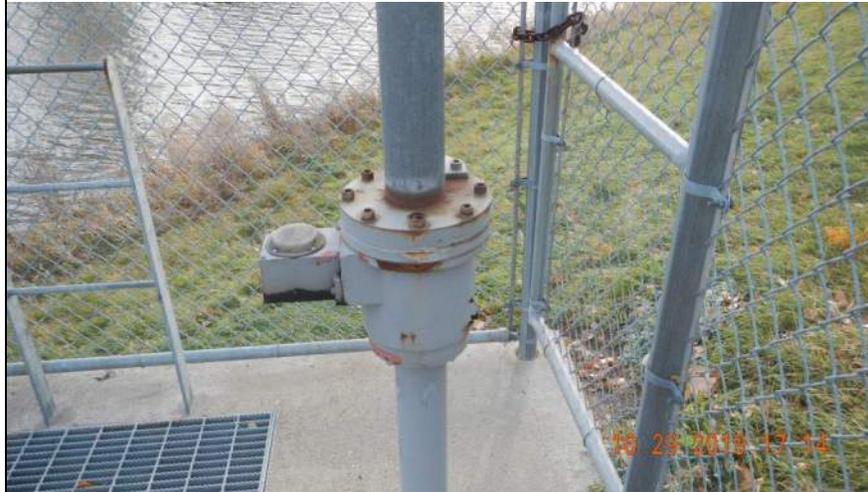
13. Other Metallic Items		A	All metal parts are protected from corrosion damage and show no rust, damage, or deterioration that would cause a safety concern.	BMTV_2019_a_0009: Station_1 0+73: Corrosion, rusting on stem.: Remove corrosion and repaint; Replace metallic item (M) BMTV_2019_a_0020: Station_1 -05+25: Corrosion and cap for gatwewell missing.: Remove corrosion and repaint; Replace metallic item (M)
		M	Corrosion seen on metallic parts appears to be maintainable.	
		U	Metallic parts are severely corroded and require replacement to prevent failure, equipment damage, or safety issues.	
		N/A	There are no other significant metallic items.

Inspect ID: BMTV_2019_a_0009 **Title:** USACE_CEMVP_BMTV_2019_a_0009_1.jpg **Rated Item:** 13. Other Metallic Items
Caption: Rating: Minimally Acceptable; Remarks: Corrosion, rusting on stem.; Action: Remove corrosion and repaint; Replace metallic item
; Station_1: 0+73

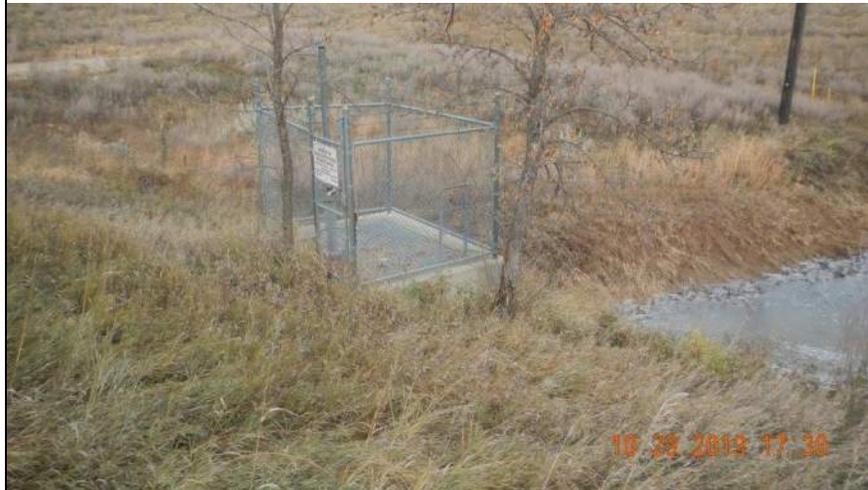
Inspect ID: BMTV_2019_a_0020 **Title:** USACE_CEMVP_BMTV_2019_a_0020_1.jpg **Rated Item:** 13. Other Metallic Items
Caption: Rating: Minimally Acceptable; Remarks: Corrosion and cap for gatwell missing.; Action: Remove corrosion and repaint; Replace metallic item
; Station_1: -05+25

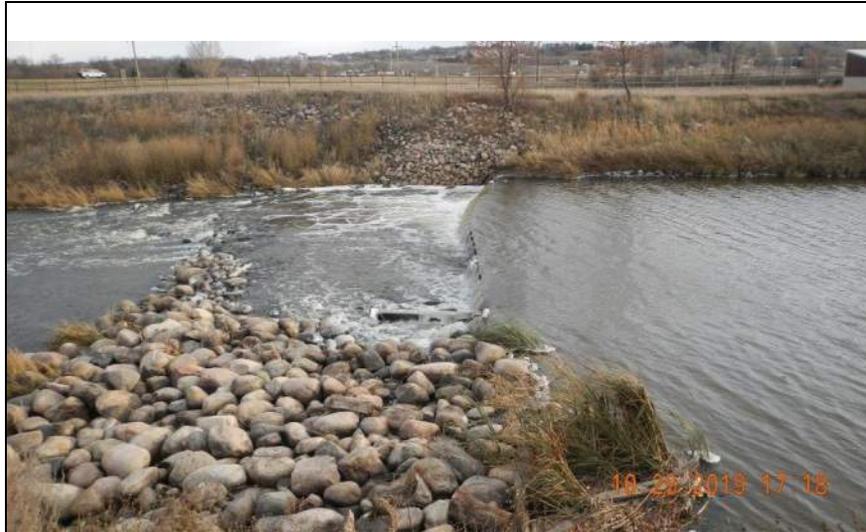
Inspect ID: BMTV_2019_a_0017 **Title:** USACE_CEMVP_BMTV_2019_a_0017_1.jpg **Rated Item:** 6. Tilting, Sliding or Settlement of Concrete Structures **Caption:** Rating: Unacceptable; Remarks: The flood damage reduction channel control structure is bowing downstream; Action: Review control structure design, evaluate current conditions (Scour and rock displacement), and repair. If repair is a change from the original design, a Corps review is required; Station_1: 0+50
