2721 75th St NW

Asbestos Inspection Report – May 1, 2025

As required by the North Dakota Department of Environmental Quality, you requested a pre-resale or demolition asbestos inspection of 2721 75th Street NW. The property consists of six structures which were all inspected for asbestos containing building materials (ACBM). The small barn, greenhouse, shed, and both garages were generally all wood construction with the garages having newer vinyl siding. The home is wood framed with a brick exterior. The house, garages, and shed had asphalt shingles while the barn had wood shakes and the greenhouse was sealant treated wood paneling. The home's Insulation consisted of fiberglass batting and panels. Kevin Ploof, Ackerman-Estvold's Environmental Specialist, conducted these inspections on April 28th, 2025.

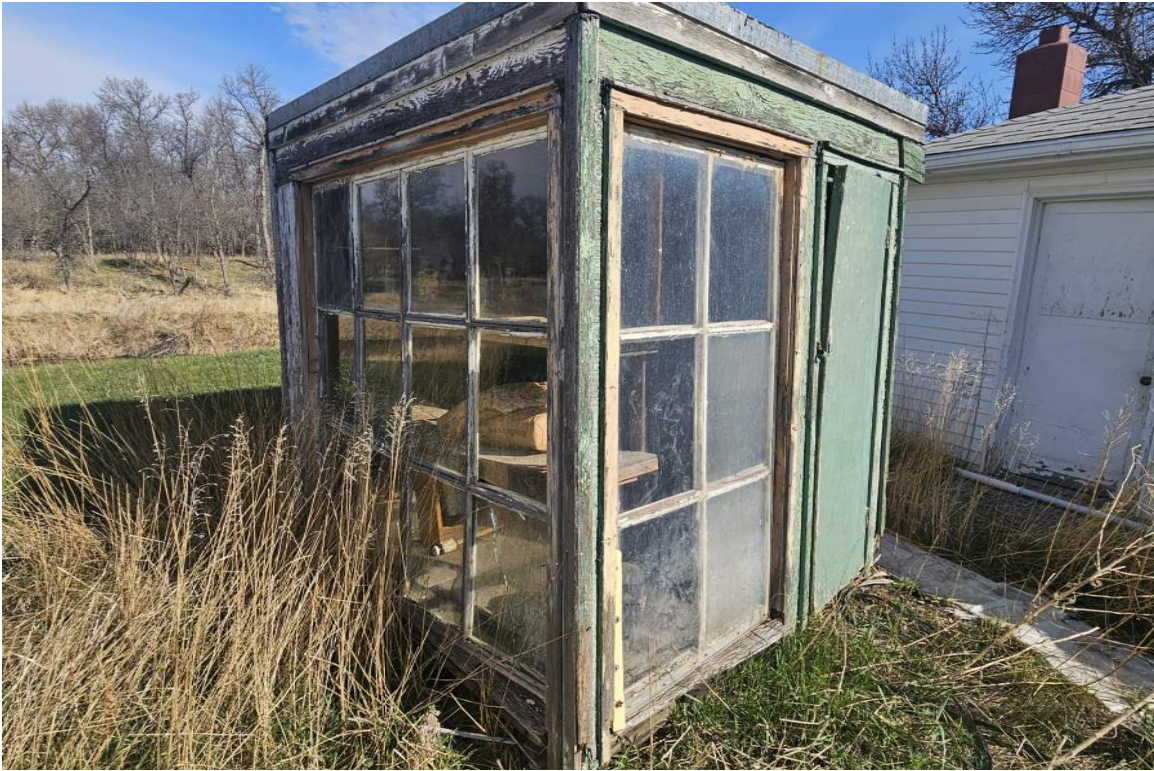
Window glazing on the two greenhouse/potting shed windows totaling 50 SF of window area (samples #9 & #10; Appendix E, Photo 1). This material is in poor condition and should be considered regulated asbestos containing material (RACM).

Photo 1 Window glazing between panes potting shed.

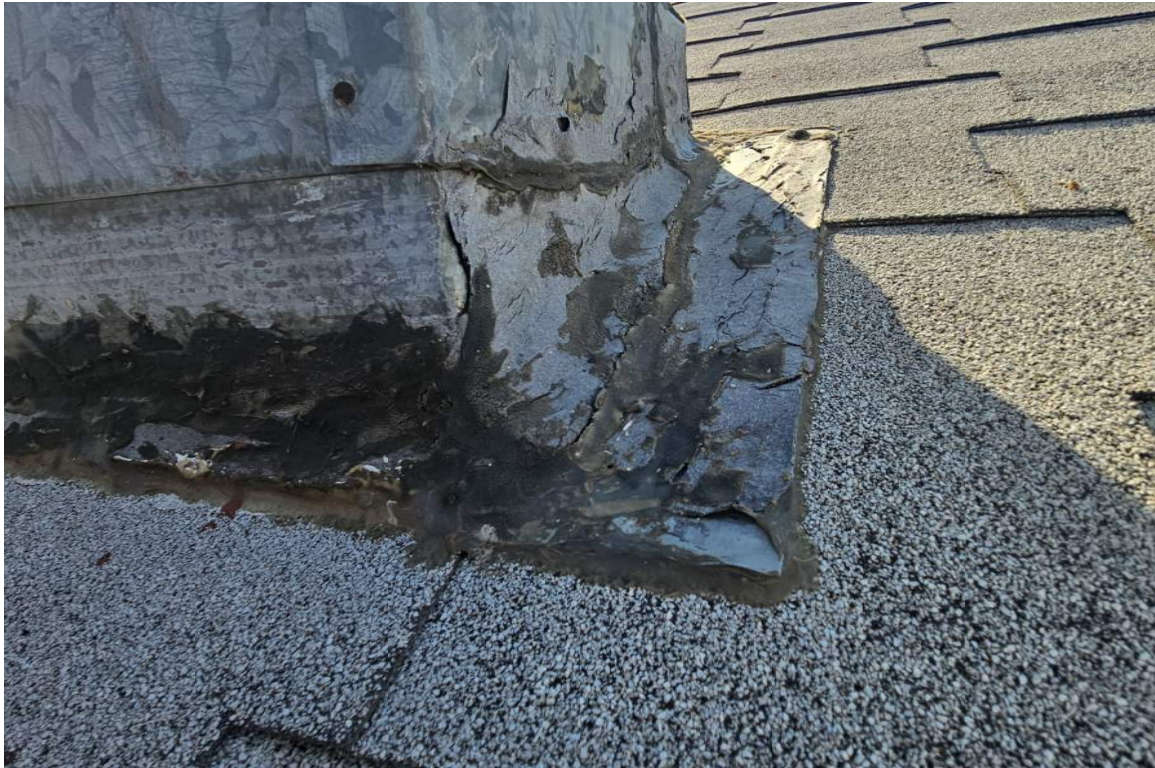
Chimney sealant located on the single stall garage (samples #25 & #26, Appendix E, Photo 2) and the house chimneys (samples #78 & #79, Appendix E, Photo 3) were also found to be ACBM. The garage chimney has just over 3 SF of this sealant and the house chimney appears to have less than 3 SF (the width of the sealant was reduced here). These sealants are Category I Nonfriable ACM. They may need to be removed prior to

renovation but do not have to be removed prior to demolition, if they are in good condition and will not become friable during the demolition activities.

Photo 2 Single garage chimney sealant.

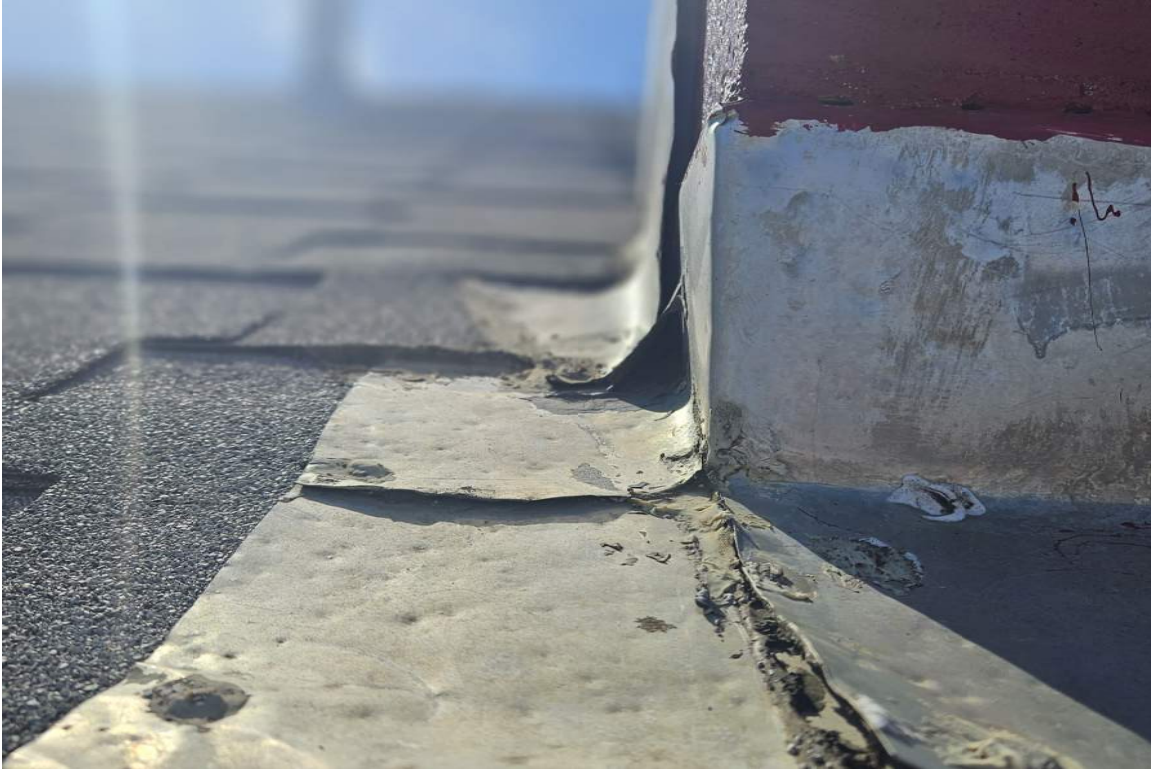
Photo 3. Home Chimney

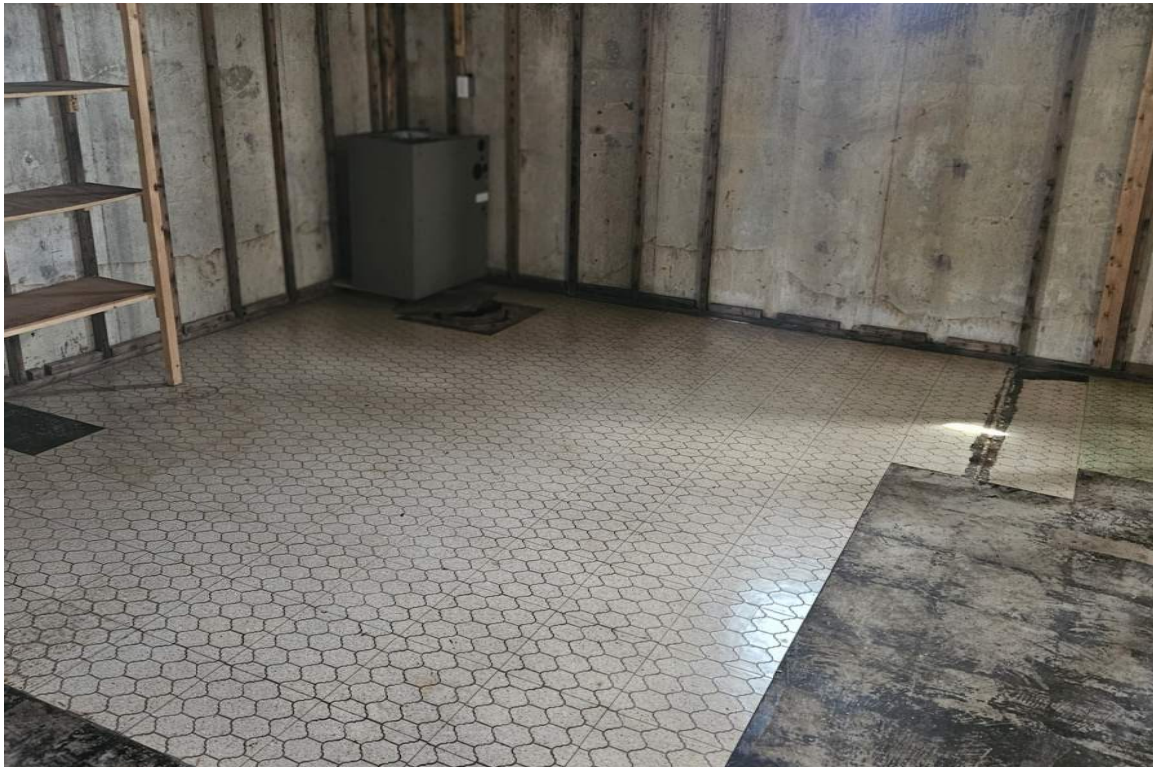
Some 12"x12" vinyl floor tiles (151 SF) located in the home's basement (samples #38 & #39, Appendix E, Photo 4) was found to contain asbestos (mastic was negative).

Photo 4 12" x 12" VCT tiles in basement.

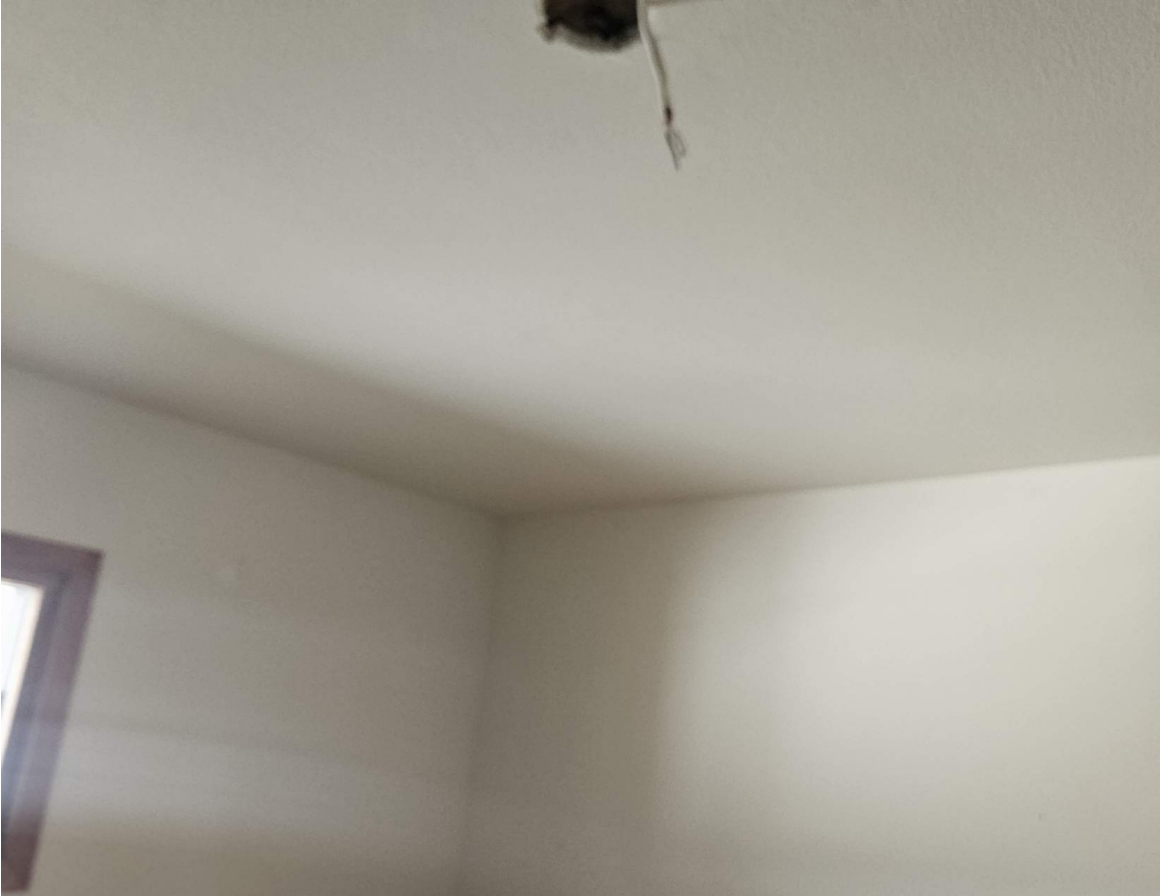
Main floor ceiling drywall (samples #47 & #48, Appendix E, Photos 5 & 6) throughout the home (1500 SF) had positive joint compound but the composite result for these were found to be less than 1% asbestos. Therefore, the ceiling drywall does not require abatement, but the presence of asbestos should be disclosed to any buyer or demolition contractor so that they can act in accordance with any other applicable regulations.

Photo 5. Ceiling drywall example.
