# SYSTEM WIDE IMPROVEMENT FRAMEWORK

## FOR THE SOURIS RIVER BASIN

COMBINED 2019 INTERIM SWIF CONTINUATION  
REPORT AND 2018 ANNUAL SWIF PROGRESS REPORT

2017 ANNUAL SWIF PROGRESS REPORT  
WARD COUNTY LEVEE SYSTEMS

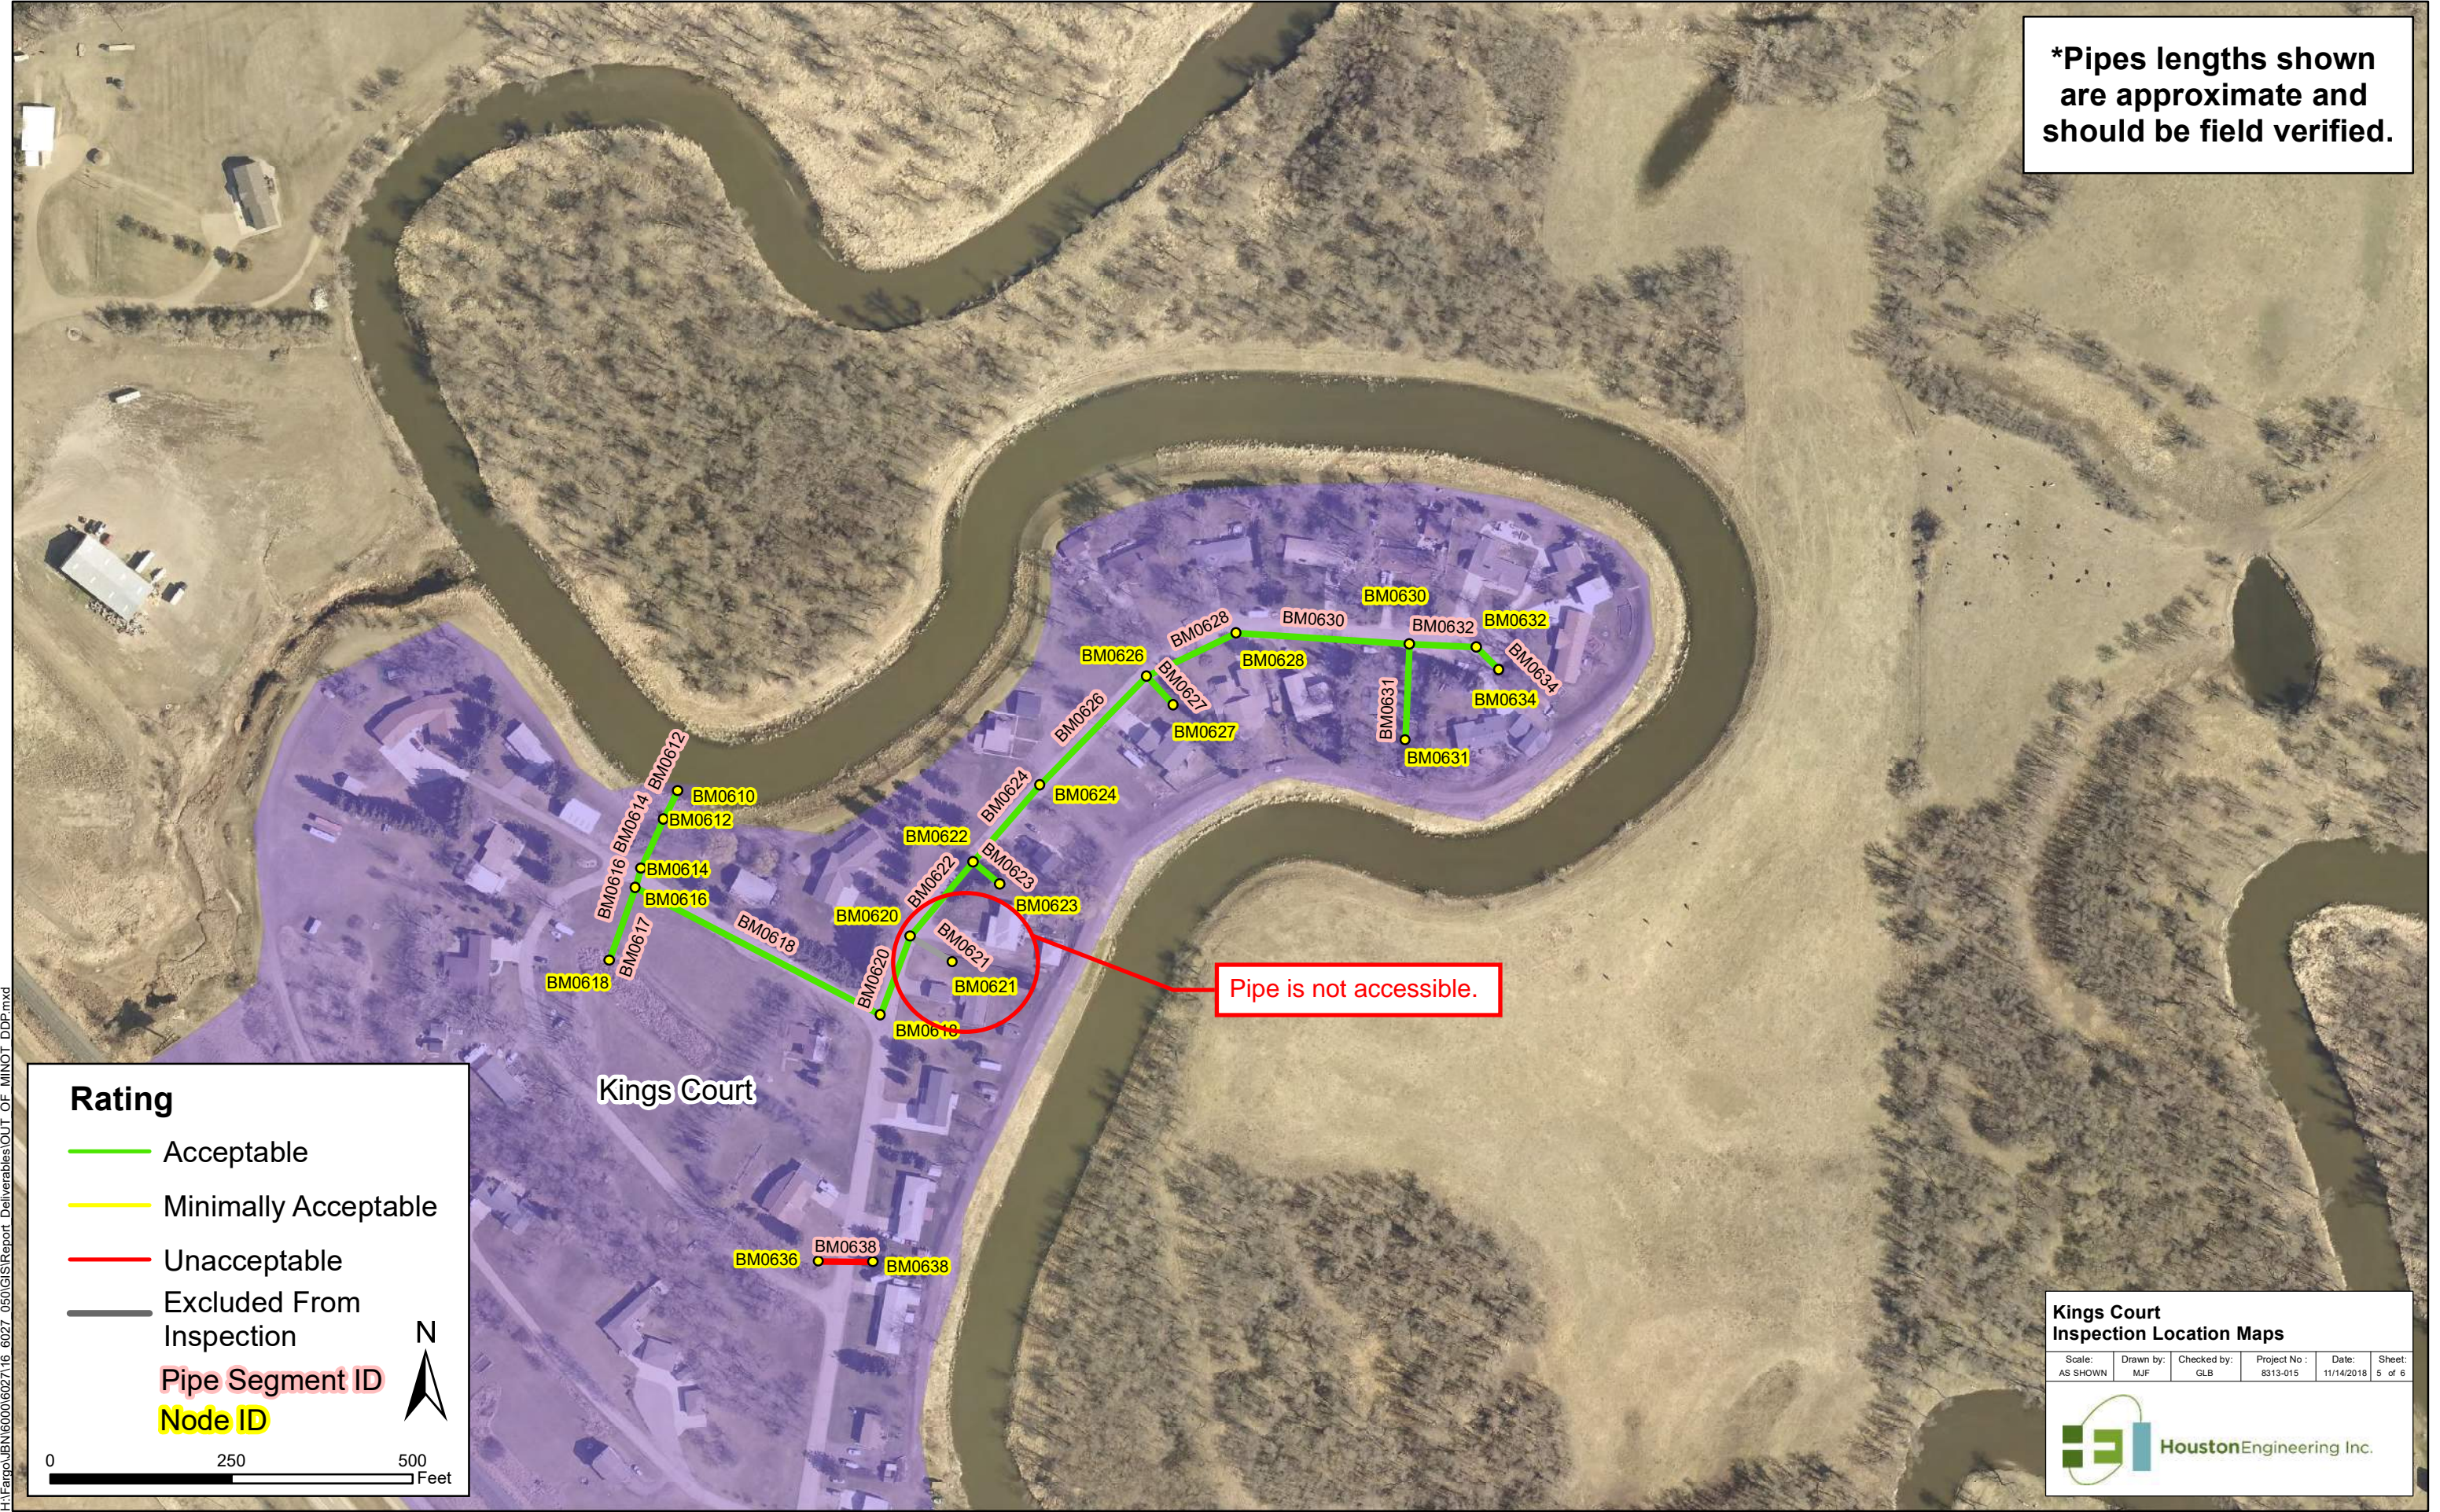
Pipe is not accessible.

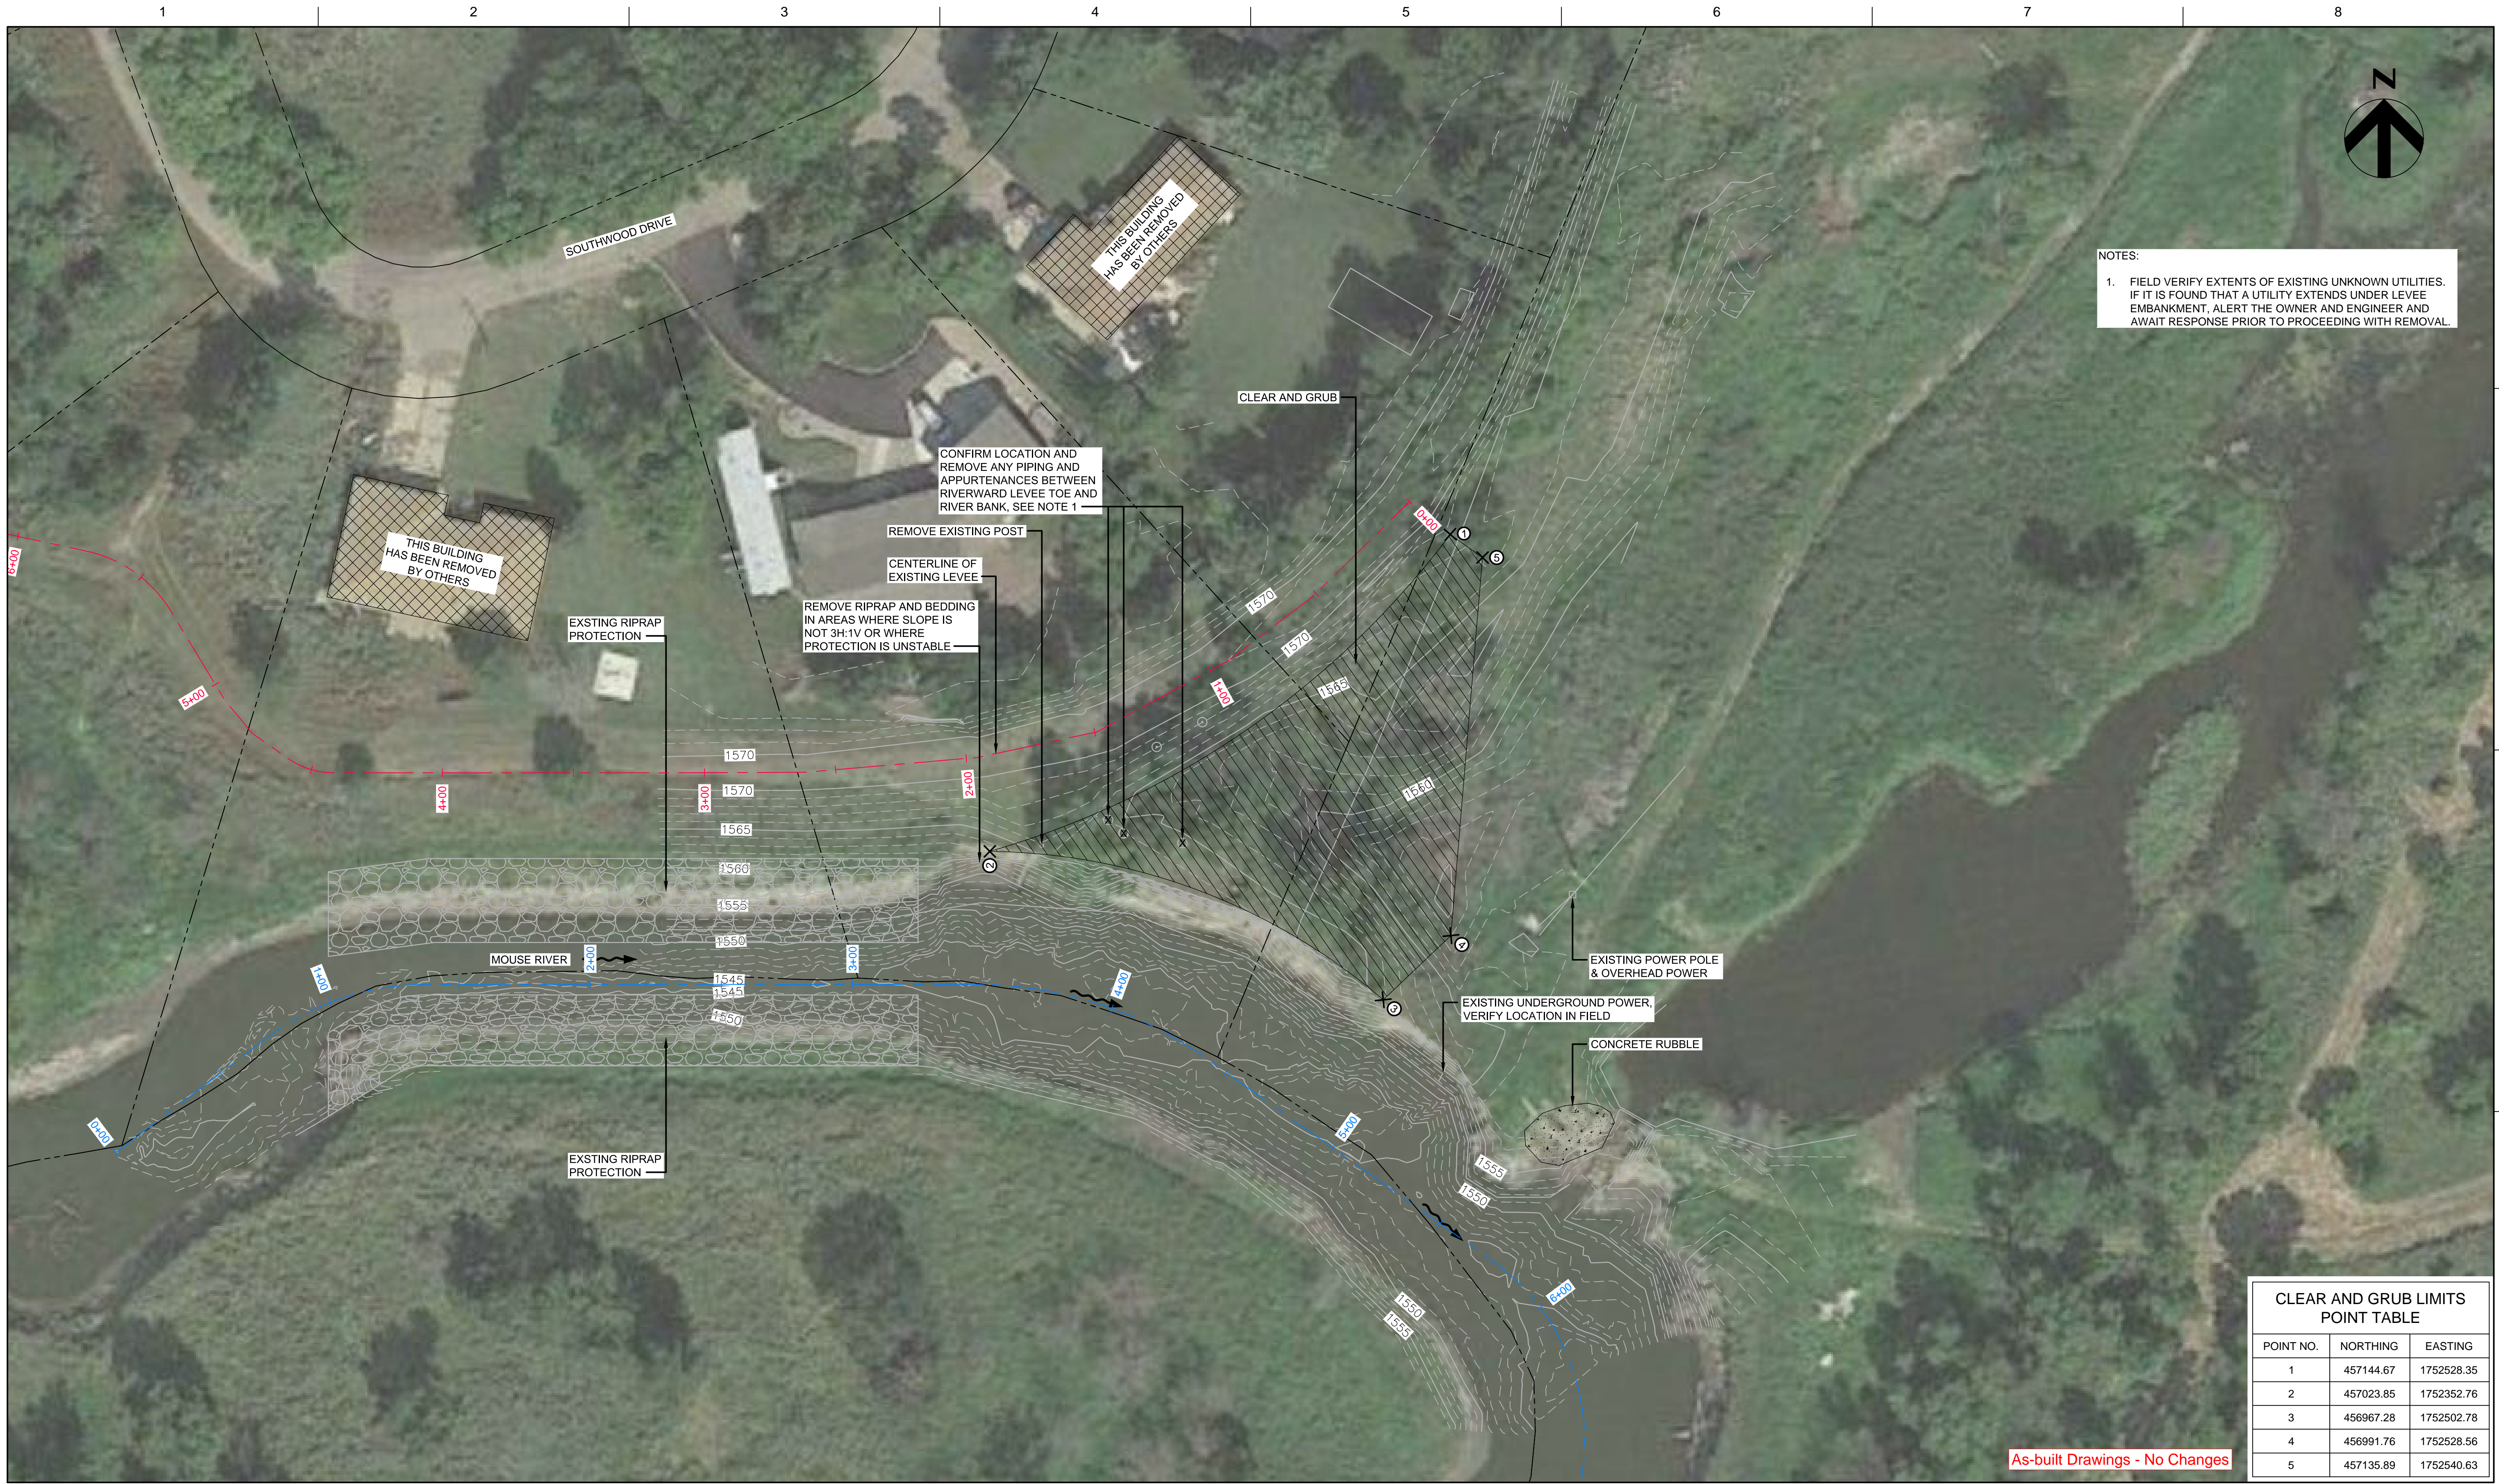
SHEET  
**00V101**

**EXISTING CONDITIONS**

NOTES:  
 1. FIELD VERIFY EXTENTS OF EXISTING UNKNOWN UTILITIES. IF IT IS FOUND THAT A UTILITY EXTENDS UNDER LEVEE EMBANKMENT, ALERT THE OWNER AND ENGINEER AND AWAIT RESPONSE PRIOR TO PROCEEDING WITH REMOVAL.

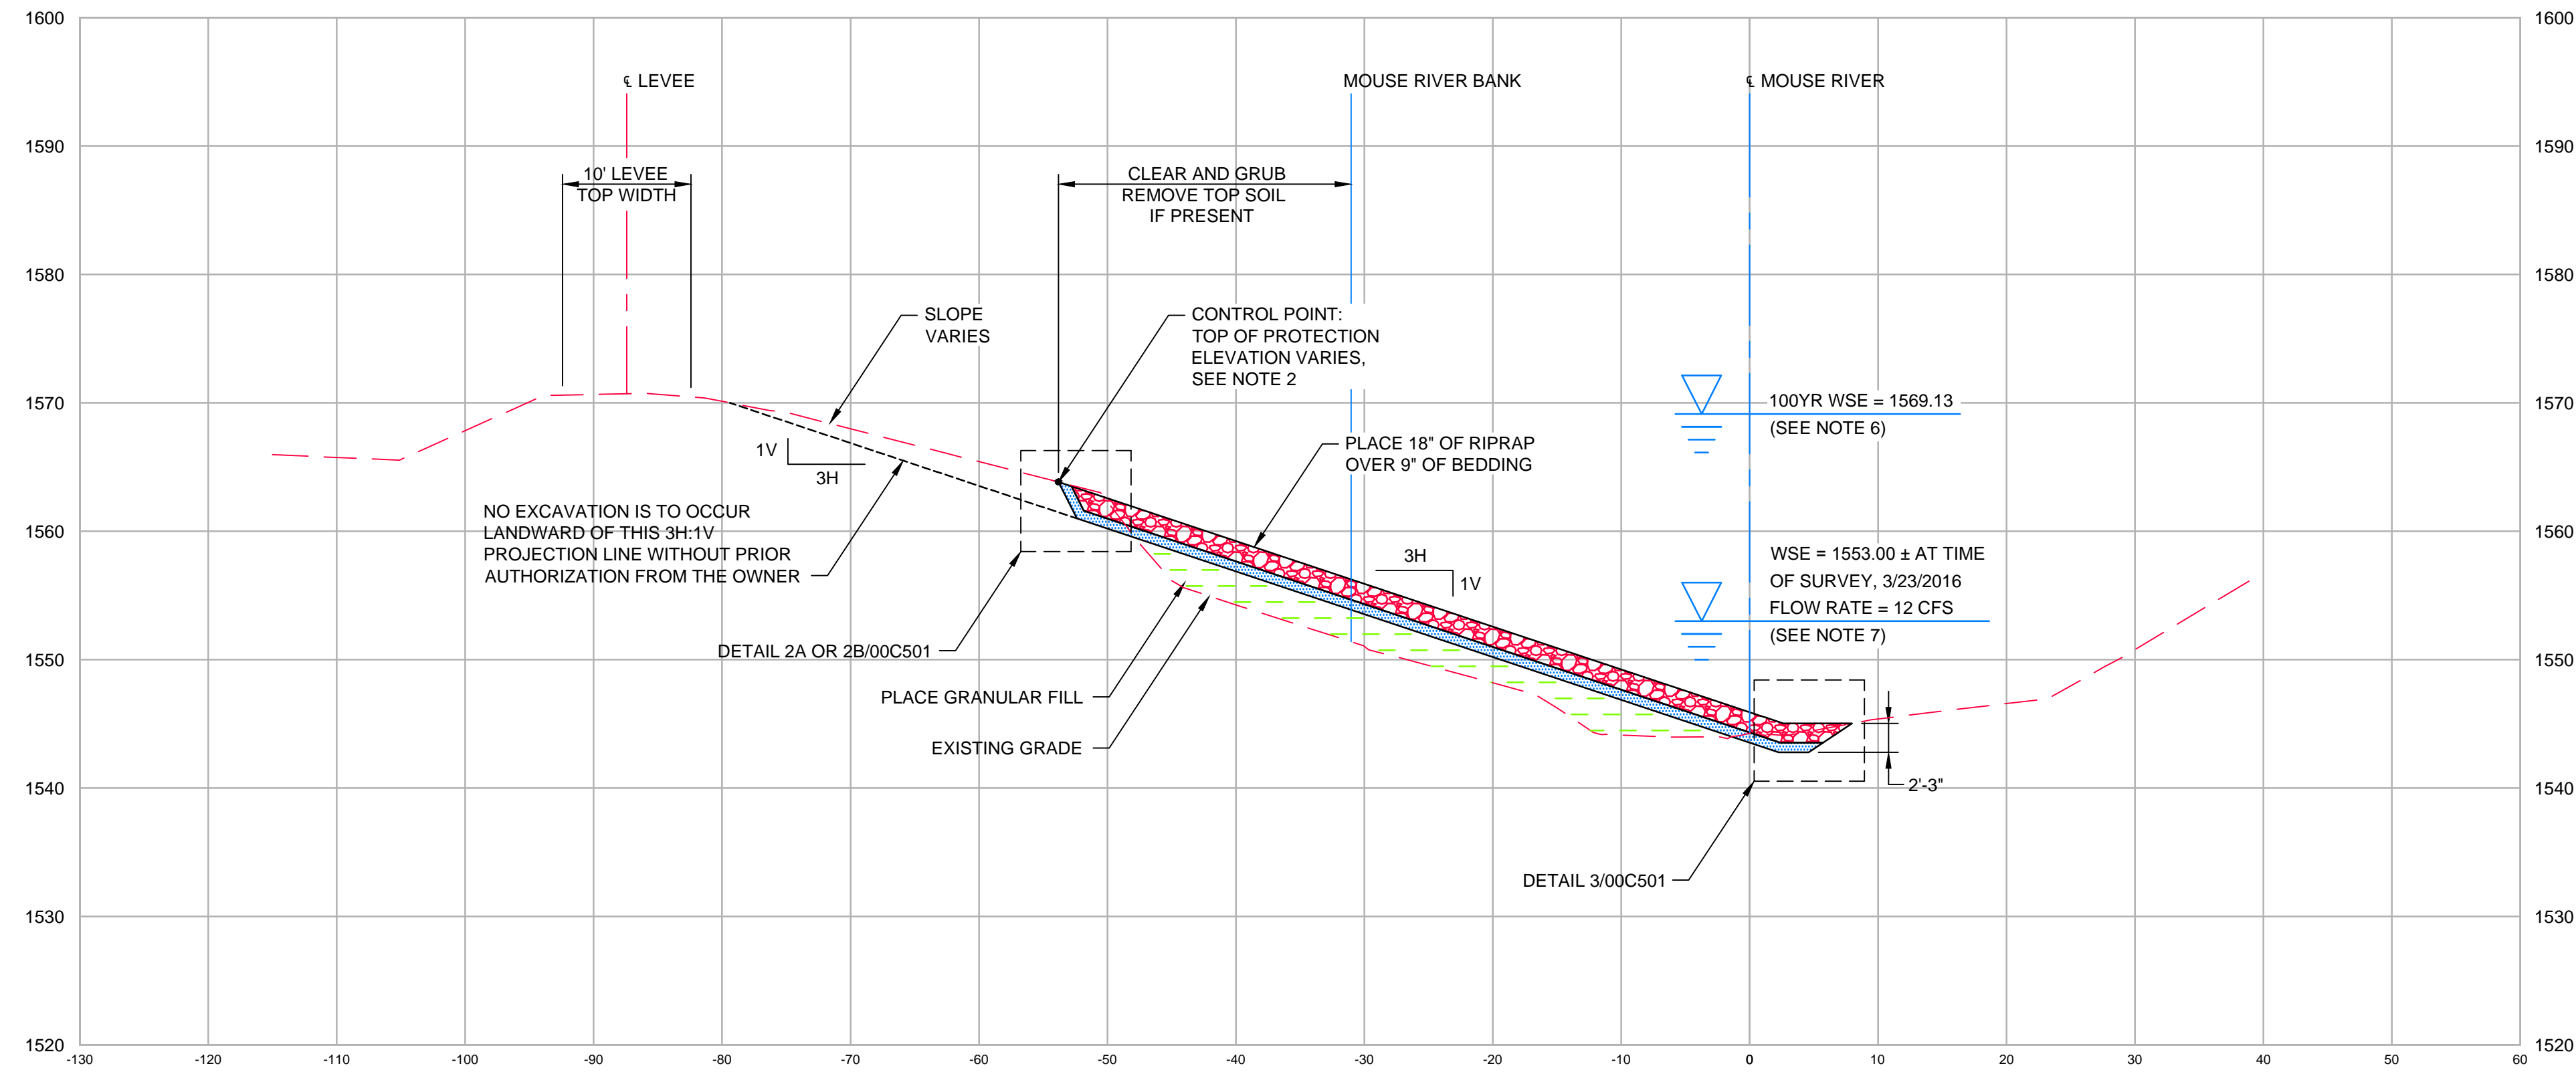
SECTION A  
STA 3+50

- NOTES:
1. CENTERLINE OF RIVER, CENTERLINE OF LEVEE AND RIVER BANK LOCATIONS ARE APPROXIMATE.
  2. SEE CONTROL TABLE ON SHEET 00C101 FOR TOP OF PROTECTION ELEVATIONS.

3. WASTE EXCAVATED SOILS WITHIN THE LAYDOWN AREA OR REMOVE EXCAVATED SOILS FROM THE SITE. SOILS WASTED IN LAYDOWN AREA ARE TO BE GRADED TO DRAIN, COVERED WITH TOPSOIL AND SEEDED.

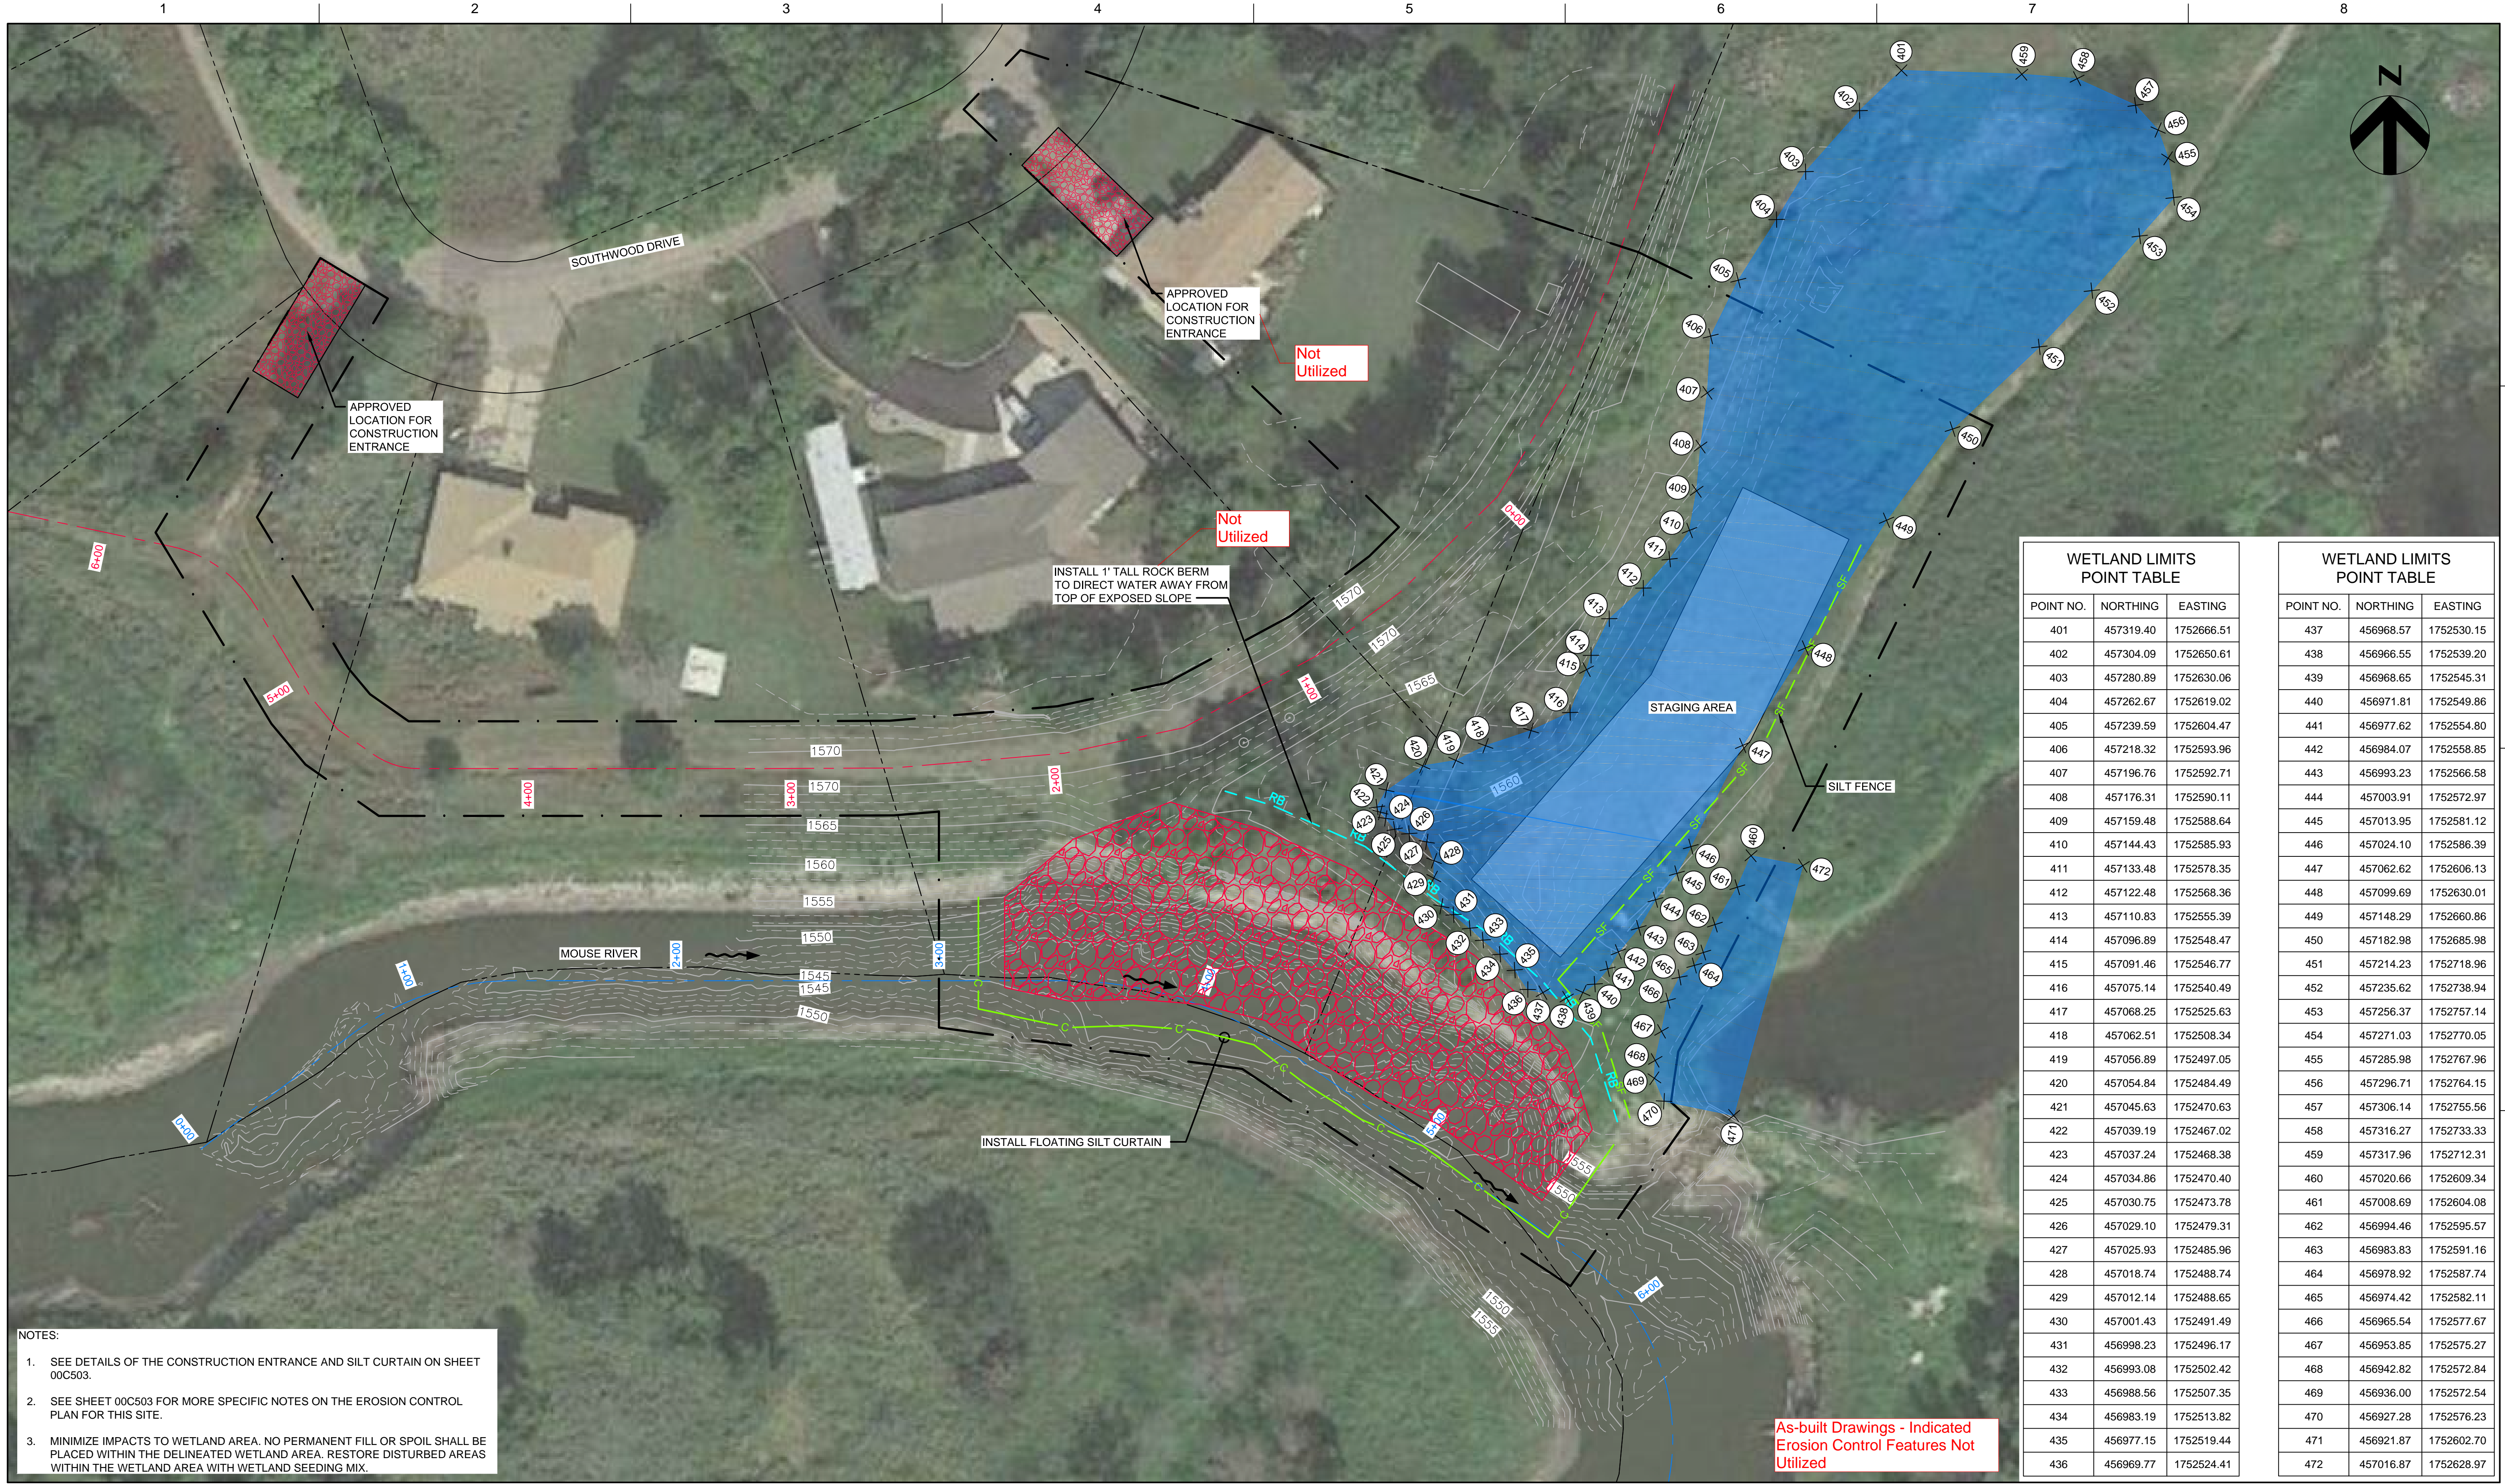
EROSION CONTROL PLAN

As-built Drawings - Indicated Erosion Control Features Not Utilized
