## Flood Damage Reduction Segment / System Inspection Report

Name of Segment / System: Souris River - Minot - Left Bank

Inspection Start Date: 10/30/2019

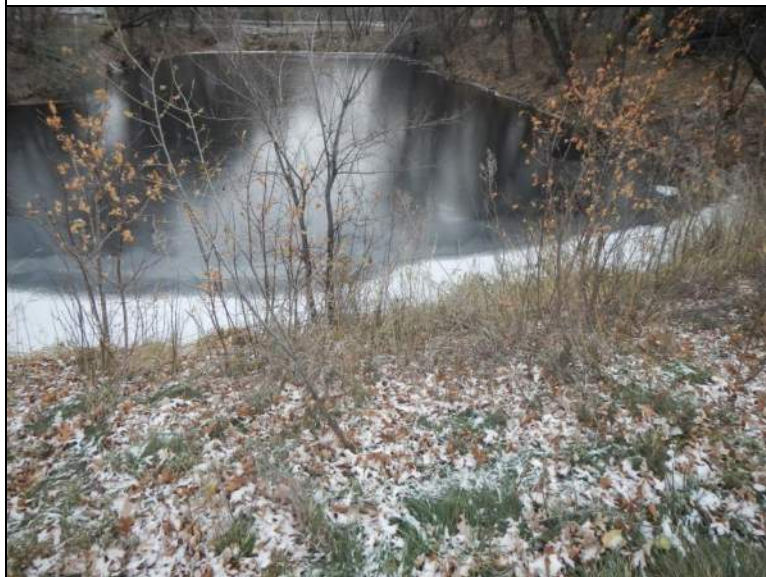
**Inspect ID:** MINL\_2019\_a\_0071 **Title:** USACE\_CEMVP\_MINL\_2019\_a\_0071\_1.jpg  
**Rated Item:** 1. Vegetation and Obstructions **Caption:** Rating: Minimally Acceptable;  
**Remarks:** Sediment is partially blocking a discharge pipe in the ponding area. Could not observe; **Action:** Remove obstructions and sediment from ponding area; **Station\_1:** 648+32

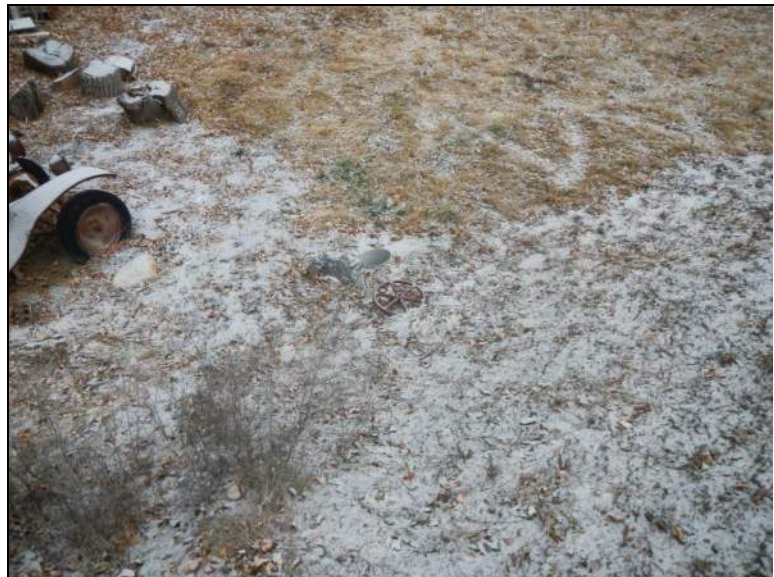
<p><b>Inspect ID:</b> MINL_2019_a_0076 <b>Title:</b> USACE_CEMVP_MINL_2019_a_0076_1.jpg <b>Rated Item:</b> 9. Culverts/ Discharge Pipes <b>Caption:</b> Rating: Unacceptable; Remarks: Culvert through levee leaked during the 2011 flood event. 2017 NOTE: Did not observe culvert, photograph is of nearby area; Action: Determine cause of leaking; Repair culvert as necessary to prevent future leakage; Station_1: 638+37L</p>
